Seismic Vulnerability of Urban Vernacular Buildings in Nepal: Case of Newari Construction

Dipendra Gautam & Hugo Rodrigues

This paper analyzes the seismic vulnerability of vernacular Newari buildings in Nepal. Based on the damage statistics and failure modes recorded during 1934, 1988, 2011, and 2015 earthquakes, damage probability matrices and seismic fragility functions are derived in this paper. Notable seismic features of the Newari buildings are identified and reported using forensic approach. The result of this study highlights that the vernacular Newari buildings are highly vulnerable in the case of minor to major earthquakes; however, the seismic features have contributed to downscale the damage extent.

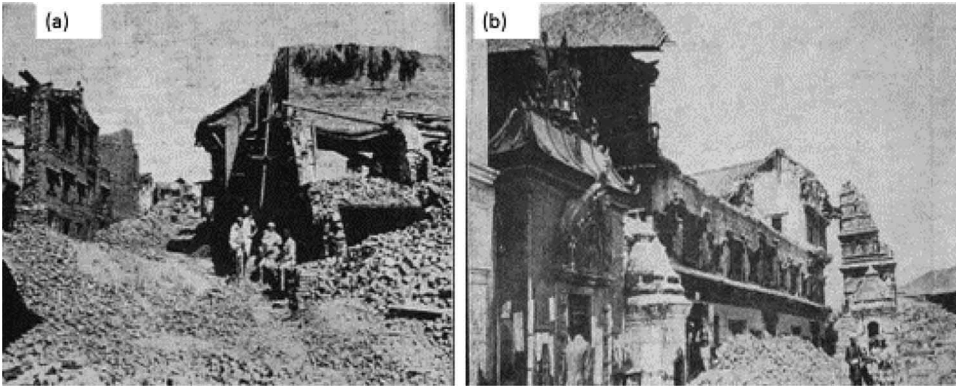
Images taken by Rana [1935] after the earthquake confirm that the buildings at the corner of row housing settlements were damaged more than the standalone buildings. This may be due to combination of vulnerability as well as additional lateral load imposed by adjoining buildings.

Figure 3. (a) Combined in-plane and out-of-plane failure in masonry walls (courtesy: [Rana, 1935]) (b) collapse occurred in the upper story due to mass concentration (courtesy: [Rana, 1935]).

The description presented by Rana [1935] also considered some of the improvement measures for post-earthquake reconstruction as: (a) use well-dried bricks with smooth finish; (b) Oil mixed and dried bricks “*Chiga: appa*” are better than other brick types; (c) do not construct more than a story with raw bricks; (d) use light roofing; (e) limit the height of vernacular buildings to 51 ft.; (f) mix cow dung for improved mortar quality; (g) use timber posts rather than brick pillars; (h) avoid river banks and land plots beside the ponds for construction; (i) provide timber band “*Nas*” in masonry walls; (j) reduce weight of gable portion; (k) provide sufficient masonry wall in between the openings; (l) lime mortar is superior to mud mortar or mud with cow dung; and (m) determine building height and foundation depth per the quality of construction materials.

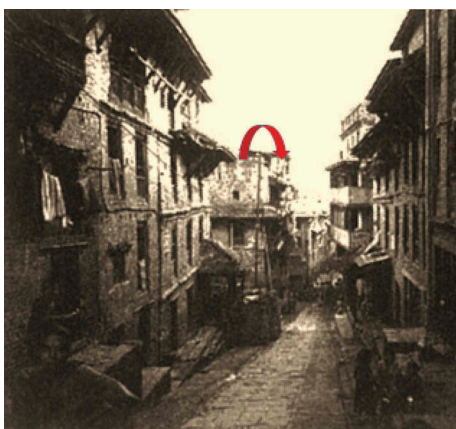
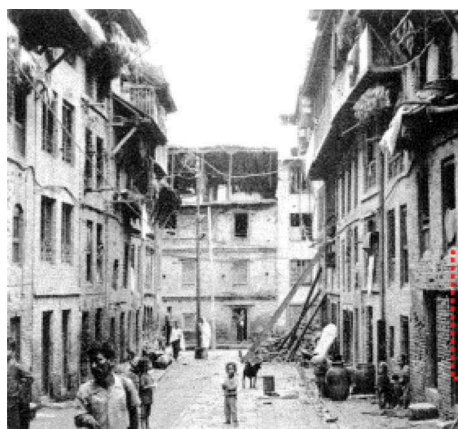
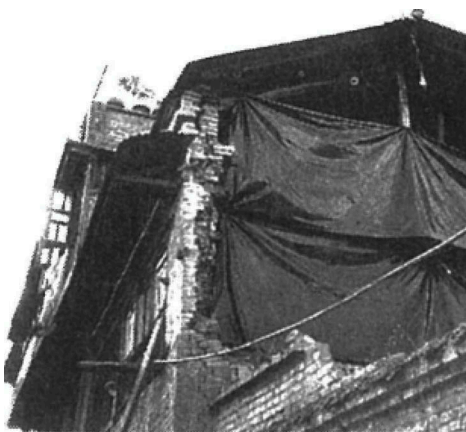
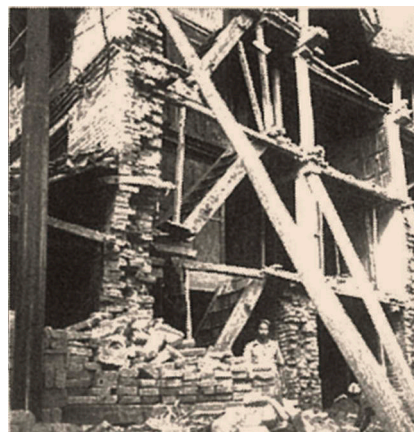
Figure 4. (a) Damaged buildings in the sloping ground due to Udaypur earthquake (courtesy: [Gupta, 1988]) (b) structural pounding in row houses (courtesy: [Gupta, 1988]) (c) gable collapse (courtesy: [Fujiwara *et al.*, 1989]) (d) damage due to in-plane and out-of-plane mechanisms (courtesy: [Fujiwara *et al.*, 1989]).

joists; (k) heavy gable construction and roofing (Fig. 4c; l) heavy masonry wall (thickness ≥ 500 mm); (m) in-plane and out-of-plane mechanisms (Fig. 4d; n) improper opening placement [Fig. 5]; and (o) cantilevered projections.

Following their field investigation, Fujiwara *et al.* [1989] recommended some measures of earthquake-resistant constructions as: (a) lower the overall building weight avoiding the brick topping on floor level and replace the heavy roof by corrugated iron sheets or thatch; (b) restrain the gable wall along with the main structural walls below it so that a matchbox construction will be developed which assures better structural integrity; (c) place horizontal bracing in roof and floor slabs and also provide diagonal bracing at the corners; and (d) improve mortar quality.

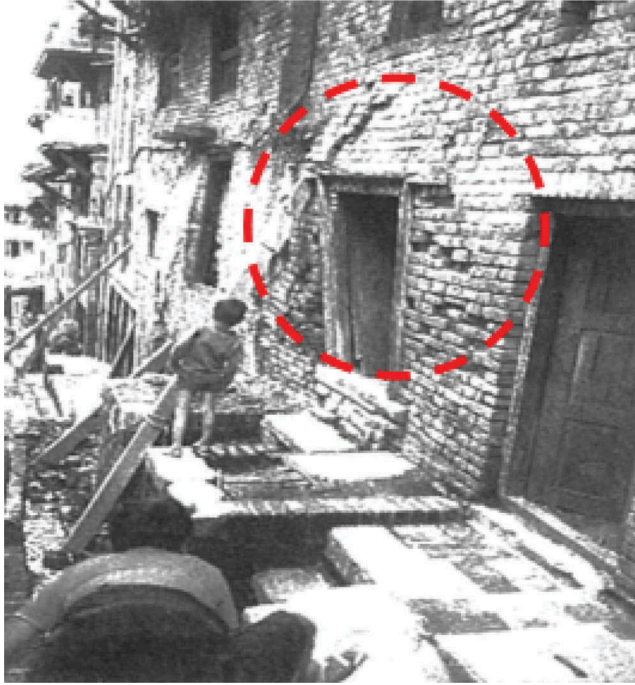
Figure 5. Bulged wall observed above the door after the Udaypur earthquake (courtesy: [Fujiwara *et al.*, 1989]).

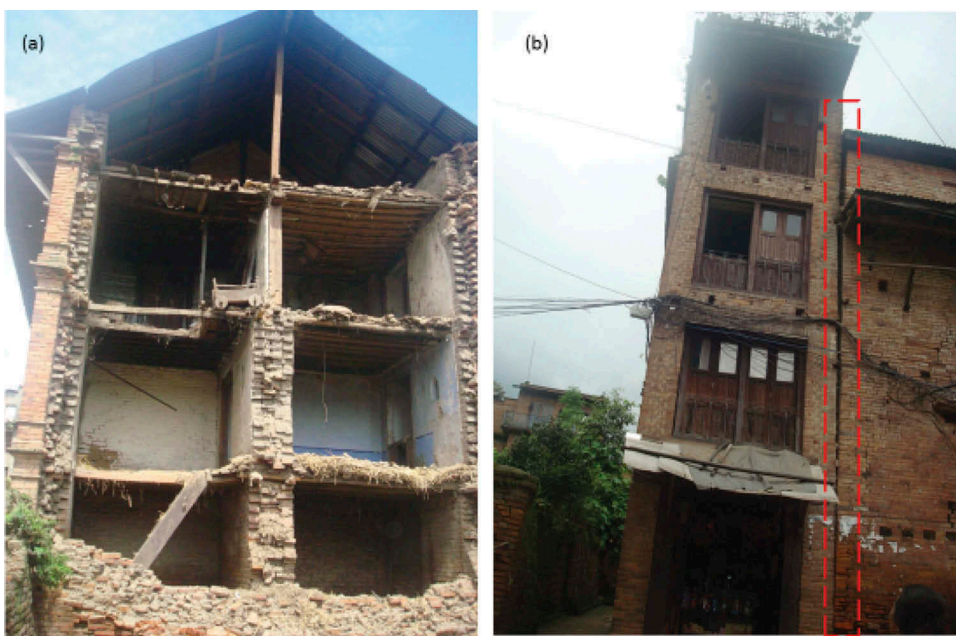
Figure 6. (a) Out-of-plane collapse of masonry wall (courtesy: Ganesh Kumar Bhattarai), and (b) structural pounding due to the Sikkim-Nepal border earthquake (courtesy: Ganesh Kumar Bhattarai).

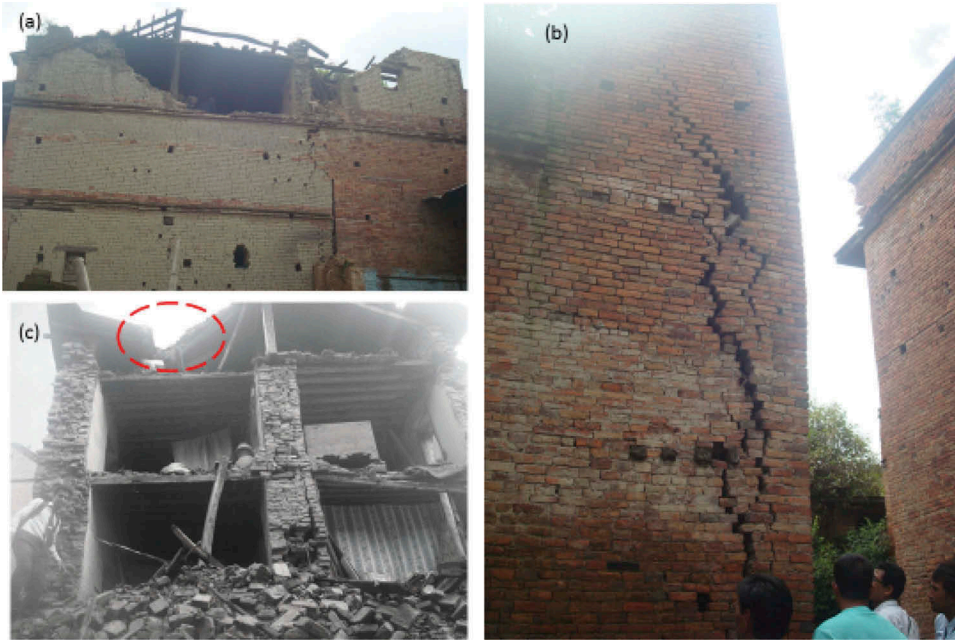
Figure 7. (a) Gable collapse occurred in two adjoining buildings (courtesy: Ganesh Kumar Bhattarai), (b) cracks propagated toward the corners (courtesy: Ganesh Kumar Bhattarai), (c) heavy roof collapse and out-of-plane failure of brick masonry wall occurred due to the Sikkim-Nepal border earthquake (courtesy: Ganesh Kumar Bhattarai).

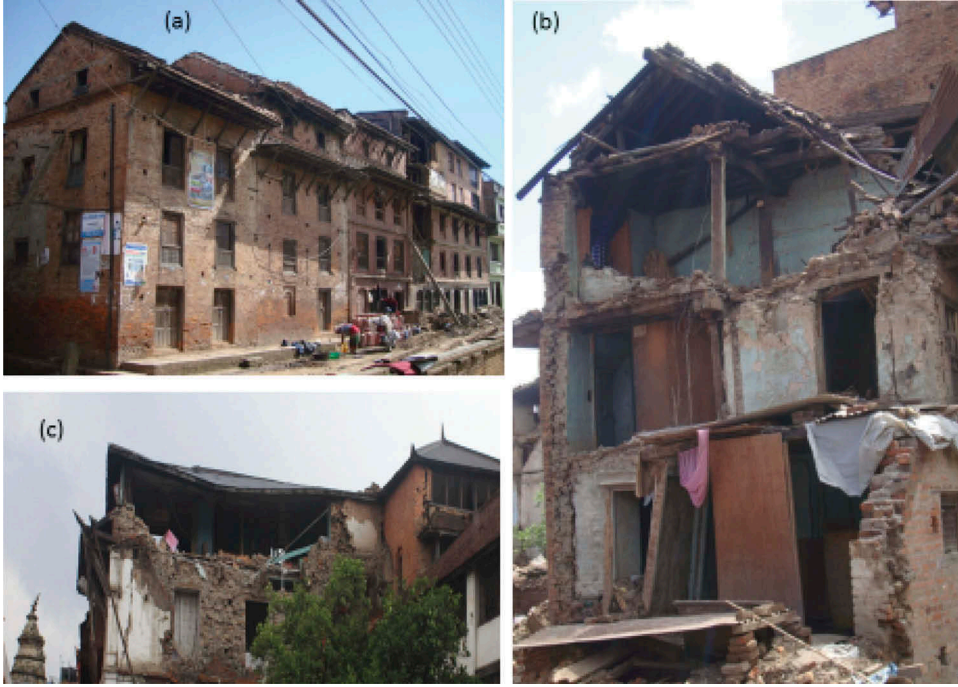
Damage element/aspect	Damage scenario
Roof	<ul style="list-style-type: none"> • Heavy roofs constructed using roof tiles sustained partial roof collapse [Fig. 9a] • Galvanized iron sheets performed well
Gable wall	<ul style="list-style-type: none"> • Out of plane failure was commonly observed [Fig. 9b] • Majority of the buildings were lacking proper connection between gable and the masonry wall [Fig. 9c]
Projections Wall	<ul style="list-style-type: none"> • Wooden projections (various forms of windows) performed well [Fig. 10a] • Out-of-plane failure was observed as the most common failure mechanism [Fig. 9c] • Walls at the edge of the settlement suffered progressive collapse in out-of-plane direction [Fig. 10b] • Out-of-plane collapse of heavy wall constructed in upper stories was also common [Fig. 9c] • Walls were separated due to lack of proper connection and binding between orthogonal walls as well as the structural and partition walls [Fig. 11a] • Veneered partition walls performed better than the brick masonry partitions • Few cases of in-plane wall failures were observed in the buildings having many openings and relatively large size • Delamination of wythes was observed in some cases [Fig. 11b]

Figure 9. (a) Minor damage on roof (b) out-of-plane collapse of walls (c) gable collapse occurred due to the Gorkha earthquake.

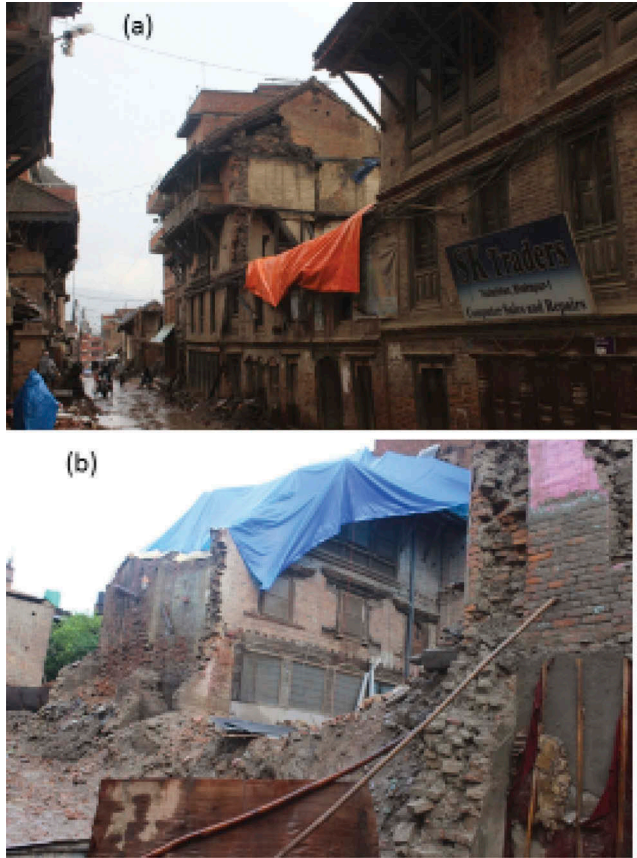
Figure 10. (a) Undamaged projections supported by cantilevered timber joists (b) collapsed wall on the building situated at the corner of row housing settlement due to Gorkha earthquake.

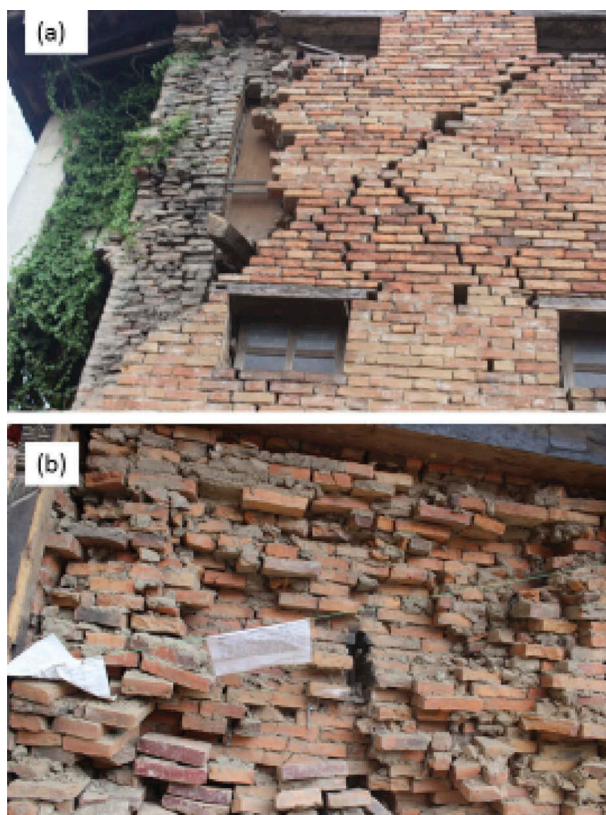
Figure 11. (a) Separation of orthogonal walls (b) delamination of wythes observed after the Gorkha earthquake.

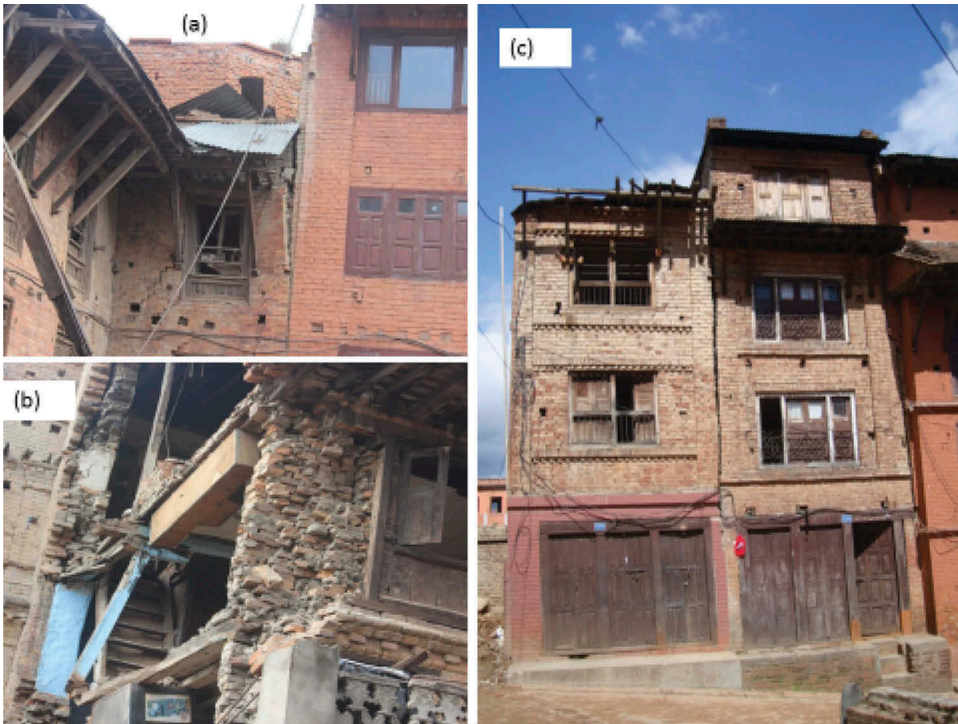
Corner	<ul style="list-style-type: none"> • Reentrant corners were bulged out and large cracks were developed at the interaction region [Fig. 12a] • Corners were constructed without any special provisions thus damage was commonly observed at the corner region • Mud mortar was found to be shrunk throughout the structural system; brick units were observed to be remaining in isolation so that structural integrity and homogeneity was compromised [Fig. 12b]
Structural pounding	<ul style="list-style-type: none"> • Due to row housing system and intermediate modifications (reconstruction) and due to the variation in dynamic properties of adjoining structures, many cases of structural pounding were observed [Fig. 12c] • Sometimes single building was found to be separated exactly into two halves and partial reconstruction done which led to the damage in the remaining older portion of the building. Change in slenderness ratio due to division of single building into two was also observed in many buildings.

Ground floor	<ul style="list-style-type: none"> • For commercial purpose, the ground story was provided with shutters instead of structural masonry wall and damage was also recorded in such buildings [Fig. 12c]
RC slabs over masonry walls	<ul style="list-style-type: none"> • RC slabs over the masonry walls was observed in many buildings and many of such buildings observed damage either in terms of brittle collapse or heavy damage in the entire building [Fig. 13a]
Construction site	<ul style="list-style-type: none"> • Areas like Suryamadhi, Inacho, Golmadhi, Byasi, Jela were more affected due to inclined terrain and in some cases, due to ridgeline effect. Two rows of more than 100 buildings were destroyed in Jenla [Fig. 13b]. Similarly, beside the Suryamadhi square and Byasi neighborhood, all buildings except few RC were collapsed
Mortar	<ul style="list-style-type: none"> • Even after the earthquake, mud mortar was being used [Fig. 13c] for reconstruction; however, almost 60% of the collapsed buildings were constructed using mud mortar

Figure 12. (a) Reentrant corner damage along with structural pounding (b) separated masonry units and the mud-mortar (c) structural pounding observed due to the Gorkha earthquake.

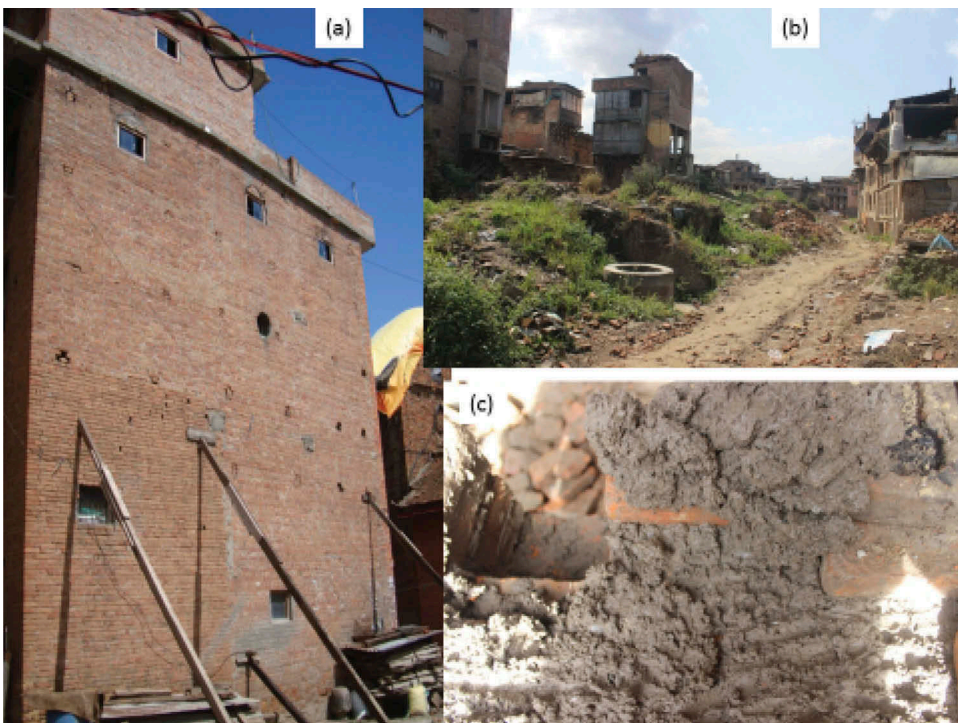
Figure 13. (a) RC slab constructed in the existing brick masonry building which underwent incremental construction after the Gorkha earthquake (b) destroyed neighborhood in Jela ridgeline (c) mud mortar used for reconstruction after the earthquake.

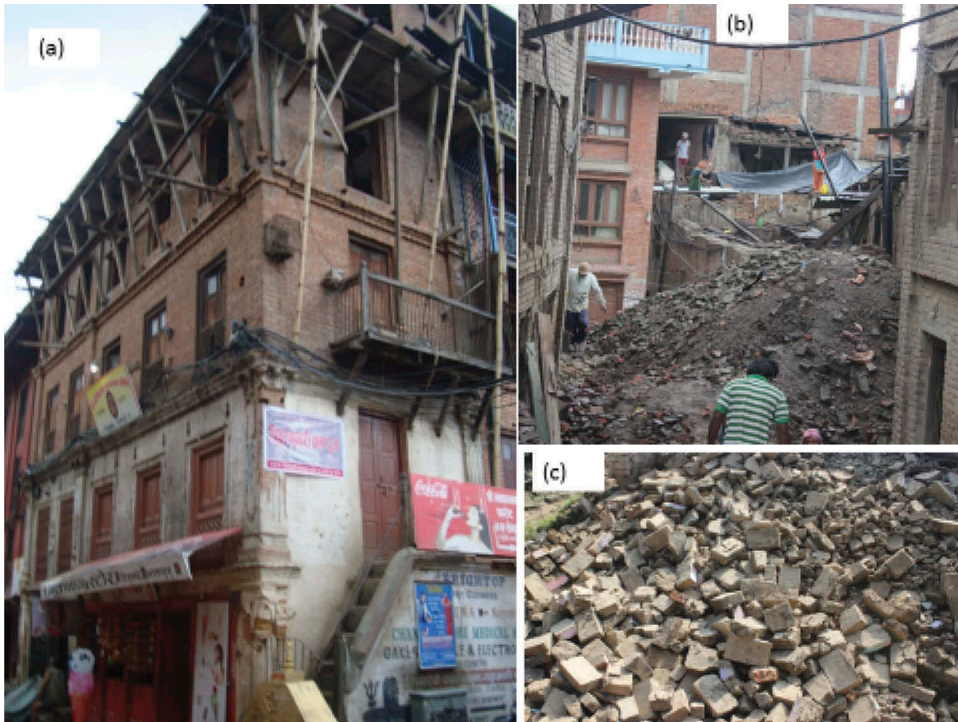
Incremental construction	<ul style="list-style-type: none"> • Many cases of incremental constructions were identified and surprisingly one or two stories of substandard reinforced concrete construction were found in some locations [Fig. 14a]. Even in partly damaged buildings, after three months of the earthquake, some stories of RC were found to be added
Building age and occupancy scenario	<ul style="list-style-type: none"> • Many of the damaged buildings were told be used for at least three generations without any repair and strengthening, even after the earthquakes during 1988 and 2011. The debris from the collapsed buildings was observed to be decayed heavily [Fig. 14b] • Countable fraction of buildings of age more than 82 that sustained the 1934 Bihar-Nepal earthquake were also identified during field reconnaissance
Masonry units	<ul style="list-style-type: none"> • Virtually all collapsed and heavily damaged structures manifested the marginal quality of brick; improperly dried and irregular shaped [Fig. 14c]

Figure 14. (a) Building with masonry and RC incremental constructions above the vernacular masonry construction (b) debris reflects decayed construction materials (c) irregular size and poor quality of bricks used in structural walls.

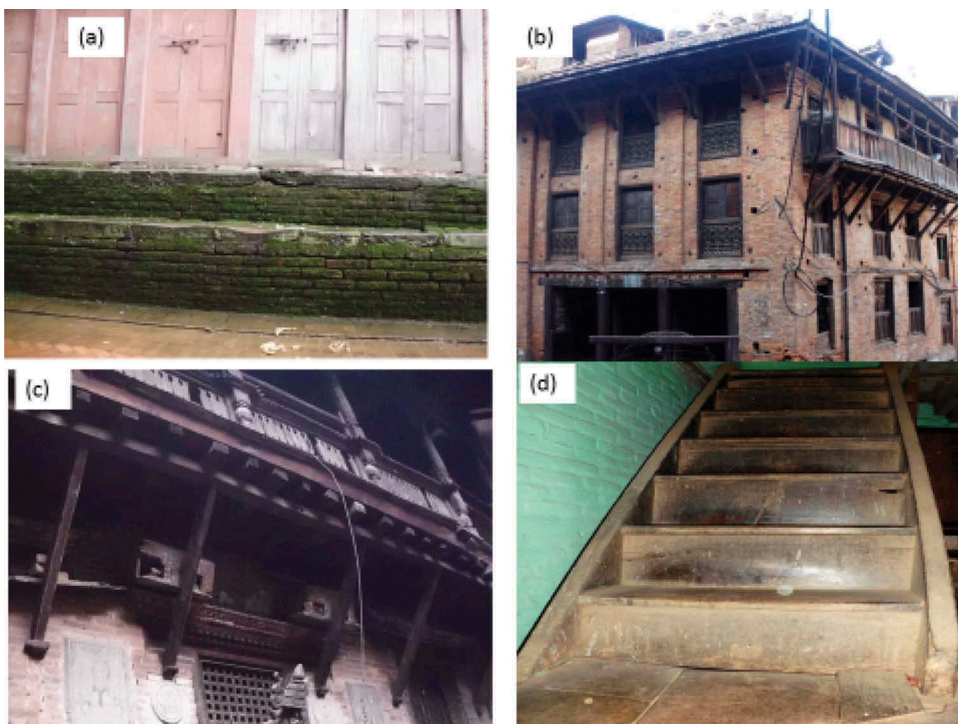
Figure 15. Identified seismic features: a) plinth constructed in sloping ground b) symmetrical building c) timber struts for mainstreaming cantilevered load d) wooden ladder.

Seismic features	Observed/expected contribution
Plinth construction	<ul style="list-style-type: none"> Some of the buildings in sloping sites were found to be provided raised plinths and damage occurrence was relatively insignificant in such buildings [Fig. 15a]
Building shape	<ul style="list-style-type: none"> Virtually all buildings were found to be rectangular assuring $L/B < 3$ provision of Nepal Building Code [Fig. 15b]
Openings	<ul style="list-style-type: none"> Many buildings with smaller openings were observed and damage was found to be marginal; however, the opening size was not responsible for survival of structure solely [Fig. 15b]
Timber struts	<ul style="list-style-type: none"> Measurements in above 40 buildings showed $B \times H$: 1.35×0.64 m size of door in average Timber struts wherever provided were found to be effective in avoidance of heavy roof collapse [Fig. 15c] Cantilevered load was observed to be mainstreamed by timber struts in number of vernacular buildings

Vertical transportation system	<ul style="list-style-type: none"> A significant feature was the light weight wooden ladder [often moveable] constructed from wooden planks [Fig. 15d]
Timber bands at various level	<ul style="list-style-type: none"> Timber bands [sill/lintel/roof] or “Nas” were found to be used in some buildings [Fig. 16a] and out-of-plane mechanism was not observed in such buildings
Wooden pegs	<ul style="list-style-type: none"> In the case of vernacular buildings, several timber units were found to be tied together with wooden pegs and distortions were not observed in local scale
Corner post	<ul style="list-style-type: none"> Quite a few corner posts [brick masonry] were observed, and it was clearly observed that the damage propagation was effectively controlled by corner posts [Fig. 16b]

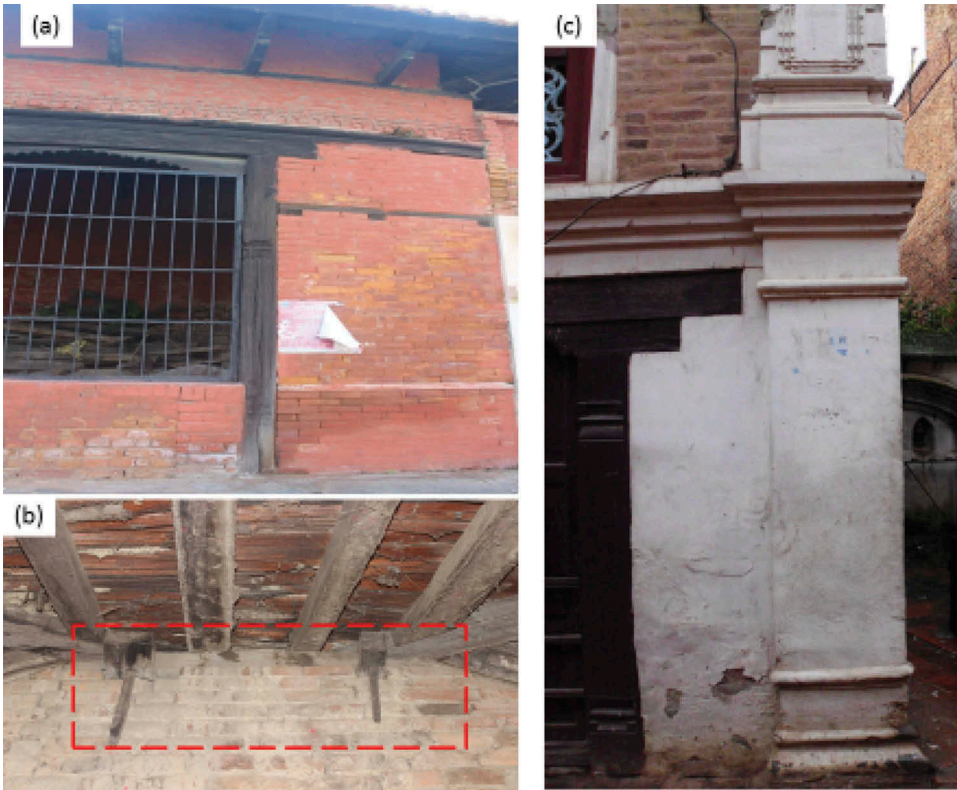
Figure 16. Identified seismic features: (a) timber bands at various levels (b) wooden pegs used to stitch connections (c) corner post.
