# Common structural and construction deficiencies of Nepalese buildings

**Abstract** This paper outlines the common observed failure patterns in the buildings of Nepal after  $M_W$  7.8 Gorkha (Nepal) earthquake. Several types of damage patterns were observed for reinforced concrete buildings, as well as for unreinforced masonry and adobe houses during the reconnaissance survey performed immediately after the earthquake of 25 April 2015. Several field visits in the affected districts were conducted and associated failure/damage patterns have been identified and analyzed. This paper also covers damage patterns in non-engineered buildings, middle and high-rise buildings, commercial complexes, administrative buildings, schools and other critical facilities from Kathmandu valley as

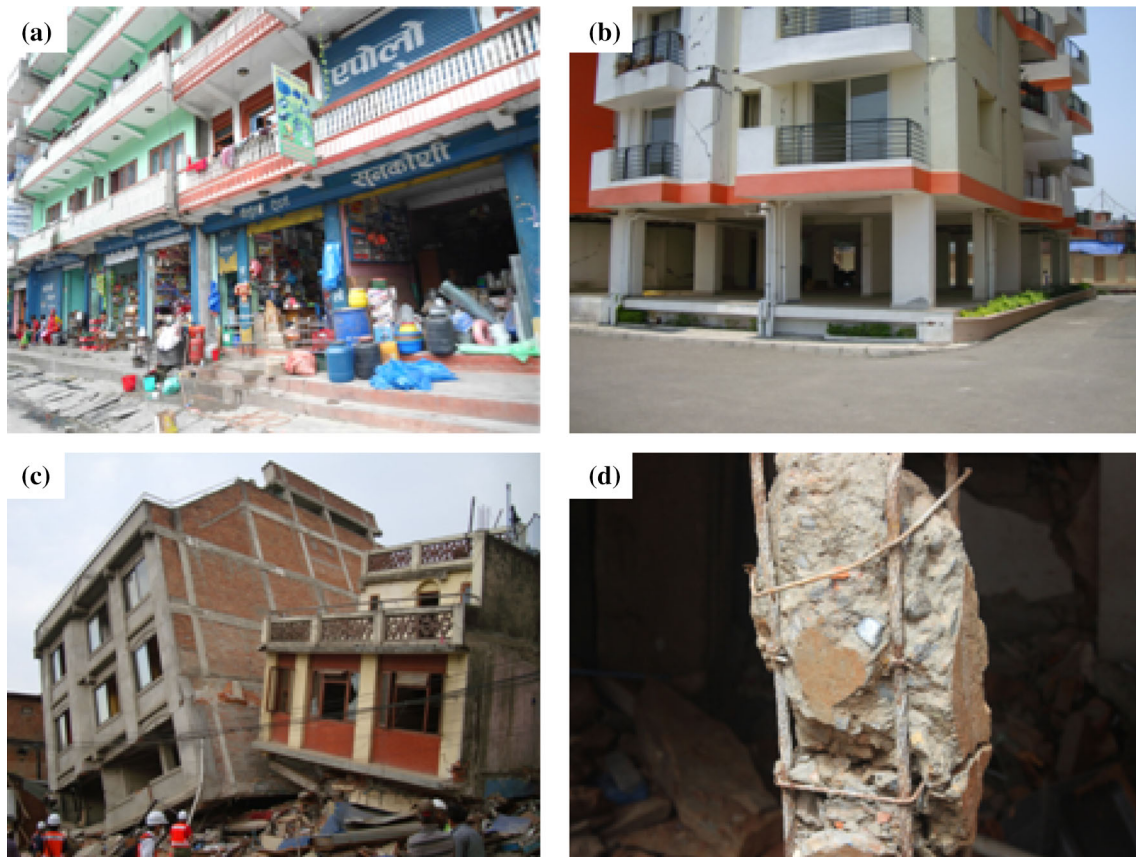
**Fig. 1** a Ground floor of residential buildings without infill walls. b Ground floor of an apartment building without infill wall. c Soft storey and structural pounding failure. d 16 mm diameter rebar but only four in number (corroded as well) from a collapsed building in Kathmandu

walls (Fig. 1b). Such practices have led the soft storey failure during 2015 earthquake in most of the damaged RC buildings (Fig. 1c). In addition to this, it was observed that most of the buildings in residential level were found to be practicing “weak column-strong beam” as depicted by the massive beams and smaller columns during field reconnaissance. Due to lack of infill wall on ground floor, the increased flexibility has significantly triggered the increased displacement in ground floor thus majority of the cracks or minor to severe damages were found to be concentrated therein during reconnaissance.

The longitudinal rebar’s are mostly limited to 12–16 mm diameter and usually in four to eight in numbers. In most of the collapsed buildings, the longitudinal rebar’s were usually four, however majority of the building columns were found to be constructed with six rebar in vertical direction. The intense damage was significantly governed by the horizontal re-bars (stirrups). The stirrups were found to be 6 mm diameter bars usually gaped in regular interval of 0.15 m or more and in some cases (Fig. 1d), such gap was measured up to 0.40 m.

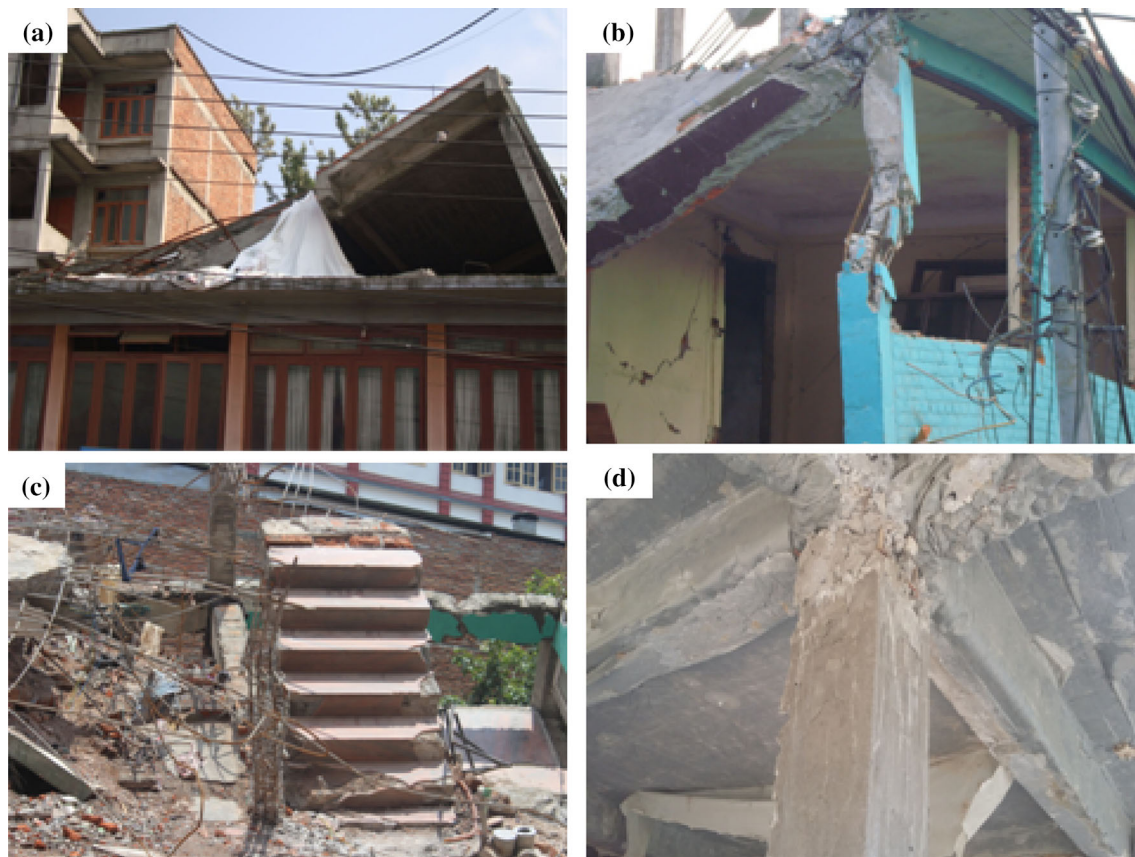
**Fig. 2** **a** Collapsed column due to welded vertical re-bars. **b** Column failure due to large gap of stirrups. **c** Outwardly placed 6 mm diameter re-bars exposed on collapsed structures. **d** Poor beam column connection with exposed re-bars

Reinforcement in infill walls were not found to be provided in residential constructions with exception to some apartments. Due to lack of reinforced walls in most of the brick kiln chimneys, almost all chimneys suffered from partial to complete collapse in Kathmandu valley [12]. More significantly, the connection between the structural components was also found to be poor. In some cases, it was observed that people preferred welding for connection of vertical reinforcements rather than anchoring thus failures were observed in those columns (Fig. 2a). The larger gap of stirrups was noticed to be significantly contributing in the failure of columns (Fig. 2b). Moreover, the structural damage and building collapse was found to be more governed by too less, smaller diameter and tying the vertical re-bars outwardly (Fig. 2c). Similarly, the beam column connection and layout of the reinforcement was found to be random leading to minor to serious damages. The workmanship defect along with the connection deficiencies were widely observed (Fig. 2d).

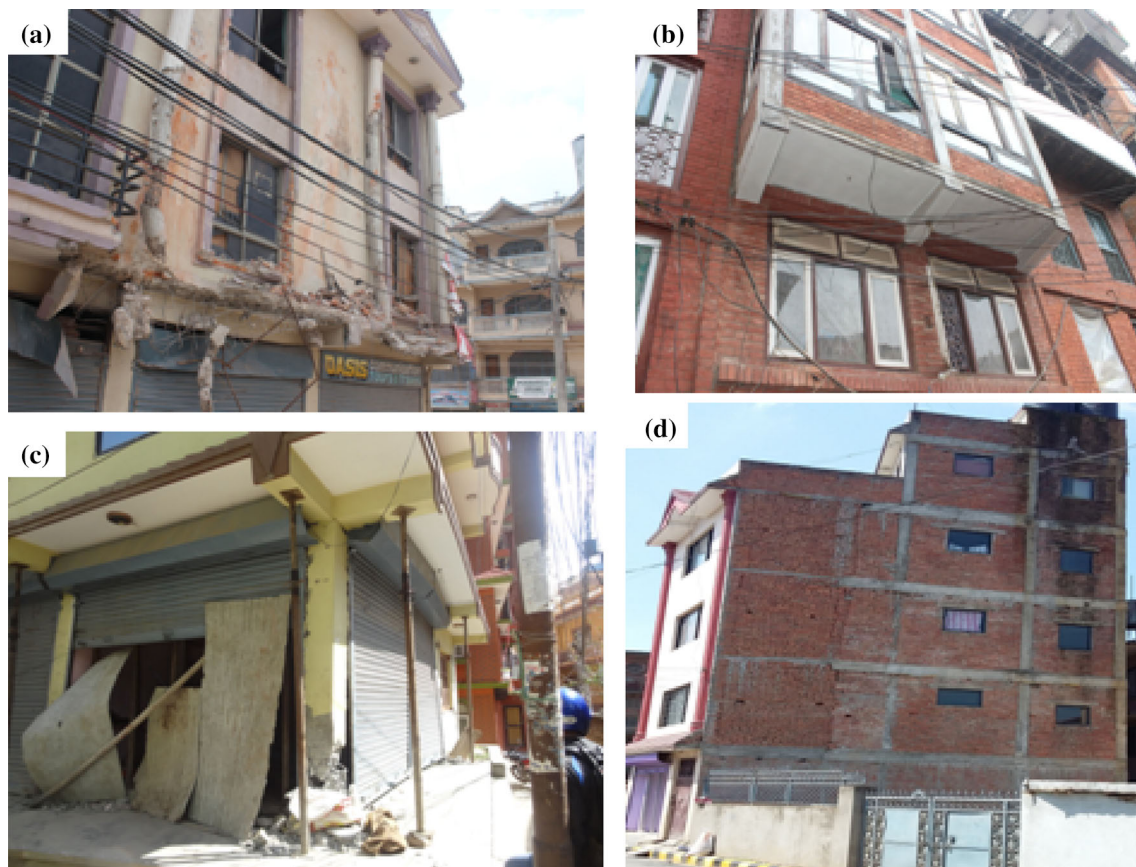
from first storey were commonly observed in residential construction within as well as outside Kathmandu valley (Fig. 3a). The floating columns are frequently used for increasing the built up area from upper stories (Fig. 3b). Due to lack of continuous load path during earthquakes, the lateral forces are not effectively transferred to the foundation. The overturning forces developed lead to buckle the columns of ground floor and subsequent damage was noticed in some buildings (Fig. 3c). Due to poor mechanism of construction monitoring, many of the urban constructions were noticed to be haphazardly increasing the housing size beyond structural system (Fig. 3d). Figure 3d is a residential construction in Lalitpur sub-metropolitan city which is taken as the successful example of building code implementation framework in Nepal, however the enforcement of building code was not found to be effectively monitored.

**Fig. 3** a Floating column with projected construction in upper stories. b Floating columns and continued construction in upper stories. c Column buckling in a building with cantilevered construction and floating column. d Large cantilevered construction projected from structural system

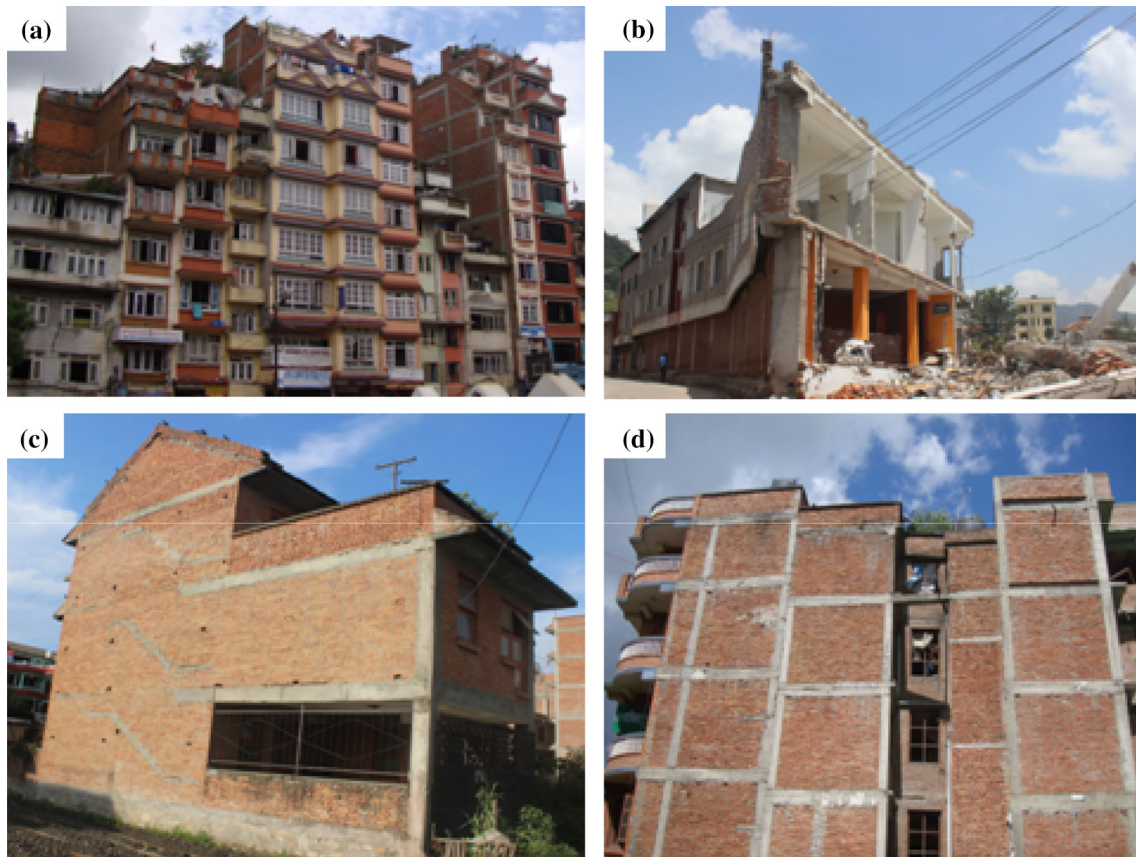
**Fig. 5** **a** A neighborhood in Kathmandu metropolitan city with dominance of slender structures. **b** Asymmetric building with severe damage in Kathmandu. **c** Columns too less and not even in grid.

**d** Two RC buildings connected with a beam and one masonry building in between at Bhaktapur

Nepal. Later, with the commercialization of areas, houses with the same column size were made up to seven stories. This was the significant cause for damage in most of buildings in Nepal during 2015 Gorkha earthquake. In addition to this, several houses were found to be constructed with combination of load bearing walls and columns (Fig. 5c), in doing so, it was observed that columns were too less and heavy RC slabs were provided for load bearing wall system. In some sites of Kathmandu valley, some of the construction flaws like joining masonry as well as RC buildings were observed (Fig. 5d).

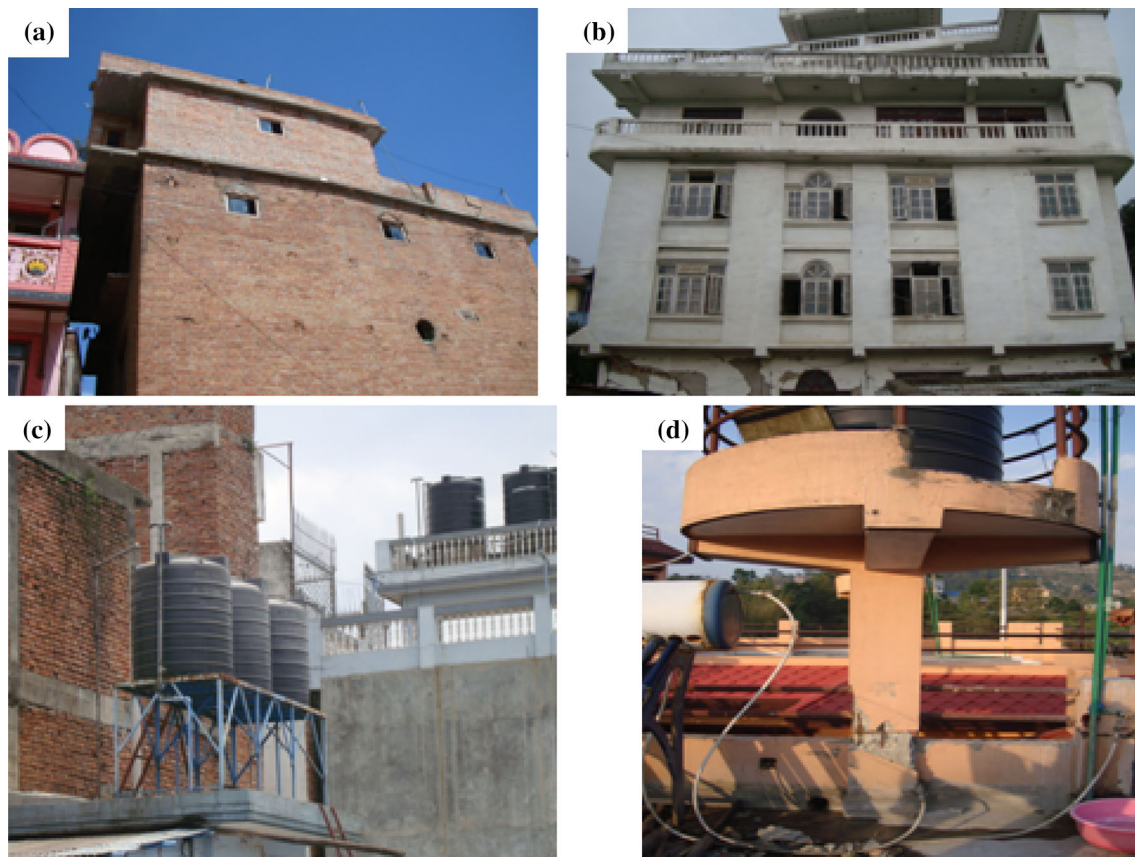
In some locations of Kathmandu valley, traditional masonry houses were found to be added with reinforced concrete construction in third or four storey (Fig. 6a). Many of the buildings in Kathmandu are constructed with higher load concentration in upper stories and reducing the column size while constructing upper stories (Fig. 6b). Water tanks were found to be installed in every RC building in Nepal for gravity distribution in taps, though the weight of water tank was found to be nevertheless

accounted during structural analysis and design before construction even if it was obvious to install. At least one to five water tanks of varying capacity were found to be installed during field reconnaissance (Fig. 6c). Due to continuation of single column for water tank and construction of short column, some of the buildings sustained damages in those structures (Fig. 6d). Also in some houses, the load of telecommunication tower was found to be established without any structural analysis and design.

**Fig. 6** **a** Plain cement concrete construction with RC slab above traditional masonry building. **b** Massive construction in upper stories and subsequent damage in ground floor. **c** Water tanks in Kathmandu

valley buildings. **d** Continued column from structural system damaged after Gorkha earthquake in a colony building

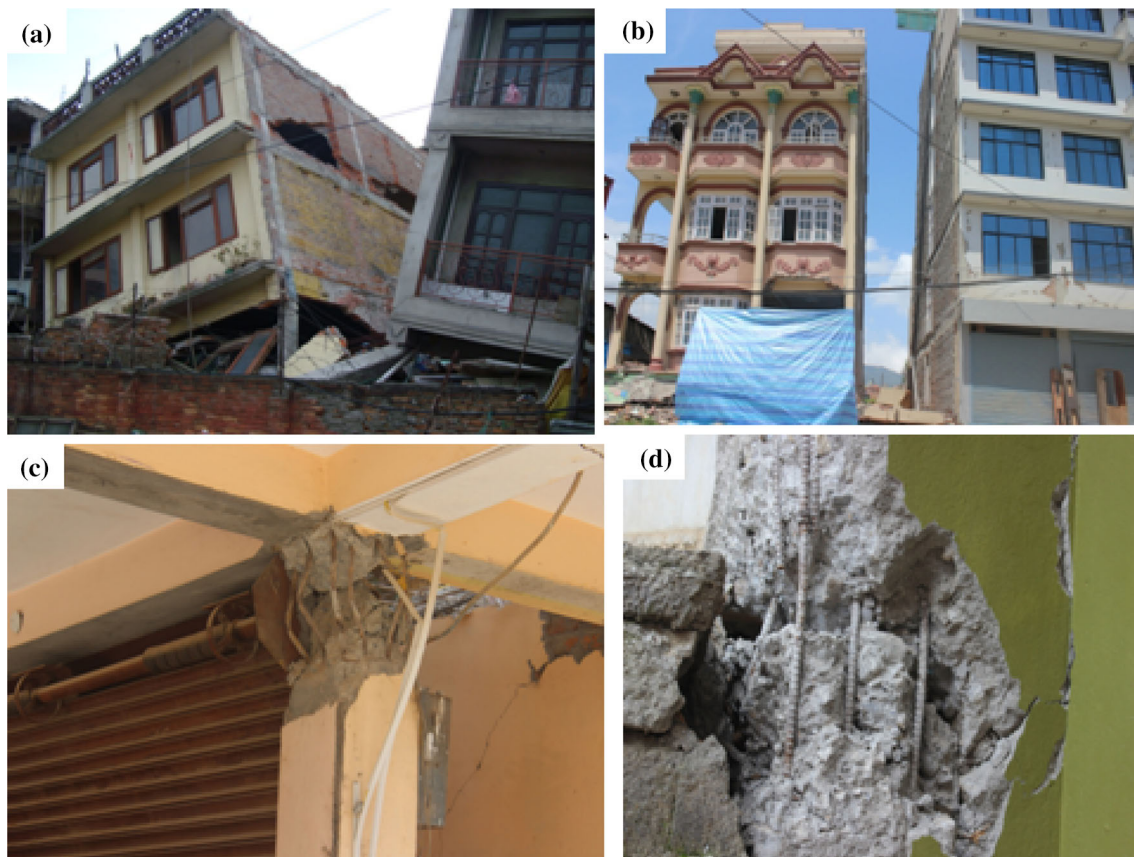
so almost all portion of land is covered by the structural system. Due to such close proximity led pounding, some structures were found to be separated some 3 m (Fig. 7b).

In columns, due to large spacing between the stirrups, weak column strong beam, insufficient development length of rebar, among others were found to be governing the damage concentration in columns. Plastic hinge formation (Fig. 7c) was also observed in some of the structures along with concrete spill caused due to buckled re-bars on ground floor (Fig. 7d).

**Fig. 7** **a** Collapsed buildings due to structural pounding in Gongabu (Kathmandu). **b** Structural pounding led displacement of building (3 m) in Sitapaila (Kathmandu). **c** Plastic hinge formation. **d** Base of first storey column with buckled rebar and concrete spall

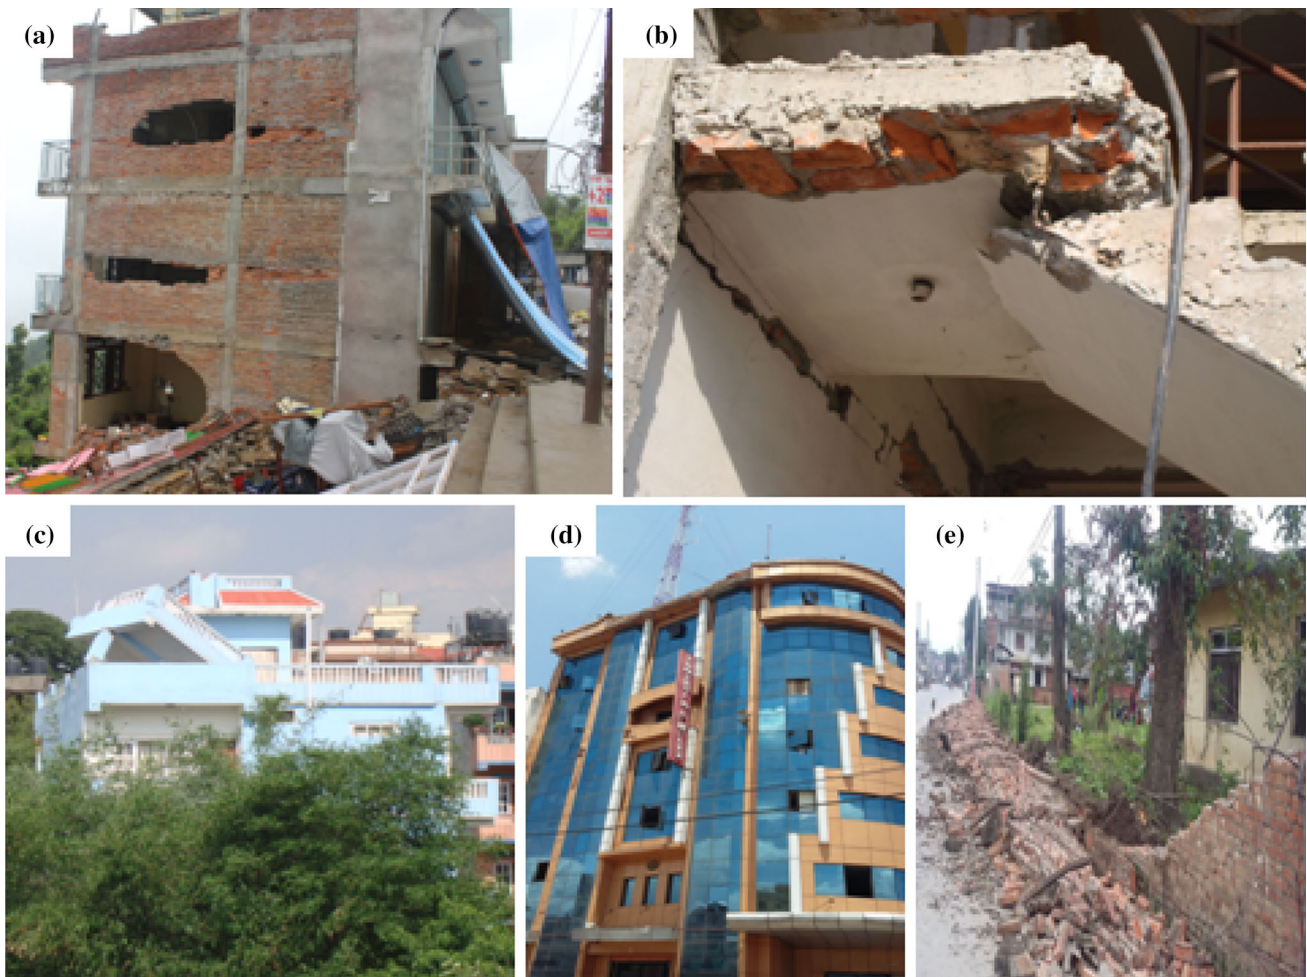
Damages in staircase without proper anchoring with structural members was also noticed (Fig. 8b). Staircases could effectively perform as diagonal bracing members but due to lack of sliding joints in design most of the damage concentration was found to be in staircase. Also staircases are never isolated from structural elements as well, so the performance of buildings during earthquakes is also affected by the heavy staircases.

Failure of water storage tanks was noticed during the reconnaissance (Fig. 8c). Water tanks are not accounted during building design and also it is found that owners themselves hire masons to construct water tanks. Moreover, there is no proper regulation to monitor how many water tanks a single building can install is not governed by any by-law or design code. Due to this fact, many houses in Kathmandu were found to be installing water tanks, heavy purification system and water heating systems.

Damage in parapet walls was observed in some RC buildings which were not reinforced and excessively high (Fig. 8d). The anchorage with roof diaphragm was found to be often lacking in case of damaged parapet walls.

The boundary walls were among the severely collapsed non-structural members during 2015 Gorkha earthquake (Fig. 8e). In order to separate property line or for security purpose, boundary walls were found to be constructed in almost every house within Kathmandu valley in newer settlements. However, in case of older settlements and outside Kathmandu valley boundary walls were not frequent. Due to poor workmanship and inferior quality of plain cement concrete construction proper binding was not assured so around

**Fig. 8** a Out of plane collapse of brick infill wall in Chautara (Sindhupalchowk). b Damaged staircase. c Damaged water tank. d Damaged parapet wall in a high rise building. e Damaged boundary wall

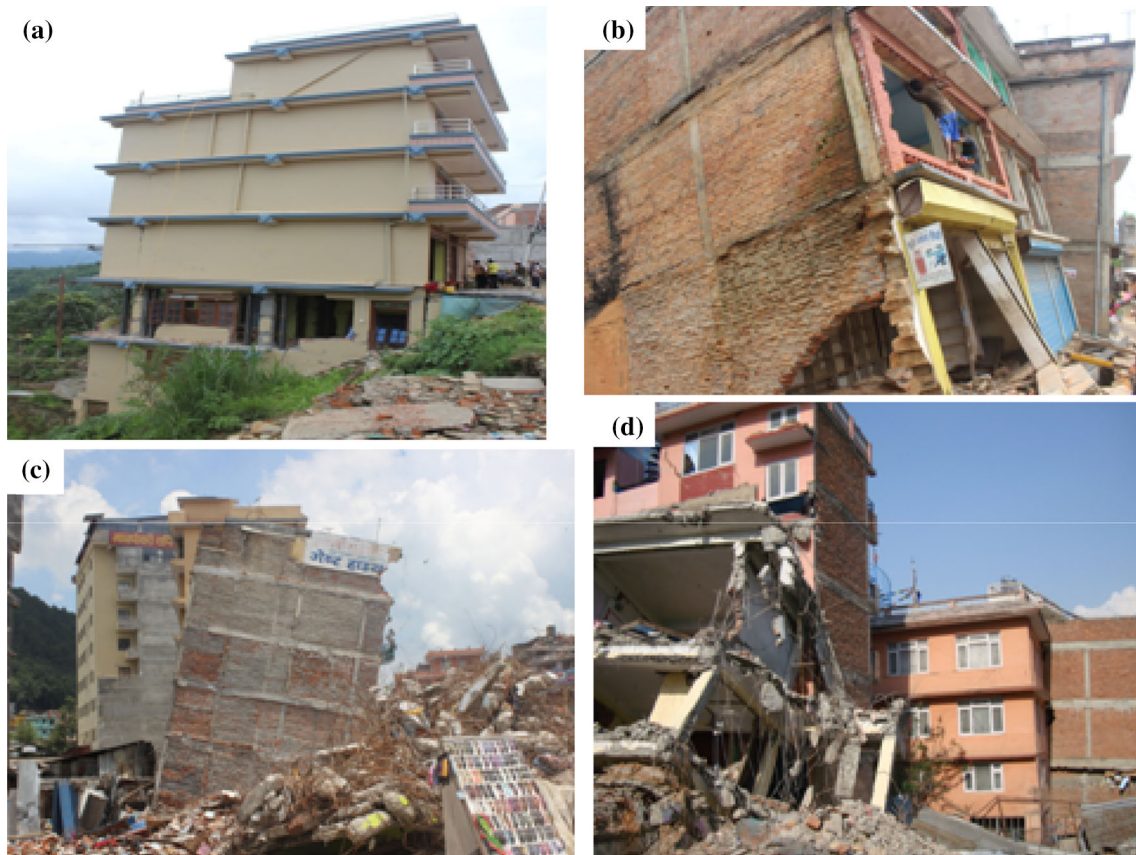
was observed that the buildings constructed in river banks were facing rocking and sliding of foundation problem (Fig. 9c) even if the structural system was undamaged. Moreover, both foundations as well as structural deficiencies led building collapse were also noticed in some locations within Kathmandu valley (Fig. 9d).

**Fig. 9** **a** RC building in stepped foundation with partial damage. **b** Building tilted with column failure due to stepped foundation. **c** Large displacement in foundation led tilting of building constructed

in river bank in Gongabu (Kathmandu). **d** Collapsed RC building in Kathmandu due to combination of foundation as well as structural deficiencies

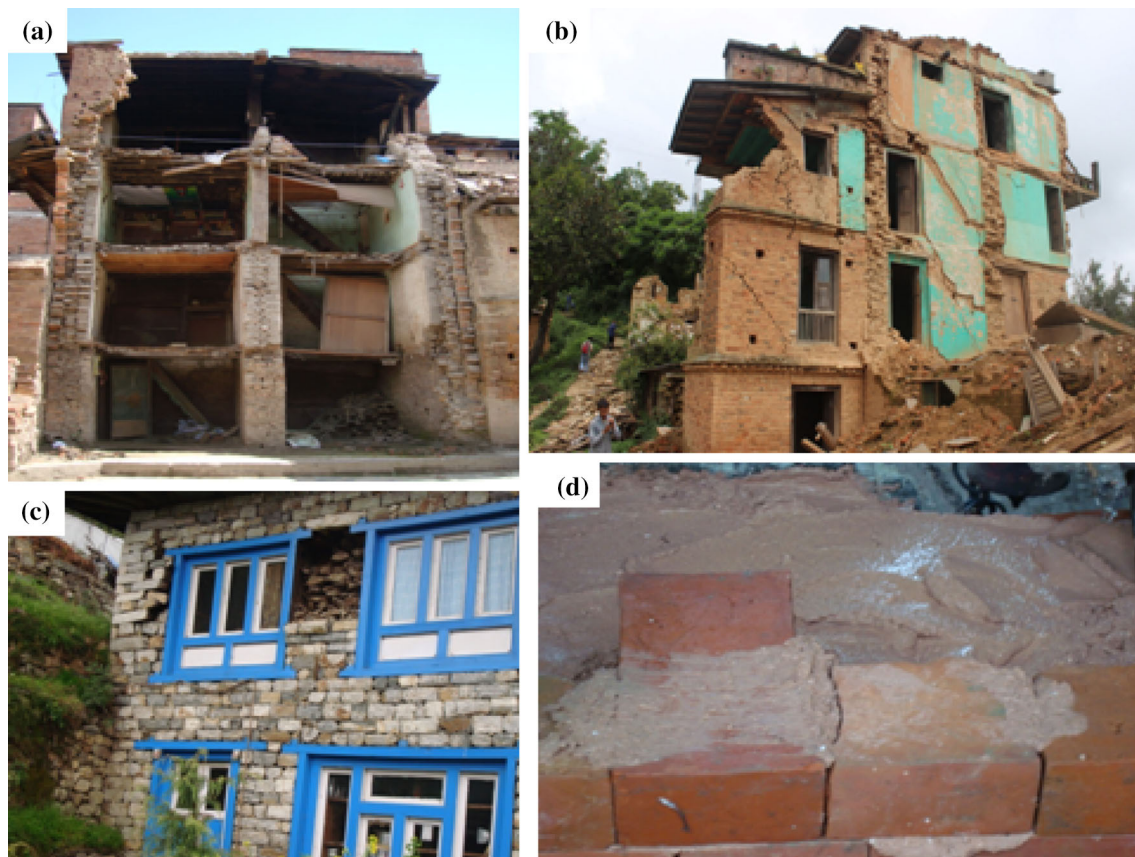
Almost all, except some URM buildings were found to be not consisting any bands at various levels like; sill, lintel or gable. Due to lack of proper bonding in masonry load bearing wall, out of plane collapse was more commonly observed in Kathmandu valley and other settlements with abundance of URM buildings (Fig. 10a). In most of the URM building, the orthogonal walls were found to be behaving differently due to lack of proper connection between such walls showing poor integrity. Also due to lack of integration of several members within the structural components, out of plane failures were more intense than any other type of failure (Fig. 10b). In case of masonry structures, due to poor quality of binding materials, delamination of wythes was also common in stone masonry houses outside Kathmandu valley (Fig. 10c), however such

**Fig. 10** **a** Out of plane collapse of load bearing masonry wall in Bhaktapur. **b** Heavily damaged masonry structure in Chautara due to out of plane collapse of majority of walls. **c** Delamination of wythes

observed in stone masonry wall in Solukhumbu (Everest base camp area). **d** Common practice of mortar placement for masonry construction

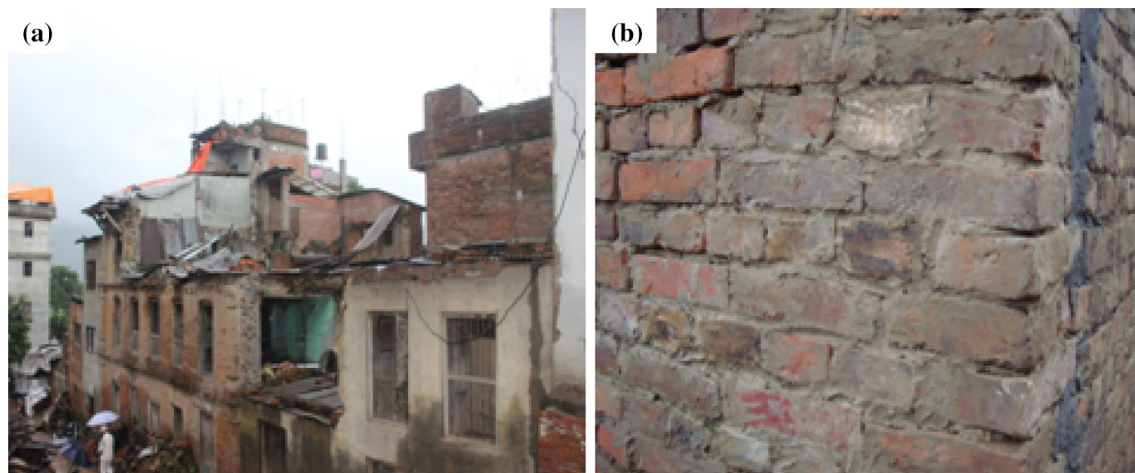
The structural integrity depends also on monolithic and homogenous behavior of masonry structures; however the mud mortar used for binding the brick/stone units were found to detached already and brick/stone units were found to be behaving separately (Fig. 11a). This binding problem led the severe devastation during 2015 Gorkha earthquake in the historic settlements of Kathmandu, Lalitpur, Bhaktapur, Sankhu, Harisiddi, Barpak, among others. Even after the earthquake damage people were found to be using the same binding material for reconstruction (Fig. 11b). This could be detrimental in future events.

**Fig. 11** **a** Failure of masonry units due to lack of proper binding. **b** Mud mortar used for reconstruction of URM building destroyed during 2015 Gorkha earthquake at Bhaktapur

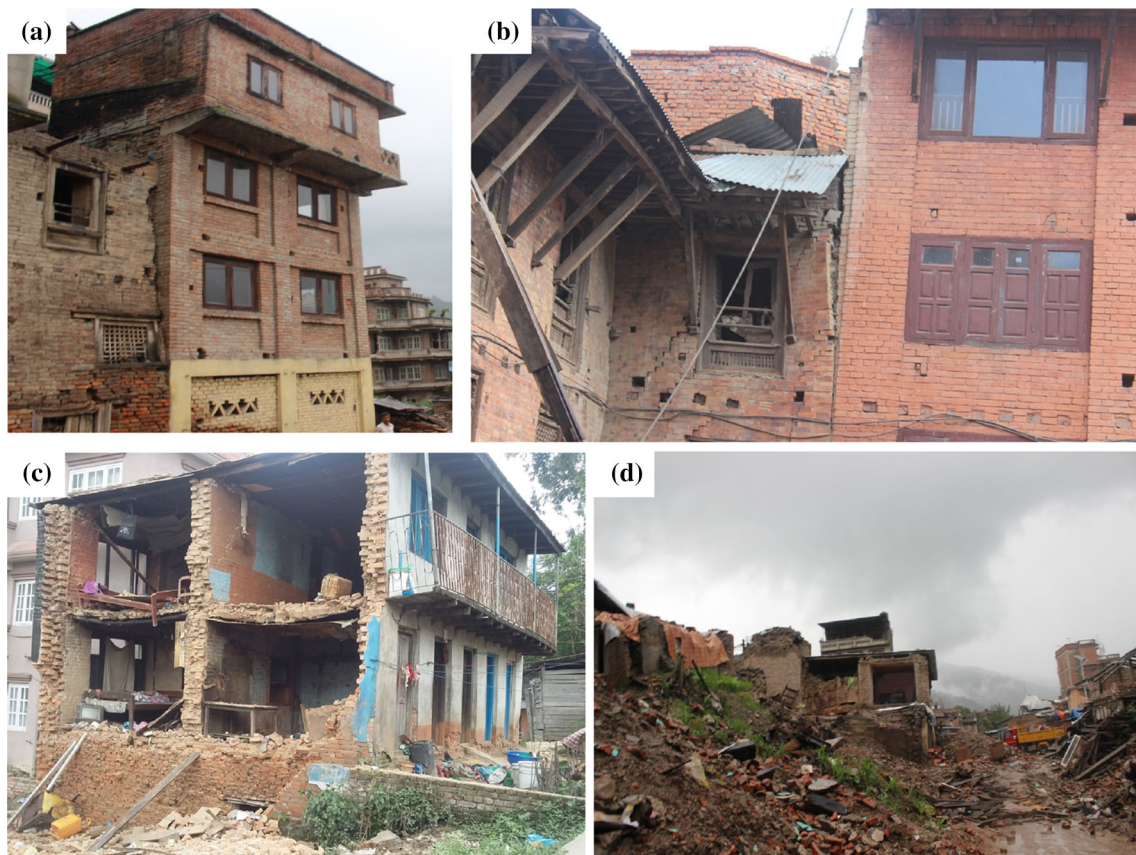
cantilevered constructions, many of the buildings in Kathmandu valley were observed with load path discontinuity (Fig. 12a). The reentrant corners and diaphragm discontinuities were also noticed in masonry construction practices

**Fig. 12** a Heavy load concentration in the fourth storey of a masonry building. b Re-entrant corner and associated damage in masonry building in Bhaktapur. c Lack of connection led collapse of wall. d Heavy damage in old masonry houses in Sankhu

in Nepal (Fig. 12b). Masonry buildings up to six stories were found inside Kathmandu valley and in case of outside Kathmandu valley the number of stories for masonry buildings is limited to four. Struts in some masonry buildings performed the function of transferring the cantilevered load into structural wall [13], but majority of masonry structures were found to be without having struts even if the roofing was too heavy constructed with roof tiles.

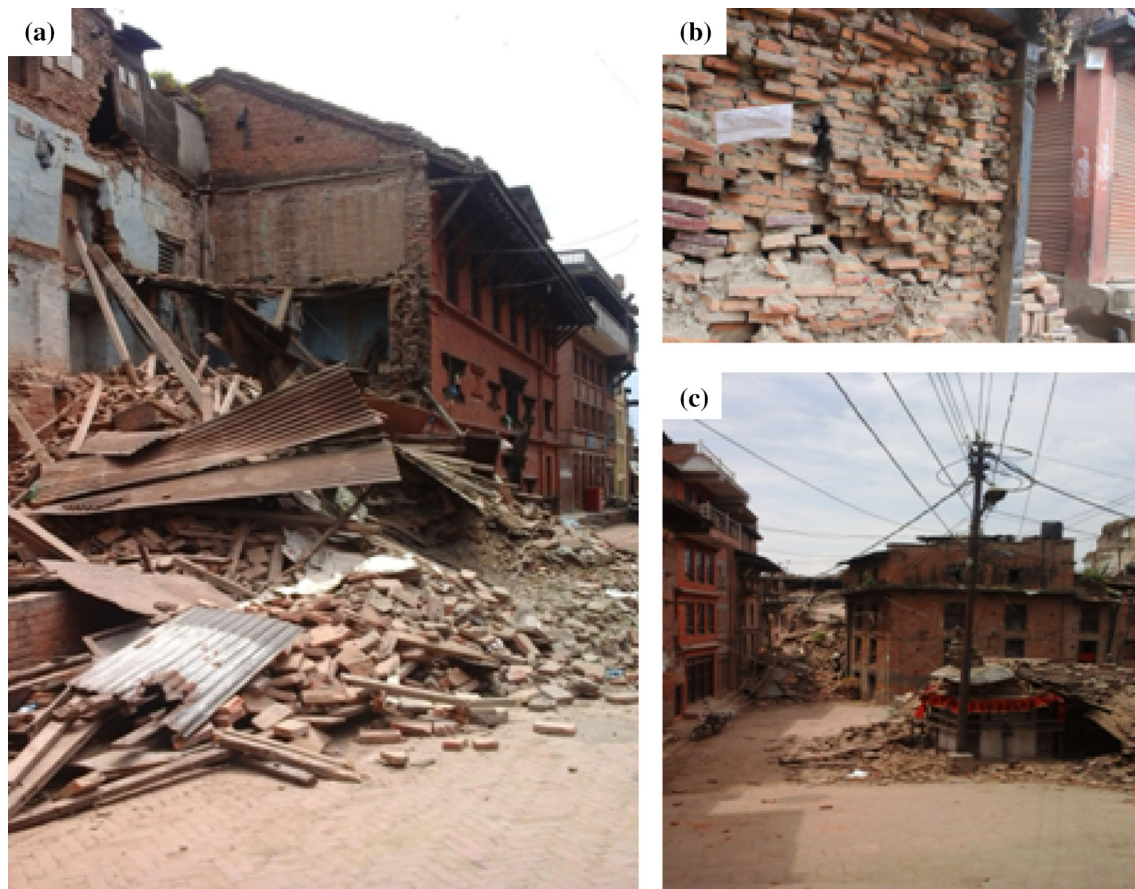
**Fig. 13** **a** Damage in shared wall. **b** Segregated mud mortar and associated delamination of wythes. **c** Damaged building with inclined foundation and intact buildings having leveled foundation

settlement where single house is divided into two and phased construction or repair was done in either unit. The thickness of brick masonry wall was found up to 0.60 m but poorly connected with mud mortar. Such mud mortar binding was found to be detached from brick units many years back and delamination of wythes was commonly observed in those buildings with segregated mud mortar (Fig. 13b).

Shallow and spread foundation is commonly adopted in masonry constructions in Nepal. Beside this, natural terrain was found to be adopted directly for foundations so that inclined foundations were commonly observed in majority of masonry buildings constructed across and outside Kathmandu valley. It is observed that the buildings resting on inclined foundations were more damaged than those buildings resting on leveled foundation (Fig. 13c).

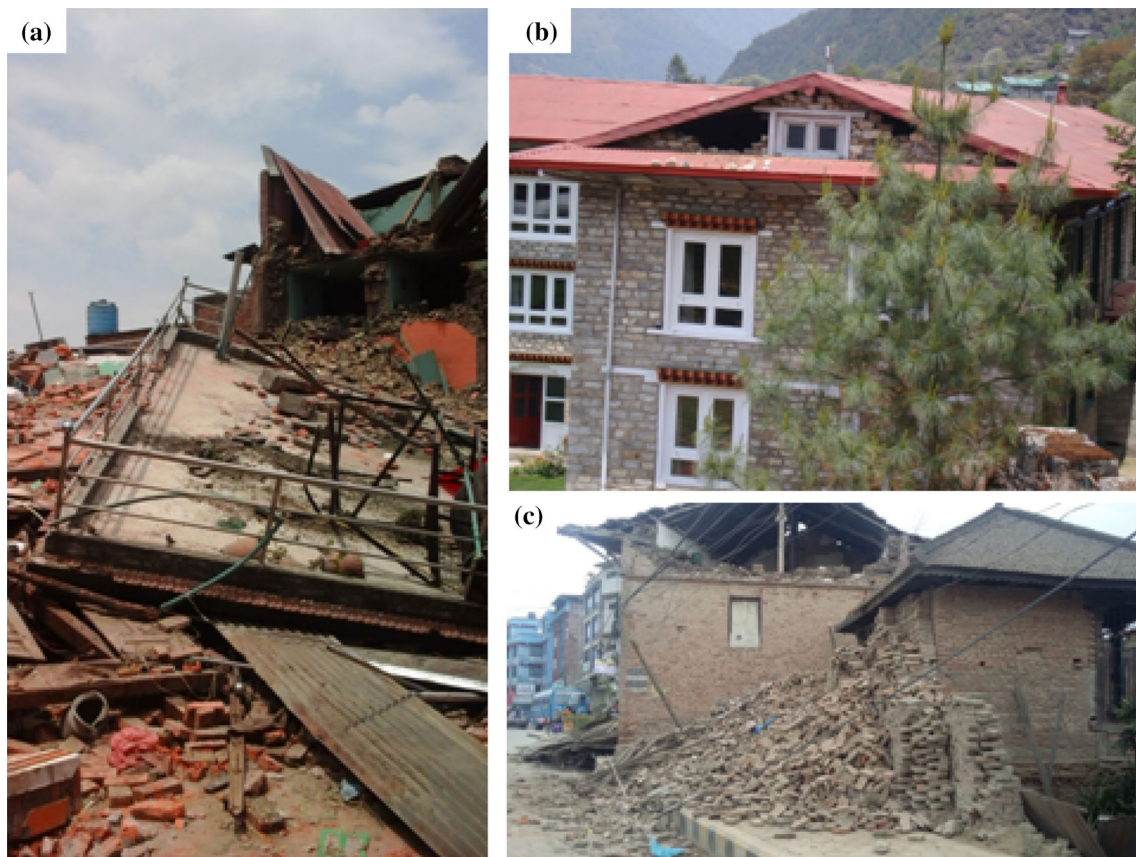
The gable portion of most of the masonry buildings was found to be constructed with thick brick wall; this ultimately led to most of the gable portion failure (Fig. 14b). The performance of thick gable wall was weak throughout Nepal in stone masonry and brick masonry structures (Fig. 14b, c). Although, some areas used to have small to big gable openings, due to heavy concentration of stacked and unsupported masonry units, failure was commonly observed in central Nepal, eastern Nepal as well as inside Kathmandu valley.

**Fig. 14** a Complete collapse of RC slab used as roofing in a masonry building. b Out of plane failure of gable portion of a stone masonry building. c Heavy gable portion out of plane failure in brick masonry

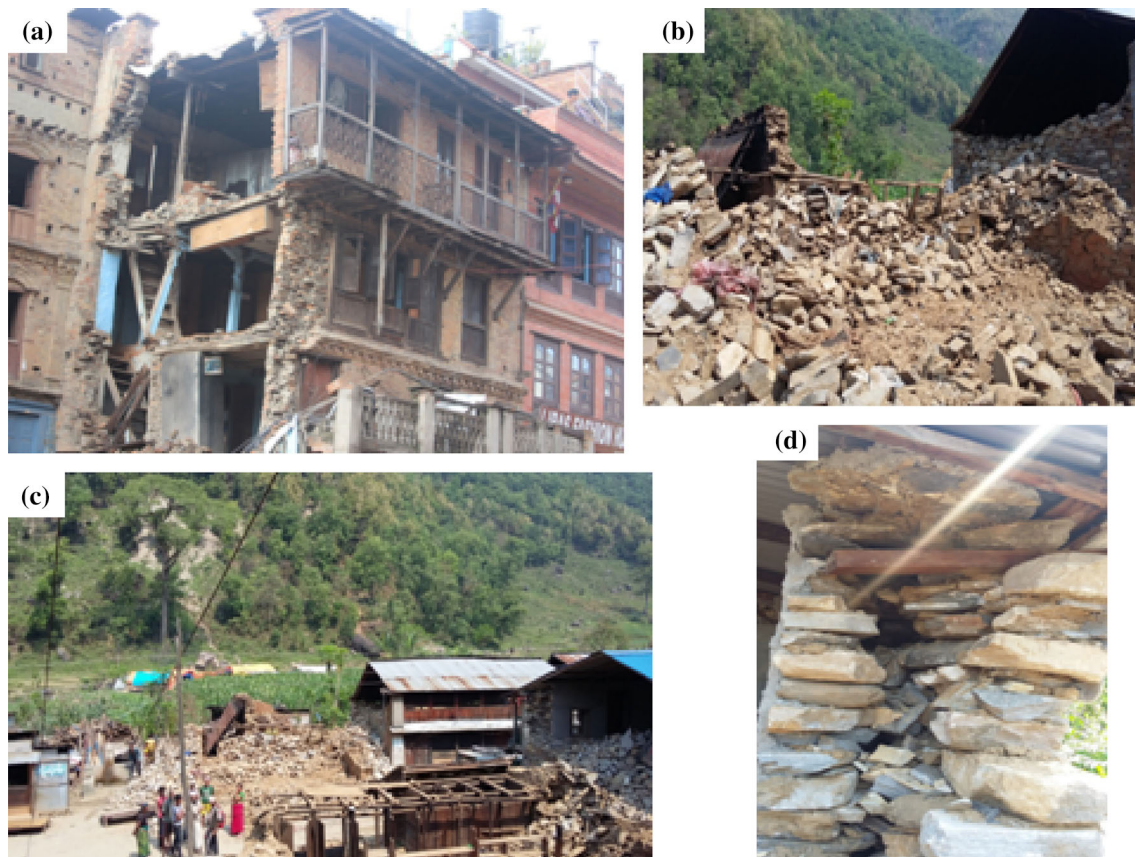
**Fig. 15** **a** Pounding and progressive failure on the building situated on edge. **b** Complete collapse of row houses in Baluwa (near epicenter). **c** Progressive failure on row houses and good performance of timber frames. **d** Separated wall due to structural pounding

thick was observed (Fig. 15d). The stone masonry houses constructed with piling of stones were severely affected like in the epicentral village of Barpak (Fig. 16a). Beside this, very heavy roofs constructed from stone slices (Fig. 16b) were found to be dominant than any other roofing system in Barpak leading to severe collapse of houses.

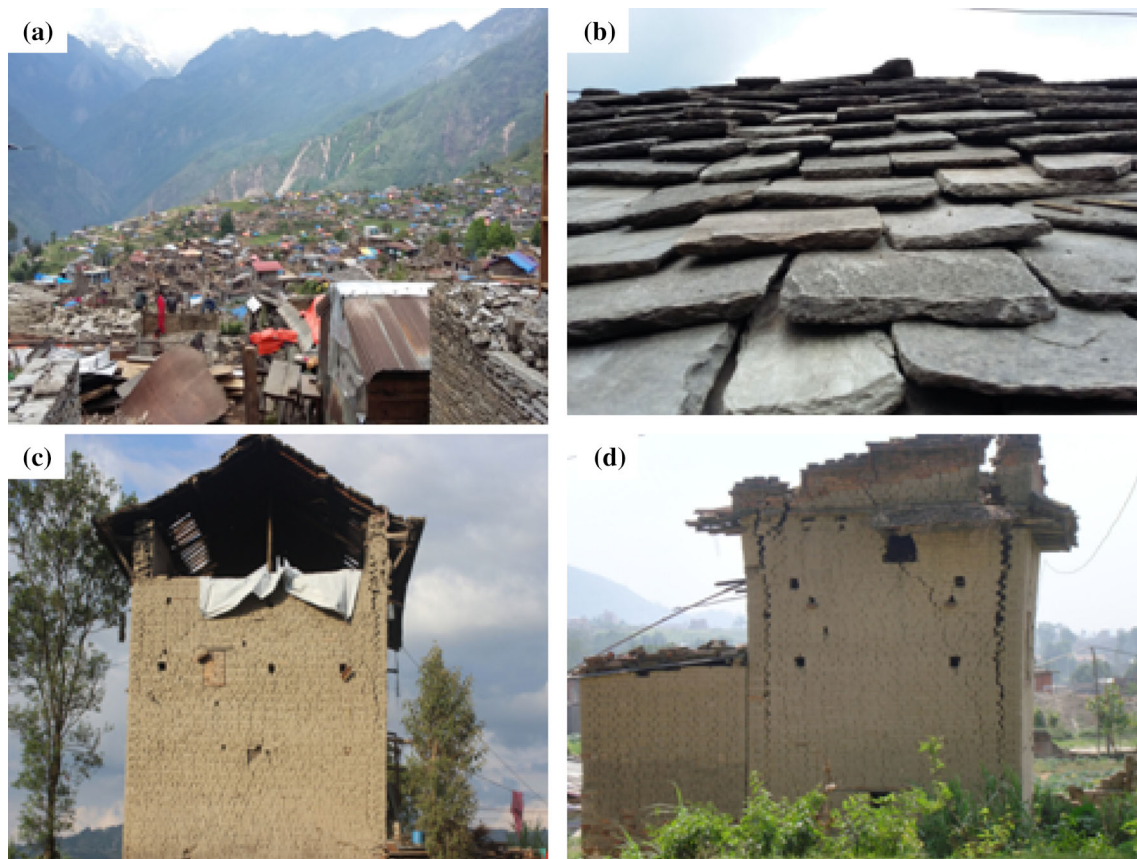
**Fig. 16** **a** Heavily damaged neighborhood of Barpak village where 1250 houses out of 1450 total were collapsed. **b** Heavy stone roofing in Barpak. **c** Gable collapse in adobe house in Bhaktapur. **d** Separation of diagonal walls in an adobe house
