Experimental study of repaired RC columns subjected to uniaxial and biaxial horizontal loading and variable axial load with longitudinal reinforcement welded steel bars solutions

Hugo Rodrigues^{a,*}, André Furtado^b, António Arêde^b, Nelson Vila-Pouca^b, Humberto Varum^b

^a RISCO, School of Technology and Management, Polytechnic Institute of Leiria, Leiria, Portugal

^b CONSTRUCT-LESE, Faculty of Engineering (FEUP), University of Porto, Porto, Portugal

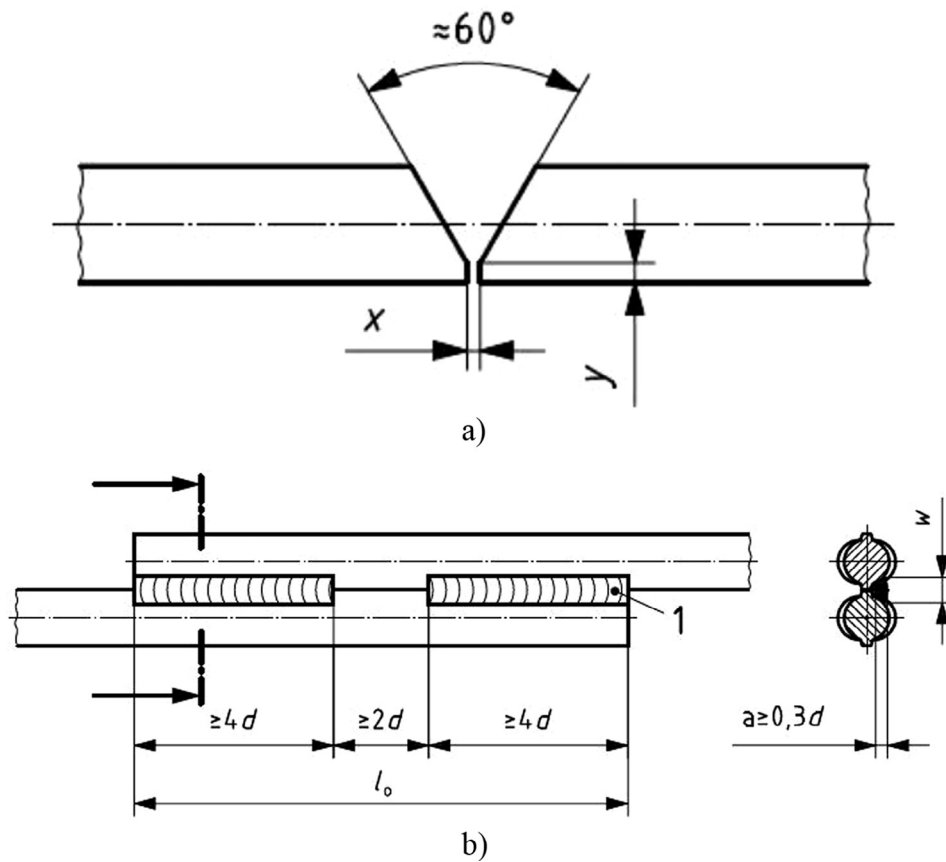
Fig. 2. Recommendation for the execution for (a) single V butt weld and (b) lap joints using single-sided intermittent lap welds disposition according to ISO 17660-1:2006 [23].

The execution of the samples were realized according the recommendations indicated in ISO 17660-1:2006 [23], such for the butt welding execution as illustrated in Fig. 2a, such for the unilateral lap joint welding execution, where the ISO 17660-1:2006 [23] recommends for the overlap of two steel rods of diameter ϕ , the minimum welding length 4ϕ that could be reduced for 2.5ϕ , for case of the welding is performed in both two sides. Where *l* (Fig. 2b) represents weld, *a* the throat thickness, ϕ nominal diameter of the thinner of the two welded bars, *l_o* overall lap length and *w* the weld width.

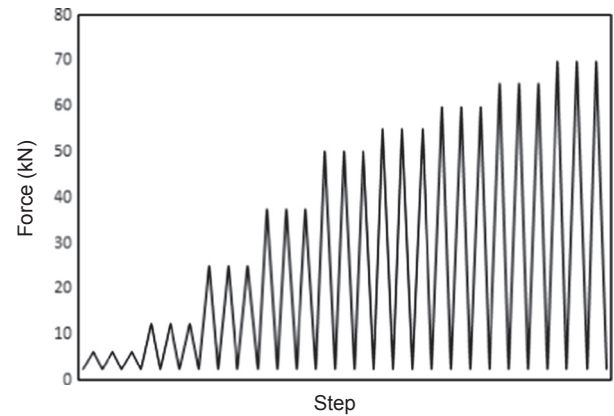
Fig. 3. Loading pattern adopted for cyclic tensile strength tests.

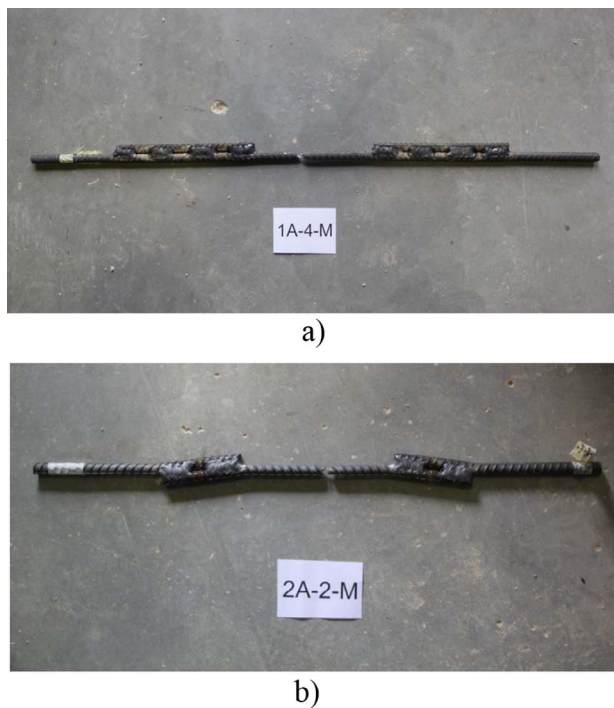
Fig. 4. Final damage observed in samples (a) ST1 and (b) ST2.

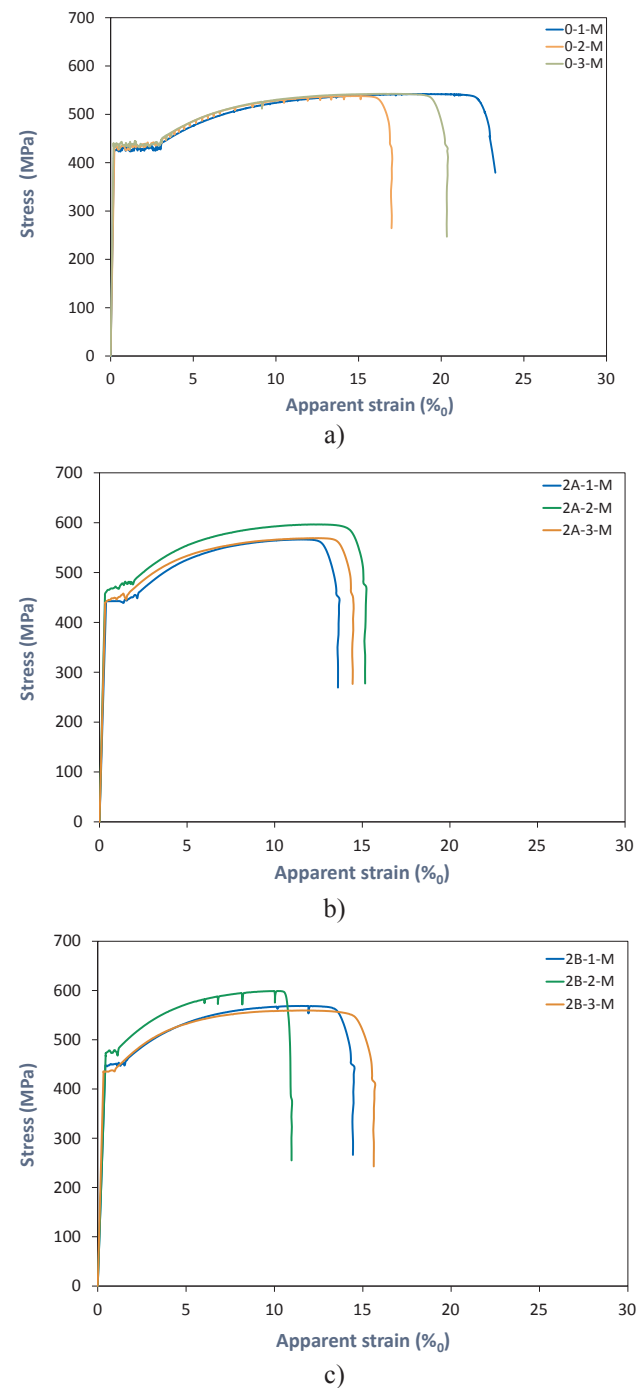
Fig. 5. Stress-strain results for the monotonic strength tests (a) Group REF; (b) Group ST2A and (c) ST2B.

solutions (about 40%) and for ST2B (50%). In the Fig. 5 can be observed in the strain-stress results in that the ultimate extension is affected, due to the accumulated effects of the axial extension and the curvature observed during the tests, that leads to a combination of strains and result in an anticipation of the fracture.

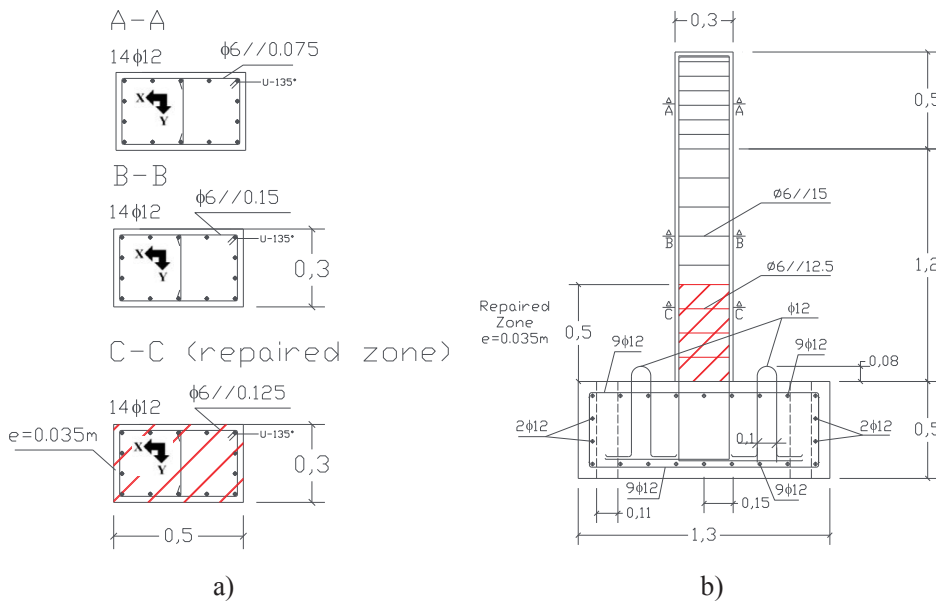
Fig. 8. RC column specimen dimensions and reinforcement detailing (units in meters): (a) Cross-sections details, (b) specimen dimensions and general scheme of the reinforcement layout.

The six specimens were repaired with two different repairing strategies, and were tested for different loading condition that will be described below. The column specimens are 1.70 m height, and are cast in strong square concrete foundation blocks with dimensions $1.30 \times 1.30 \text{ m}^2$ in plan and 0.50 m high. The cross-section dimensions and the reinforcement detailing are presented in Fig. 8. Four holes are

drilled in the foundation block to fix the specimen to the laboratory strong floor. With the cantilever model it is assumed that the inflection point of a 3.0 m height column is located at its mid-height (1.5 m), representing the behaviour of a column at the base of a typical building when subjected to lateral demands induced by earthquakes. An extra 0.20 m height is added for attaching the actuator devices. Details of the reinforcement and material properties are summarized and shown in Fig. 8 and Table 7.

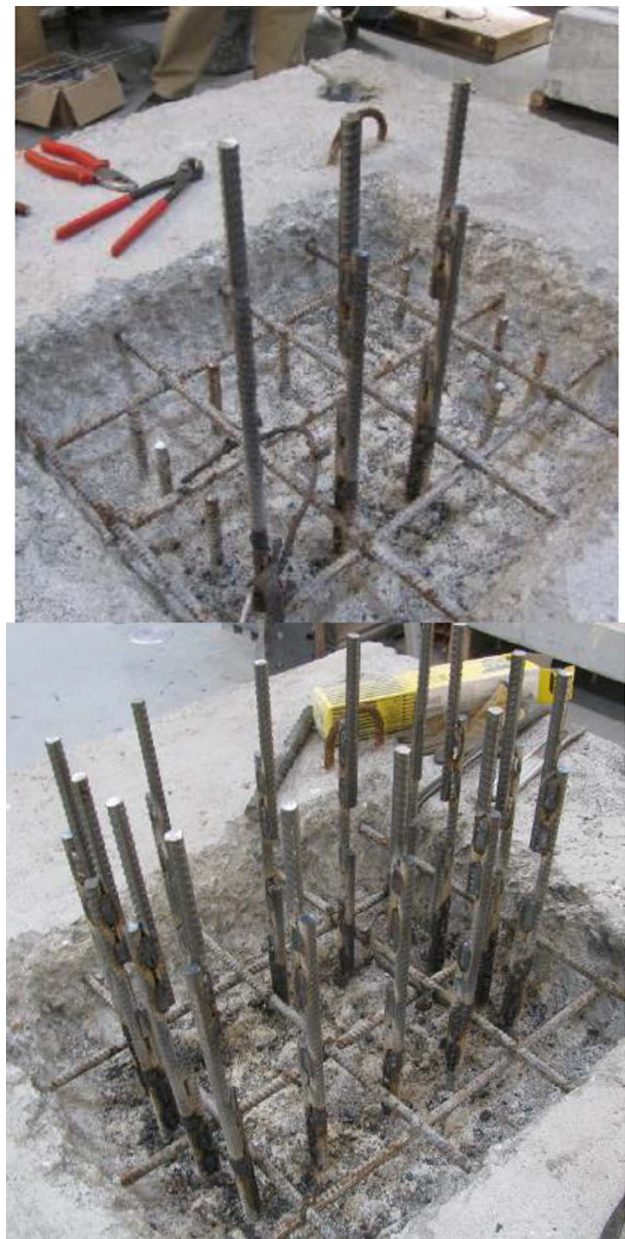
Fig. 10. Particularity of the welding procedure of the samples to the longitudinal steel rebars from the foundation.

- (1) Delimitation of the repairing area (the critical section at the plastic hinge region), typically from the footing up to 50 cm along the column height) (see Figs. 10 and 11);
- (2) Removal and cleaning of the damaged concrete;
- (3) The welding repair process of the longitudinal steel rebars started

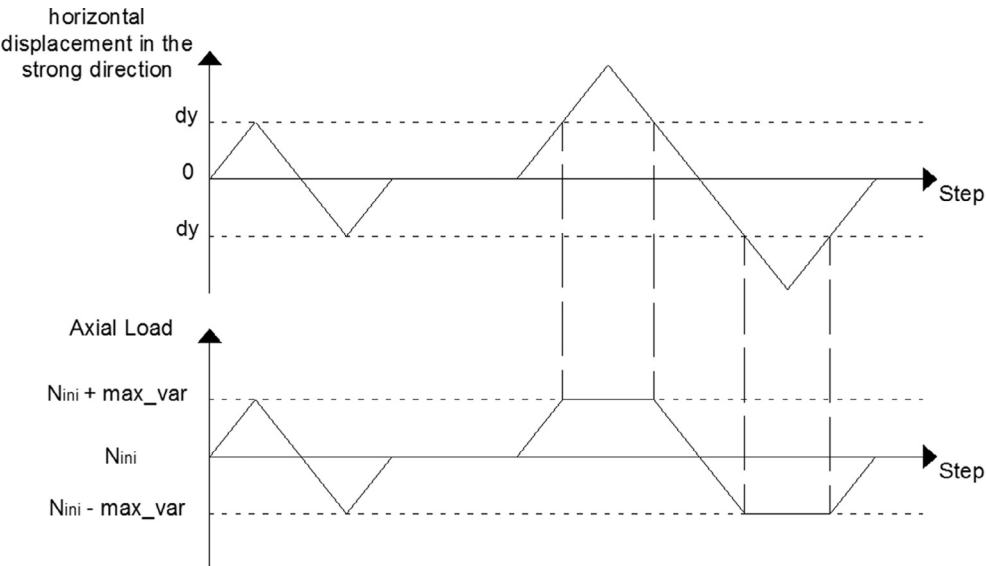
Fig. 13. Axial loading condition for tests under varying axial load.

was set on 300 kN and variations of ± 150 kN were considered as can be observed in Fig. 13.

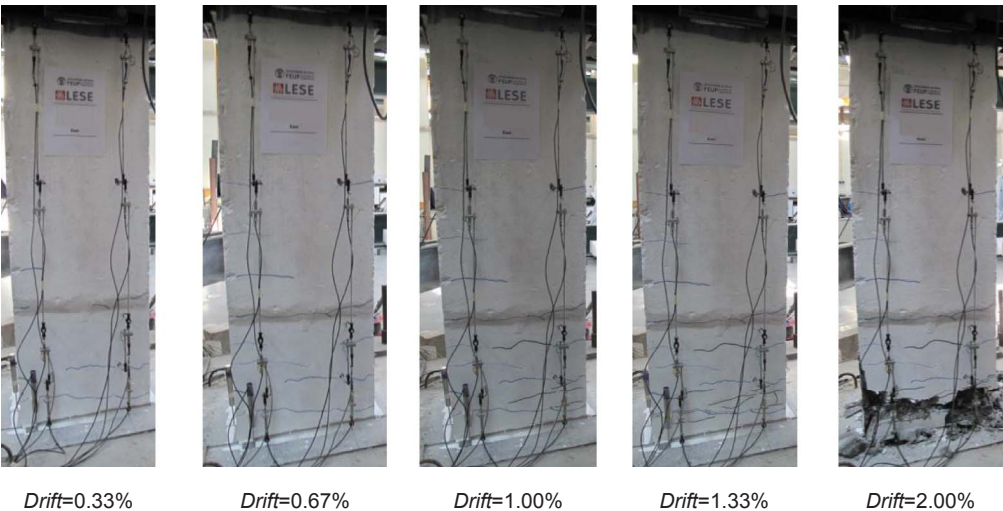
Fig. 14. Crack evolution – PC12NV1A (Variable axial load; Rhombus displacement path; Repair solution type 1A).

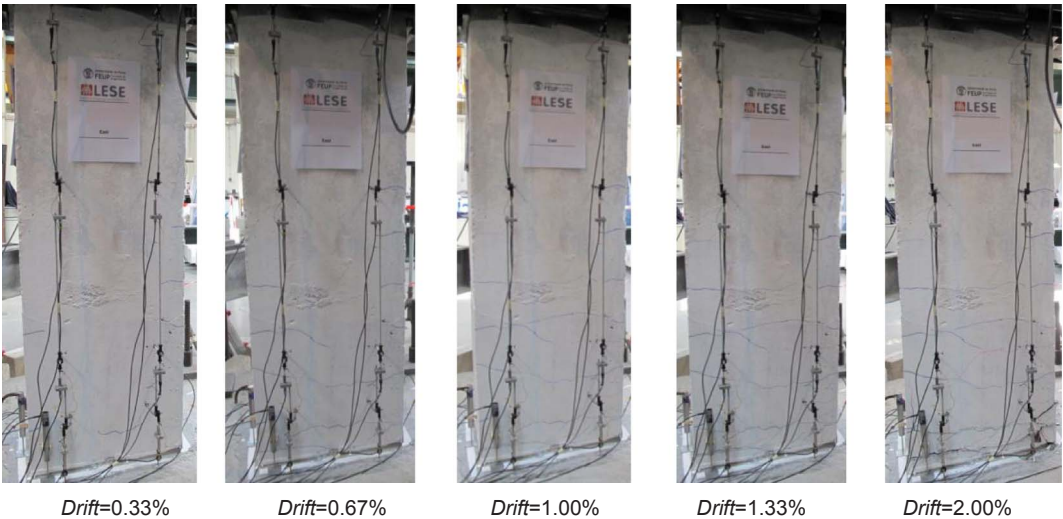
Fig. 15. Crack evolution – PC12NV1B (Variable axial load; Rhombus displacement path; Repair solution type 1B).

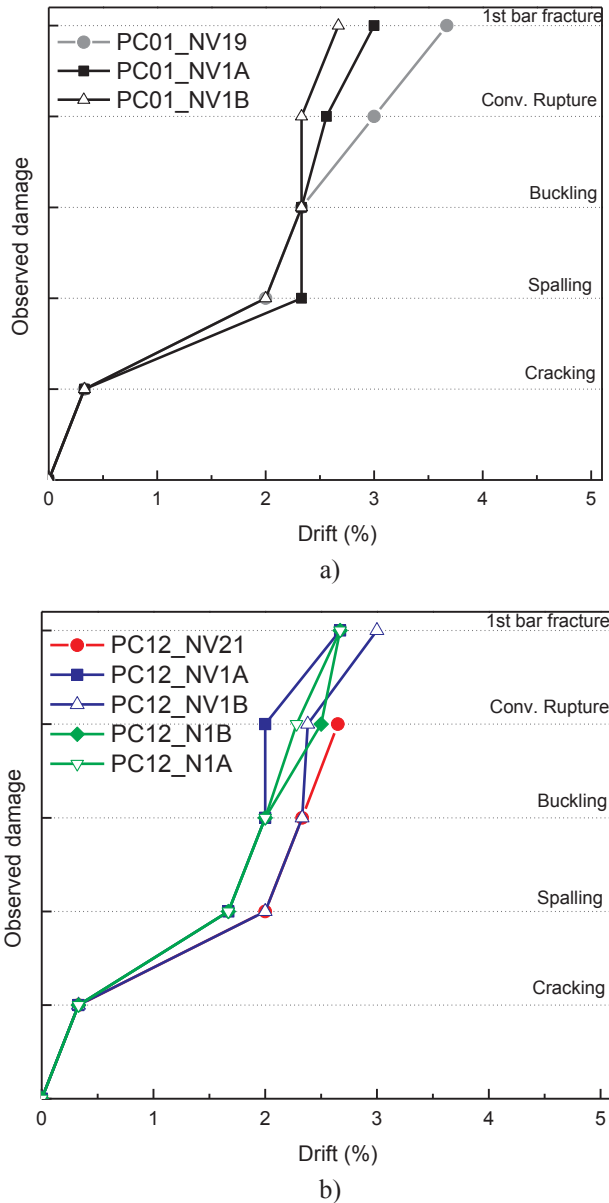
Fig. 16. Observed damage evolution: (a) uniaxial tests and (b) biaxial tests.

As observed in previous studies [7,28], it is observed higher level of damage in the base of the column for the biaxial tests when compared with the uniaxial tests with constant axial loading. For RC columns under biaxial loading combined with variable axial load, it is observed a non-uniform damage in the column, which is most evident in the north and south faces, since the maximum axial load matches with the maximum horizontal displacement according to the strong direction of the column. As expected, the buckling of the repaired re-bars was restricted to the section composed by a simple re-bar between the splicing's, since the overlap of the re-bars in the splicing provided high stiffness to this sections. Consequently, the rupture of the re-bars occurred in this zones, and it is important to note that as observed in the Section 2, no re-bar fractured in the welding sections. From the observation of all tests damages five levels of damaged were reported (cracking, spalling, buckling, conventional rupture and 1st bar rupture) and plotted in Fig. 16, and the following considerations can be performed:

- It was not found a variation of the drift demand for which occurred the beginning of the cracking, according to the repair strategy, or

- The repaired columns subjected to biaxial bending with constant axial load suffered spalling and buckling for drift demand corresponding to 66% of the original non-damaged one, with variable axial load;
- The conventional rupture occurred in the repaired columns, generally, for lower drift demands when compared with the original ones, about 30% in the uniaxial tests and 10% for biaxial tests.

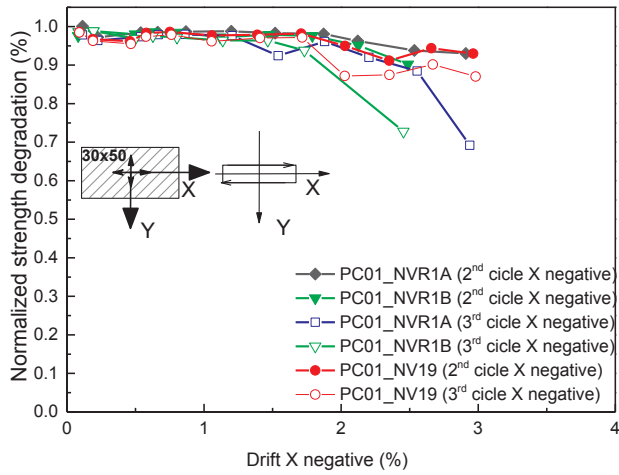
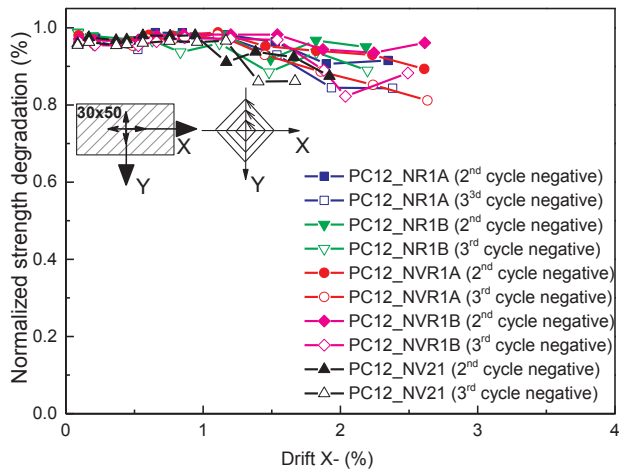
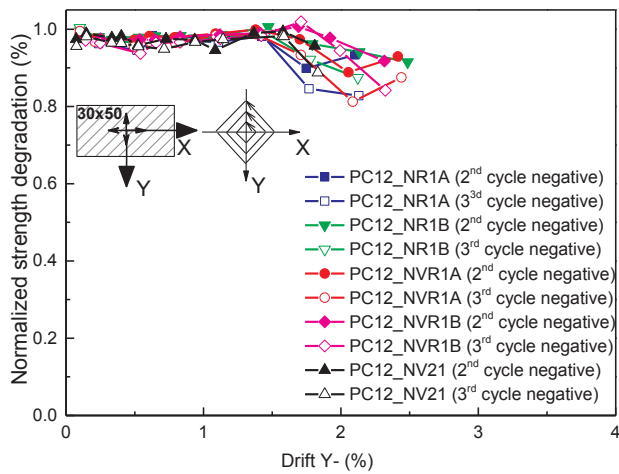
Fig. 22. Strength degradation of: (a) uniaxial tests and (b) biaxial tests with constant axial load, and (c) biaxial tests with variable axial load.

The strength degradation was estimated according to the procedure proposed by Rodrigues et al. [31] for each displacement demand (comprising three cycles), the shear force was normalized by the maximum shear force, which occurs during the first pull (Fig. 22). The strength degradation analysis was based on the semi-cycles of negative force because the first force incursion for each displacement amplitude was made in the positive force direction in all of the tests.

As observed by Rodrigues [7,28] the strength degradation in all of the columns keeps constant until certain level of drift, and by comparing this results with the obtained in Section 4.1 it is verified that the values are around for which occurred spalling and buckling. Since the above described damage states occurred for lower drift levels in the biaxial tests when compared with the uniaxial tests, the strength degradation occurred earlier.

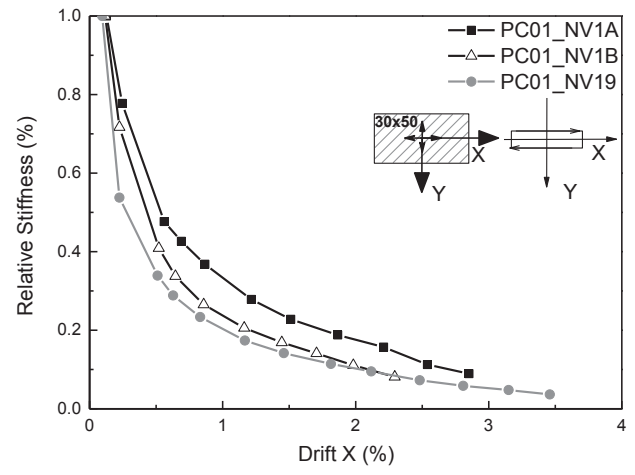
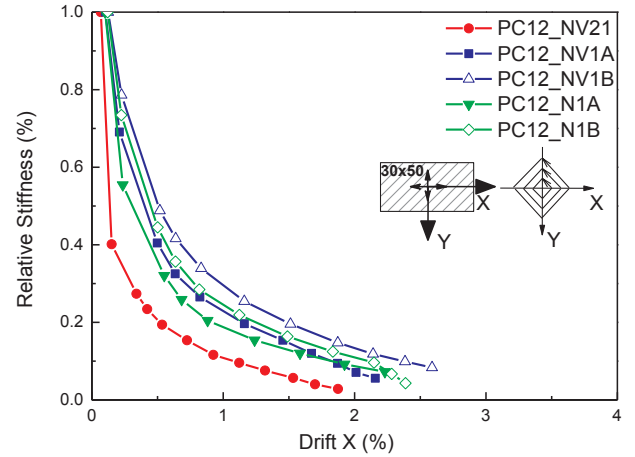
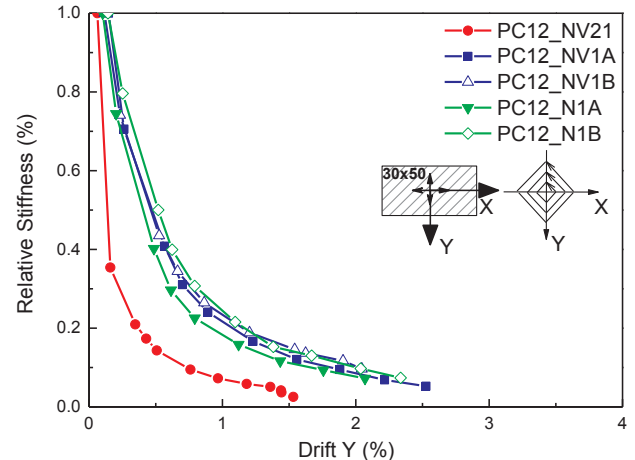
Fig. 23. Stiffness degradation of: (a) uniaxial tests and (b) biaxial tests with constant axial load, and (c) biaxial tests with variable axial load.

Stiffness degradation was evaluated by comparing the peak-to-peak secant stiffness values resulting from the first cycle of each imposed peak displacement. Fig. 23 show the lateral peak-to-peak stiffness degradation for each column in each direction. From the results, the following can be concluded:

- All of the repaired columns show less pronounced stiffness degradation for the same drift demands, when compared with the original ones;
- The stiffness degradation was not significantly affected by the constant or variable axial load;
