1st International Conference on Structural Integrity

## Experimental characterization of the in-plane and out-of-plane behaviour of infill masonry walls

André Furtado<sup>a\*</sup>, Hugo Rodrigues<sup>b</sup>, António Arêde<sup>a</sup>, Humberto Varum<sup>a</sup><sup>a</sup>CONSTRUCT-LESE, Faculty of Engineering of University of Porto, Porto 4200 – 465, Portugal<sup>b</sup>RISCO-ESTG, Polytechnic Institute of Leiria, Leiria 2400 – 448, Portugal

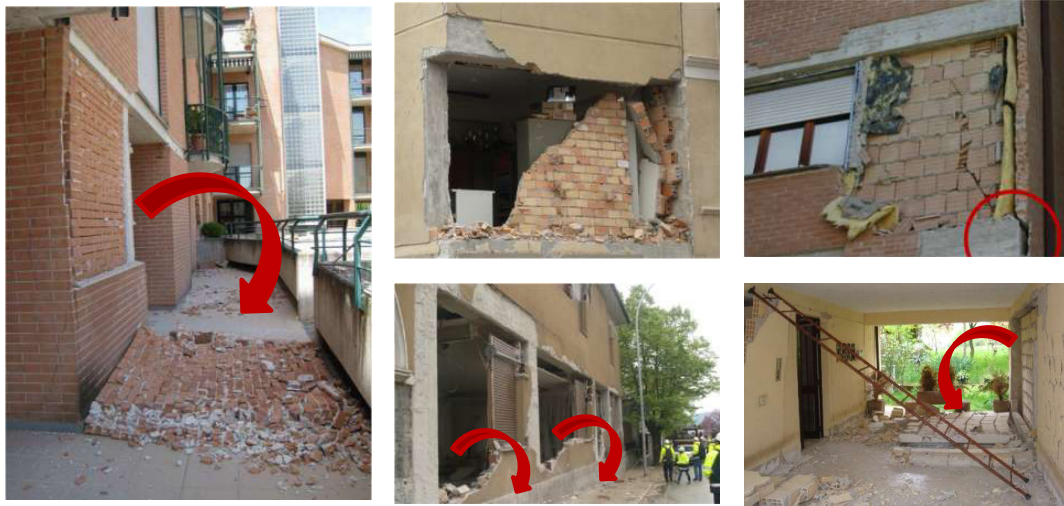
Fig. 1. IM walls out-of-plane collapses when subjected to earthquakes.

Typically the infill masonry (IM) walls are considered non-structural elements; however when subjected to earthquakes, they tend to interact with the surrounding reinforced concrete (RC) frames which can result in different failure modes, among which are the in-plane failure and the out-of-plane collapse. Recent earthquakes such as L'Aquila (Italy, 2009) [1], Lorca (Spain, 2010) [2] and Emilia (Italy, 2012) [3] identified a large number of buildings that suffered severe damage or collapse had their poor performance associated with the influence of masonry infill panels.

In fact, the contribution of the IM walls to the building's seismic performance can be favorable or not, depending on a large series of uncertain phenomena, detailing aspects, mechanical properties, and others. The infills out-of-plane behaviour was observed as one of the most important critical failures of such type of non-structural elements [4, 5], as observed in Fig. 1. A few major factors causing out-of-plane instability and poor performance are the reduced support-width on RC beams and/or slabs,

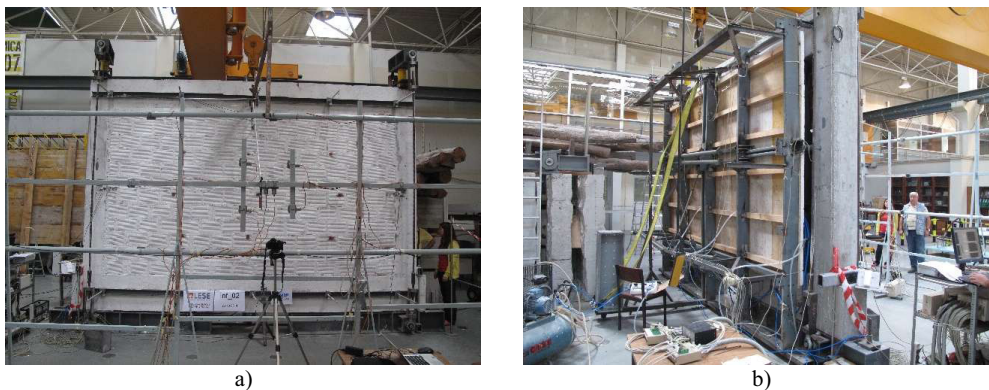
Fig. 4. General view of the experimental test setup a) Front view b) Lateral view.

The out-of-plane test consisted on the application of a uniformly distributed surface load through a system composed by seven nylon airbags, reacting against a self-equilibrated steel structure, as shown in Fig. 3 and Fig. 4.

In each column the axial load was applied by means of a hydraulic jack inserted between a steel cap placed on the top of the column and an upper HEB steel shape, which, in turn, was connected to the foundation steel shape resorting to a pair of high-strength rods per column. Hinged connections were adopted between these rods and the top and foundation steel shapes; the axial load actually applied on the columns was continuously measured by load cells inserted between the jacks and the top of each column, which was paramount to perform in-plane tests.
