Seismic damage scenarios for the Historic City Center of Leiria, Portugal: Analysis of the impact of different seismic retrofitting strategies on emergency planning

Elsa Anglade^{a,b}, Anna-Maria Giatreli^a, Anna Blyth^a, Beatrice Di Napoli^a, Francesco Parisse^a, Zahir Namourah^a, Hugo Rodrigues^c, Tiago Miguel Ferreira^{a,*}

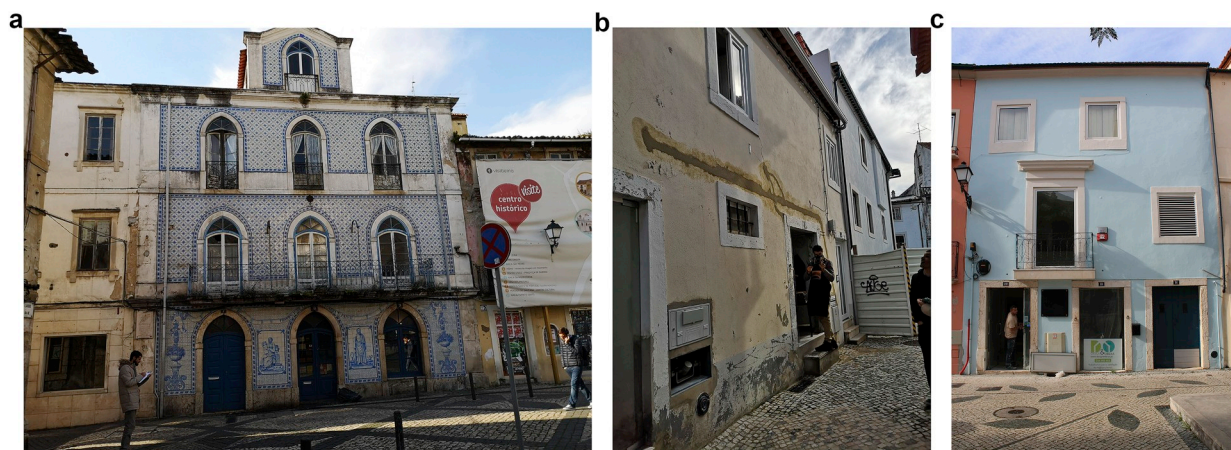
Fig. 2. Wall façades' openings: (a) Regular layout of a principal façade wall openings facing a square; (b) irregular layout of a secondary façade wall facing a minor street; and (c) latter intervention compromising the regularity of the layout of the openings.

Additionally, it can be observed that the façades' opening layouts present notable variability in the building stock. The façades facing the main streets, or the squares typically present a visible regularity in the

layout (Fig. 2a), this regularity can also be seen in the dimensions of the openings, although an appreciable difference between the sizes of the openings is observed between the typical buildings and grander ones. In contrast, the secondary façades' openings do not present comparable regularity for layout nor dimensions since the doors, and the windows were generally created according to the internal plan rather than for external aesthetic purposes (Fig. 2b). Moreover, the opening layout and dimension regularity are affected by additions and interventions carried out that may have led to additional openings of differing dimensions and/or exceeding the regular grid of the existing ones (Fig. 2c).

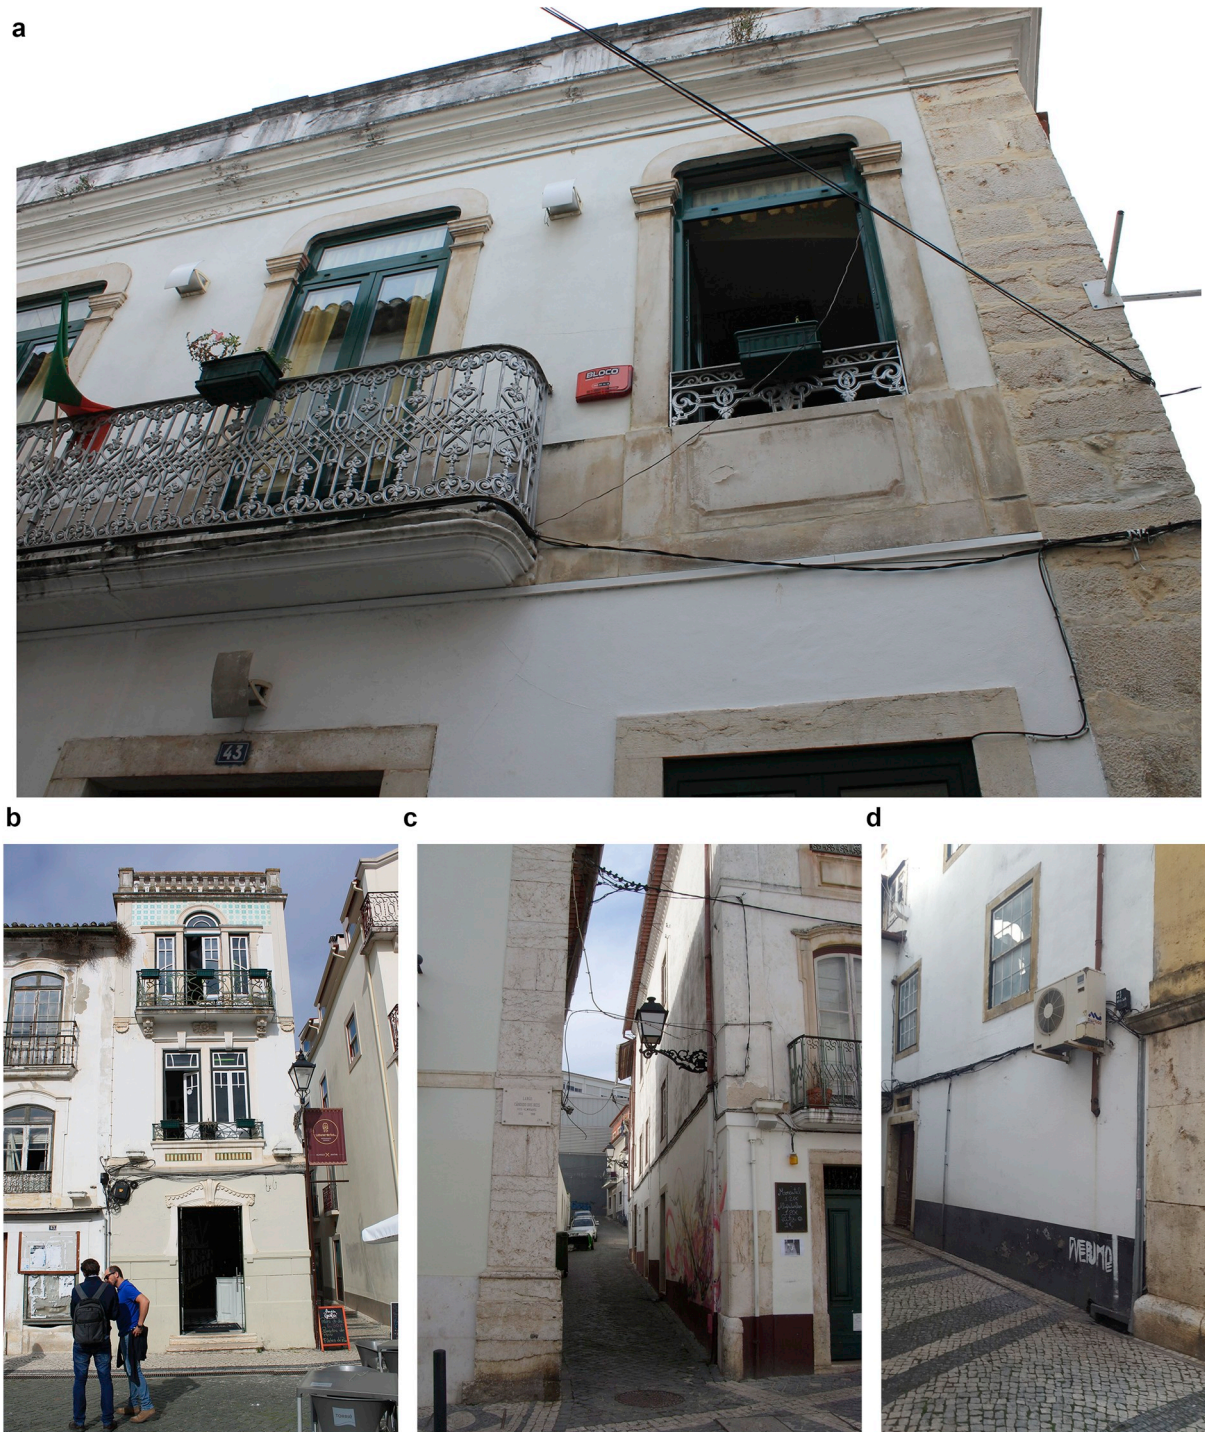
Fig. 3. Non-structural elements connected to the façades: (a) Cornice at the top of a building; (b) typical stone balcony, (c) light elements; (d) air conditioning systems.

The building stock is additionally characterized by the presence of small stone balconies and balustrades (Fig. 3b) as well as lighter elements such as streetlamps (Fig. 3c) and air conditioning systems (Fig. 3d).

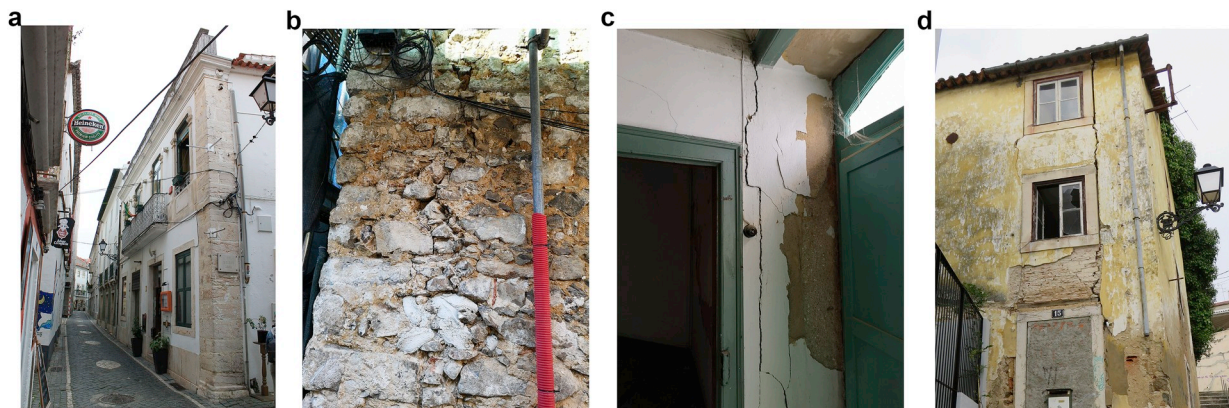
Fig. 5. Connections between structural elements: (a) Good quality connection; (b) bad quality connections between orthogonal walls); (c) detachment crack propagating in the internal corner of the façade; and (d) along the limestone lintels of the openings.

Regarding the connections between structural elements, it was observed that in some cases, the presence of large cornerstones assured a good wall-to-wall connection (Fig. 5a), while when this feature was not

detected a bad quality connection and improper interlocking was assumed (Fig. 5b).

Moreover, interior inspections allowed the observation of several signs of façade detachments, which were evidenced by the presence of diagonal and vertical cracks at the connecting corners of the façade walls with the internal walls (Fig. 5c). It is important to note that, in some cases, the presence of monolithic limestone posts and lintels framing of the façades’ openings close to the buildings’ corners can cause a detachment of the orthogonal façade compromising the connection quality between the two walls (Fig. 5d).

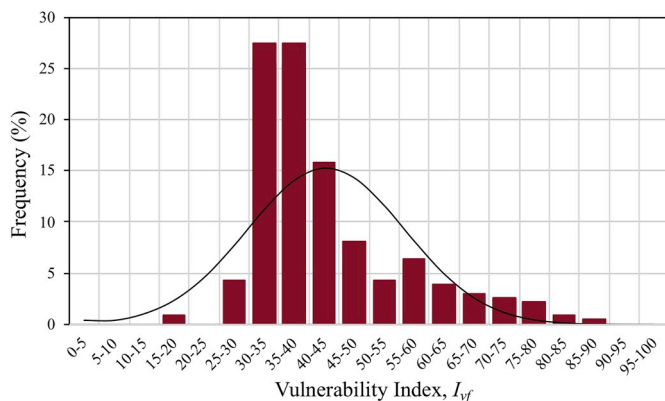
Fig. 8. Vulnerability Index distribution and comparison with the best fit normal distribution.

According to the I_{vf} distribution presented in Fig. 8, approximately

70% of the façade walls have an I_{vf} value higher than 35 and 44% higher than 40, which corresponds to 175 and 111 façades, respectively; thus, 64 façades have I_{vf} values between 35 and 40. In general, 51% of the assessed façade walls have I_{vf} values in the 35–45 range, equally distributed between 35–40 and 40–45. Also, the number of façades with an I_{vf} value higher than 45 is significant, as it is around 30% of the total, representing 74 façades. The normal distribution of the sample is also plotted in Fig. 8 and compared to the actual distribution of the vulnerability index values.

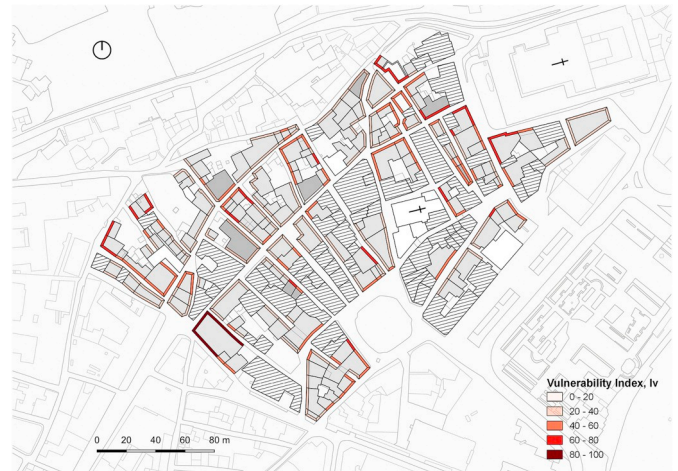
Fig. 9. Global vulnerability distribution of the façade walls.

The vulnerability index results were plotted with a GIS tool that allows for visualization and intuitive interpretation of the seismic assessment results. Fig. 9 presents the vulnerability map of the whole study area corresponding to the distribution of the vulnerability index values. A low I_{vf} is represented by a light color, while a higher I_{vf} is represented by a dark red color. Moreover, Fig. 10 shows that façades with I_{vf} values over 45 are present in all zones of the study area, although, in general, the higher I_{vf} values appear in the northeast area that corresponds to zone 3.

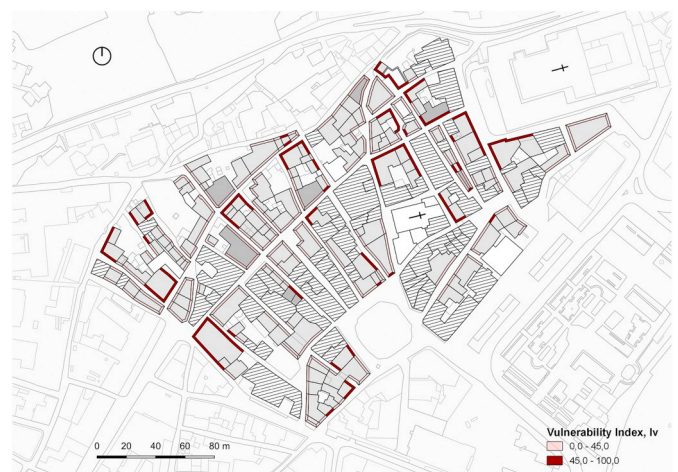
Fig. 10. Identification of the façade walls with I_{vf} values over 45.

It is also important to note that the majority of the corner walls of the larger blocks have I_{vf} values over 45 in consequence of the interaction between adjacent façade walls and the aggregate position effect. The concentration of extremely vulnerable corner blocks in zone 3 can

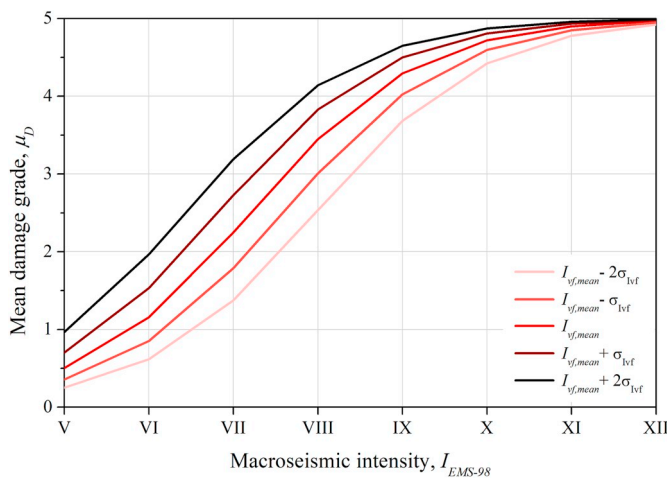
Fig. 11. Vulnerability curves obtained from the representative vulnerability index values.

The vulnerability curves plotted in Fig. 11 show the expected damage grade related to representative vulnerability index values ($I_{vf,mean} - 2\sigma_{I_{vf}}$, $I_{vf,mean} - \sigma_{I_{vf}}$, $I_{vf,mean}$, $I_{vf,mean} + \sigma_{I_{vf}}$, $I_{vf,mean} + 2\sigma_{I_{vf}}$), for different macroseismic intensities. The spatial distribution of the mean damage grade calculated for each façade is shown in Figs. 12 and 13, given macroseismic intensities of VII and VIII.

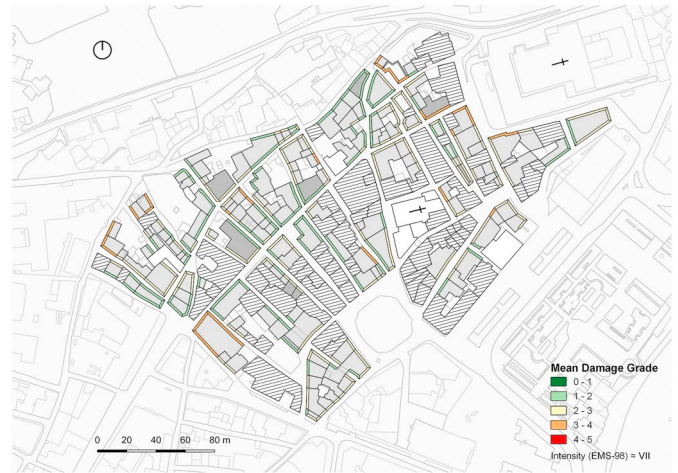
Fig. 12. Damage scenario for macroseismic intensity VII.

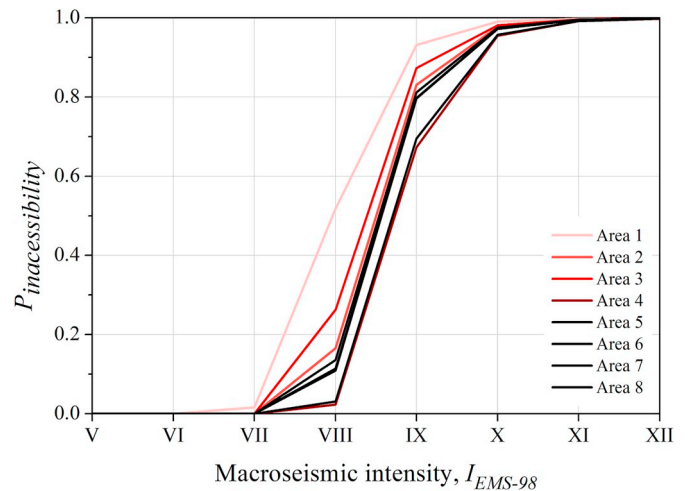
Fig. 18. Probability of inaccessibility associated with each one of the eight areas identified.

Moreover, it is possible to determine the probability of each of the identified areas being inaccessible for different seismic intensities by considering the probability of collapse of the façade responsible for the

isolation of the area. According to Equation (7), the probability of inaccessibility of an area is directly related to the probability of each of the façade walls described earlier reaching discrete damage grade D_4 , corresponding to $\mu_D \geq 3.5$:

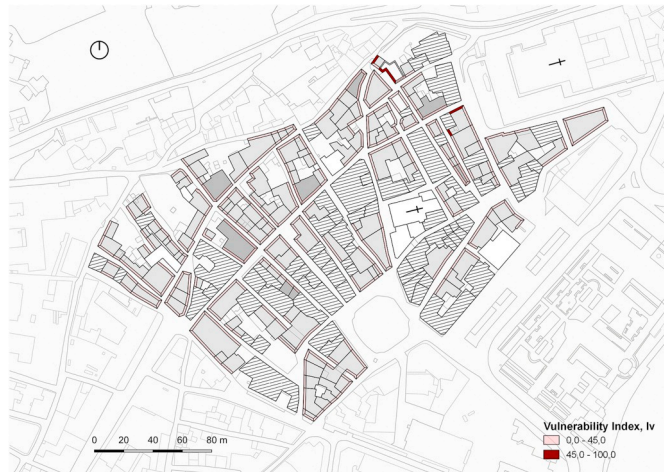
Fig. 20. Façades with I_{vf} over 45, after retrofitting.
