Traditional earthquake resistant techniques for vernacular architecture and local seismic cultures: A literature review

Javier Ortega ^{a,*}, Graça Vasconcelos ^a, Hugo Rodrigues ^b, Mariana Correia ^c, Paulo B. Lourenço ^a

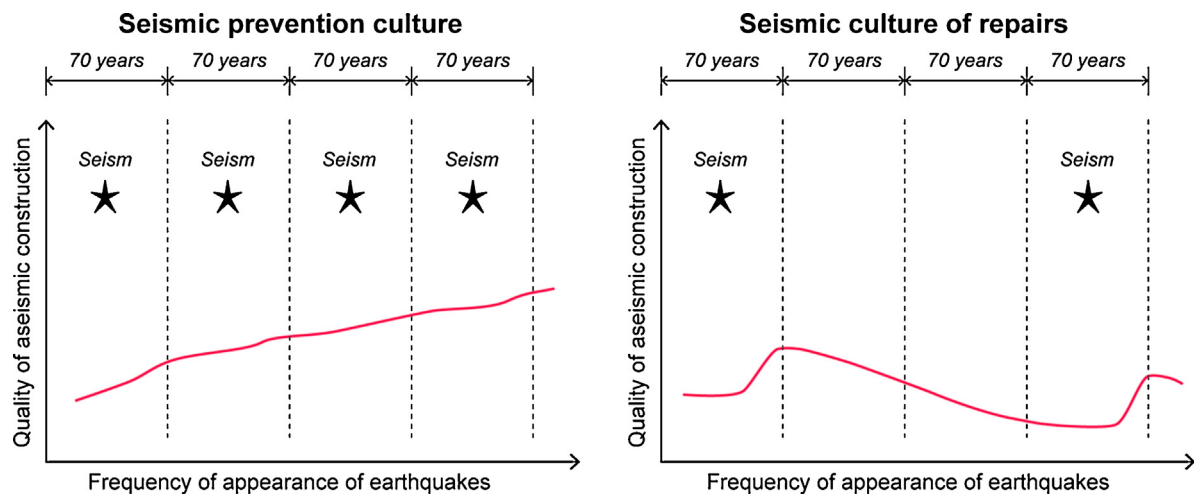
Fig. 1. Evolution of the quality of aseismic construction in relation with the earthquake frequency (adapted from [7]).

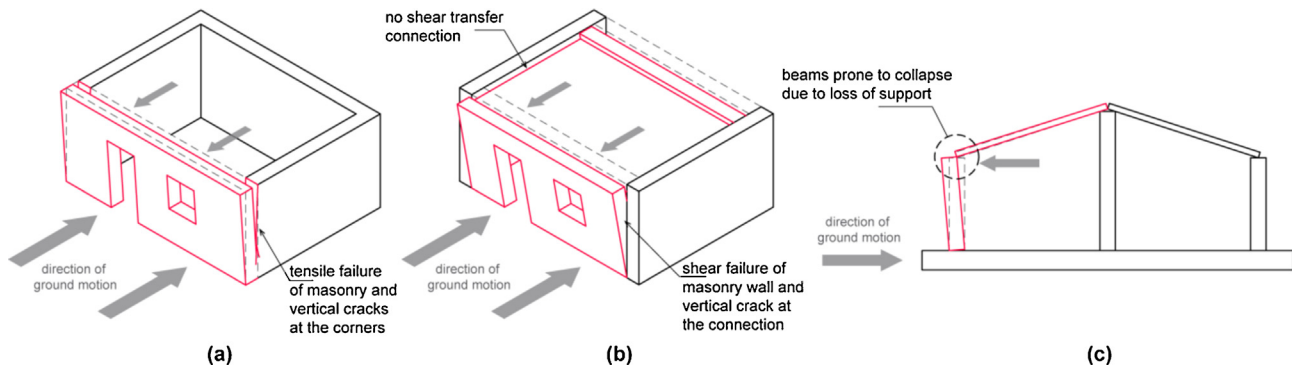
Fig. 2. (a) Global overturning of the external walls; (b) lack of anchorage between walls and horizontal diaphragms leading to the toppling of walls; and (c) separation of floors and roofs from the walls.

Deficient walls connections lead to out-of-plane failures due to the separation of walls at the corners. When seismic forces are transferred between perpendicular walls, there is a concentration of tensile and shear stresses at the connection that instigates vertical cracking and ultimately the global overturning of external walls (Fig. 2a). Additionally, if the anchorage between horizontal diaphragms (floors and roofs) and walls is not adequate, walls are free to vibrate independently and are more susceptible to top-ple (Fig. 2b). Inadequate wall-to-roof and wall-to-floor connections also lead to the separation of roofs and floors from walls. The loss of support often causes the partial and sometimes even the complete collapse of the roof and floors (Fig. 2c), which is one of the major causes of fatalities during earthquakes.

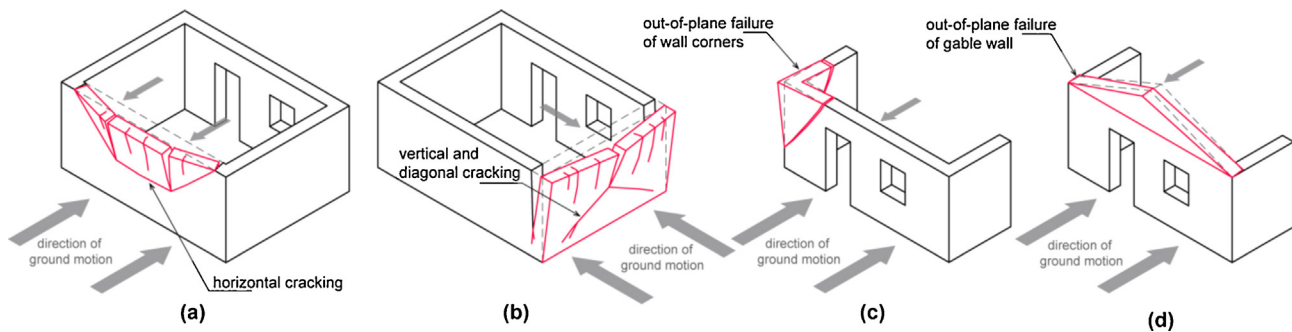
Fig. 3. (a) Out-of-plane mechanism in long walls (adapted from [74]); (b) out-of-plane mechanism in short walls (adapted from [74]); (c) out-of-plane collapse of the corner; and (d) out-of-plane collapse of the gable.

Other out-of-plane failure patterns associated to the bending of the masonry walls can also develop. The damage pattern varies according to the geometry and boundary conditions of the walls. It can consist of vertical cracks at the wall intersections preceding the tilting and collapse of big portions of the walls, sometimes even the entire wall. If the free length of the wall is significant (i.e. the distance between intermediate transversal supports), the out-of-plane mechanism typically consists of horizontal cracking in the base or intermediate height, together with vertical cracks (Fig. 3a). Failure mechanisms in shorter walls are usually formed by vertical cracks in the center of the wall and diagonal cracking, coupled with the separation of the walls at the corners (Fig. 3b). Other out-of-plane mechanisms can also involve specific structural elements of the buildings, such as the out-of-plane collapse of corners (Fig. 3c). Buildings with gable walls tend to vibrate as freestanding cantilevers and are susceptible to their out-of-plane partial collapse (Fig. 3d). These failures are facilitated at top floors in multi-story buildings, where earthquake accelerations are intensified and there are lower axial loads.

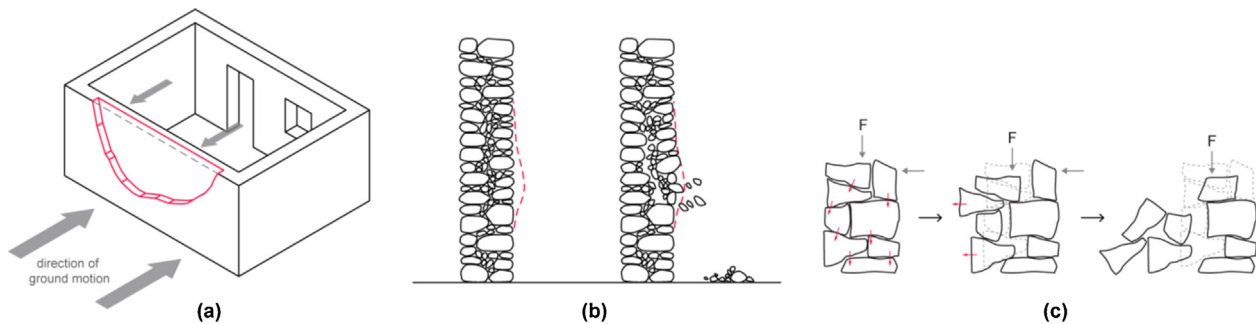
Fig. 4. (a) Delamination of the wall leaf; (b) inner leaf causing the bulging of the exterior wall leaf (adapted from [75]); and (c) wall failure caused by the irregularity of stones (adapted from [76]).

Another common damage concerning multiple-leaf stone masonry walls is the bulging of the external leaf or delamination (Fig. 4a). This type of failure is typically caused by poor quality of the masonry because of the lack of through-stones or “diatons”, which are larger stones that cross the entire thickness of the wall and allow the adequate bracing between leaves. Moreover, the space between

the wall leaves is usually filled with small stones and rubble, which can exert thrust from inside and push the leaves outward, causing the bulging and either partial or total collapse of the wall (Fig. 4b). This usually occurs at the upper parts of the wall, where the lack of weight allows the masonry to vibrate more independently [18]. The use of low quality building materials such as poorly placed irregular stones also tends to induce localized damage and partial collapses (Fig. 4c).

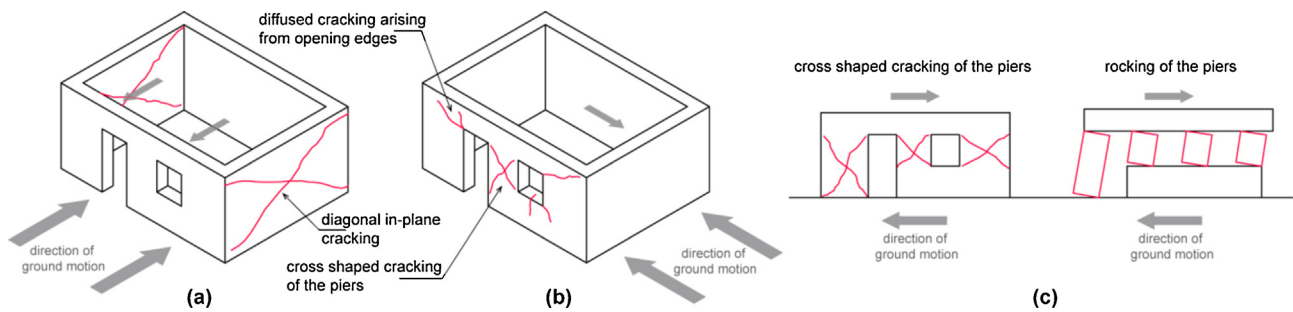
Fig. 5. (a) In-plane shear failure in the direction of the wall length; (b) shear cracking around the openings; and (c) shear cracking versus rocking of the piers (adapted from [18]).

Seismic events may also cause in-plane shear failure, which is mainly characterized by diagonal or X-cracking in the direction of the wall length (Fig. 5a). This failure is due to excessive shear efforts and low material shear strength, which is the case of earthen constructions and poorly constructed stone masonry buildings. In-plane failures also highly depend on the geometry of the walls, such as the length to height ratio and the wall thickness. The presence of openings facilitates in-plane cracking, which typically arises from the opening edges, where a greater concentration of stress is

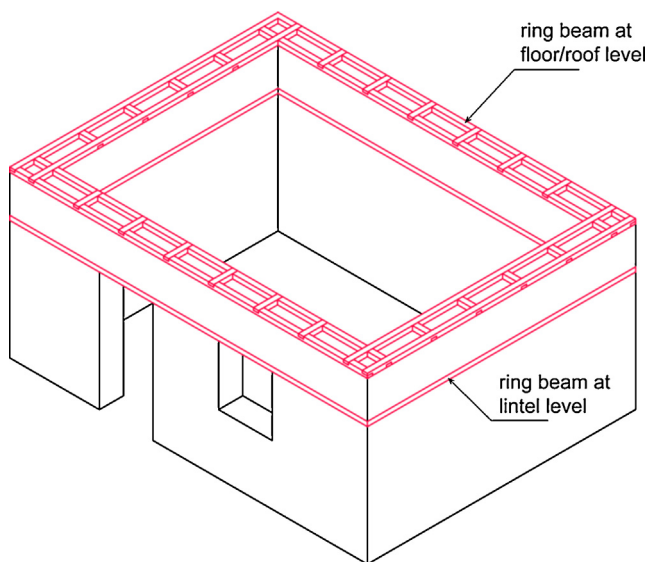
Fig. 7. Traditional timber ring beam reinforcement.

One of the most effective and widespread traditional techniques used to ensure the structural integrity of stone masonry and earthen buildings is the construction of timber ring beams, also known as bond or collar beams. Traditionally, ring beams are built using a pair of longitudinal parallel planks joined together with small transversal members in a ladder-like configuration (Fig. 7), but sometimes they simply consist of a rough timber grid of horizontal timber trunks or tree branches lying longitudinally and transversally. They are usually placed continuously at the lintel level, at the roof level or, in the case of multi-story buildings, at the floor levels. The introduction of this type of beams at different levels within the height of the walls improves the connections between

the different structural elements, tying the building and improving its “box-behavior”. In order to be more effective, ring beams should be continuous around the entire building. A proper connection between timber elements at the wall intersections should be ensured, by means of different timber joint details or even steel dowels or straps. The connection between the beam and the wall should also be ensured but it has been traditionally achieved solely by friction.

they can also help to tie the leaves of multiple-leaf masonry walls and prevent their separation. This technique does not avoid the formation of cracks, which still initiates for a loading similar to that observed in unreinforced structures [39]. However, it can greatly improve the seismic performance of the building in its inelastic range, maintaining its load-carrying capacity and being able to undergo larger deformations without collapsing. The use of ring beams as a strengthening technique in existing buildings is quite difficult, since their installation might require the raising and removal of the roof.

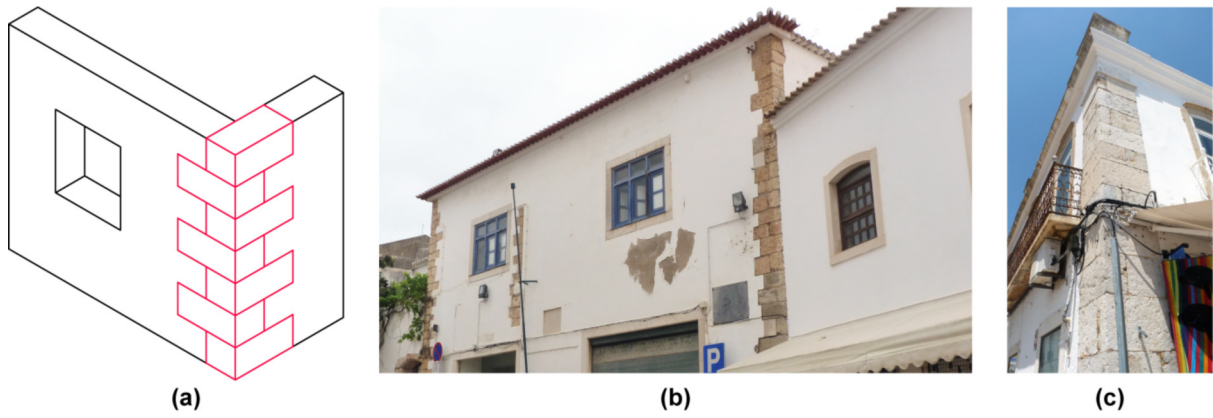
Fig. 9. (a) Traditional ashlar stone masonry quoin; (b) stone masonry quoin in Lagos, Portugal; and (c) ashlar stone masonry quoin in Vila Real de Santo António, Portugal.

The need of strengthening buildings at the corners was already emphasized by Leon Battista Alberti (1404–1472) in his treatise “*De re aedificatoria*”. He recommended thickening the walls at the corners by adding pilasters to reinforce the area [46]. Another common and efficient traditional technique of reinforcing wall-to-wall connections, mainly at the façades, is the construction of *quoins*. This technique consists of using the best quality large squared stone blocks at the corners, carefully bonded to the orthogonal walls by creating an efficient overlapping of the ashlers with the rest of the wall (Fig. 9a). However, the efficacy of quoins is limited when coupled with poor fabric or internally unconnected masonry which tends to become loose [38]. Quoins can be made of other materials, such as brick masonry, when used together with earthen walls. This technique is practically impossible to be implemented other than at the time of construction or during partial reconstruction. Quoins can be commonly found in many stone masonry vernacular buildings composing the historic city centers of many seismic prone regions, such as Italy, Greece and Algeria. There are many examples in Portugal as well, whose old city centers are also mainly constructed with stone masonry (Fig. 9b, c). Moreover, quoins can also be recognized in earthen buildings in some cases in Portugal, where pieces of schist or brick are introduced at the corners as reinforcement [47].

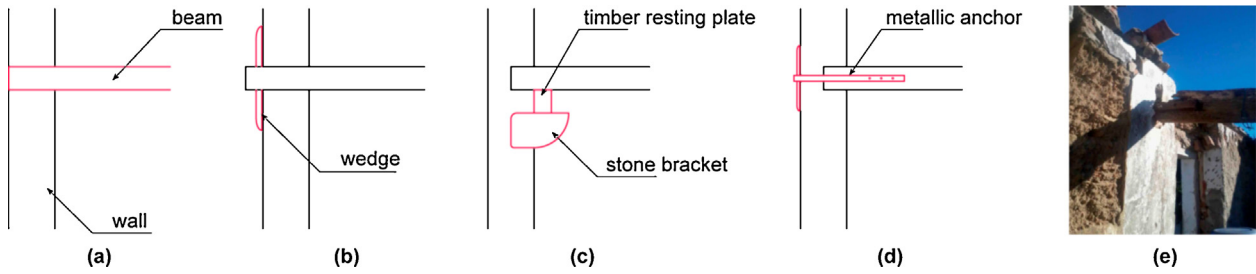
Fig. 10. Different types of reinforced floor/roof-to-wall connections: (a) timber beam resting on the whole width of the wall; (b) timber wedges; (c) timber resting plates and stone brackets; (d) metallic anchoring devices; and (e) roof timber beam strengthened with metal bracket in Melides, Portugal (photo by CI-ESG, 2013).

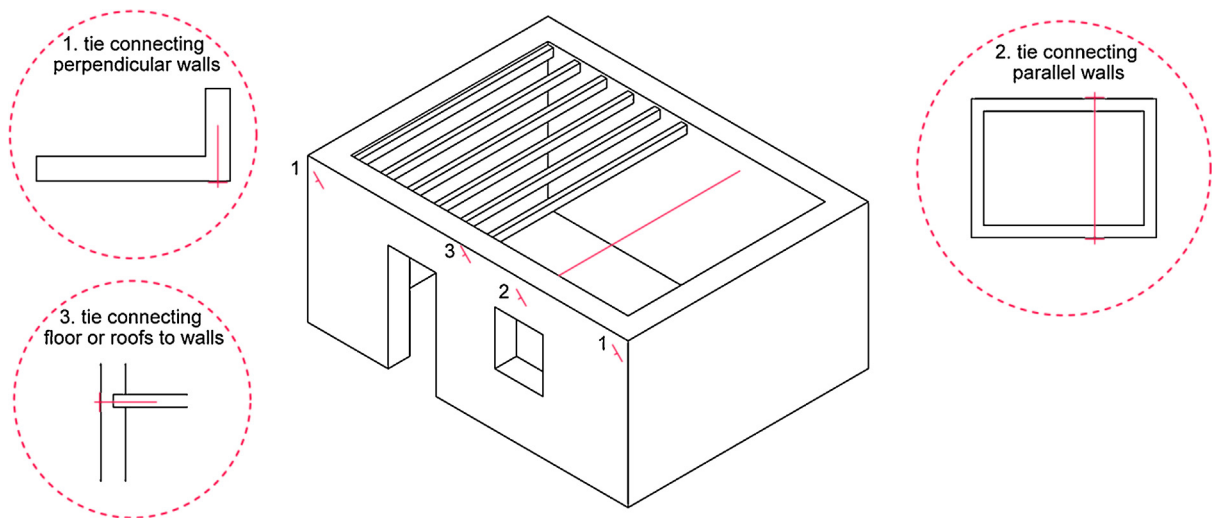
Fig. 11. Different possible locations of ties.

practice. Traditionally, ties might be the most often adopted technique to ensure the “box-behavior” of the building and improve its structural integrity. Steel tie rods and wooden tie beams can be systematically observed in highly seismic regions as a reinforcement measure to connect perpendicular load bearing walls, load bearing walls to interior walls, parallel load bearing walls, walls to floors, and walls to roofs (Fig. 11). Ties connecting parallel walls are intended to avoid their out-of-plane collapse but can also constrain the floors and facilitate a better load redistribution among the different walls, improving the overall performance of the system. They are usually placed at the floor and roof levels. Actually, a common vernacular practice is the use of the floor timber joists as ties connecting parallel walls by means of using solutions such as the ones previously described to reinforce their connection with the walls.

Ties have to be well fastened at the ends typically using steel anchor plates in the case of steel tie rods and timber wedges in the case of wooden tie beams. If not properly connected, they can actually be counterproductive and induce significant stress concentrations, causing cracking [49]. Given the fact that ties are easy to implement in existing structures before or after earthquake damage, they have been widely used for many centuries. Wooden tie beams are more frequently used in earthen buildings due to the compatibility of materials, and they can be commonly observed in many seismic prone regions, such as Peru [39]. Steel tie rods are very commonly used to strengthen stone masonry buildings across the Mediterranean region. Their use is also widespread in Portuguese vernacular architecture (Fig. 12).

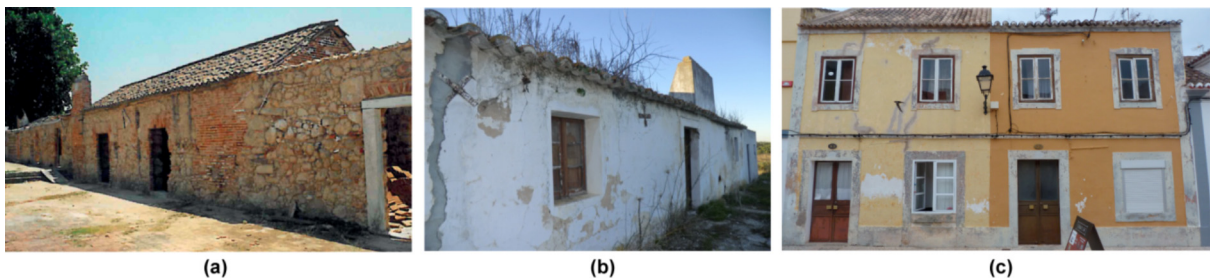
Fig. 12. Ties in Portuguese vernacular architecture: (a) Alcácer do Sal (photo by Mariana Correia, 1997); (b) Melides (photo by CI-ESG, 2013); and (c) Vila Real de Santo António.

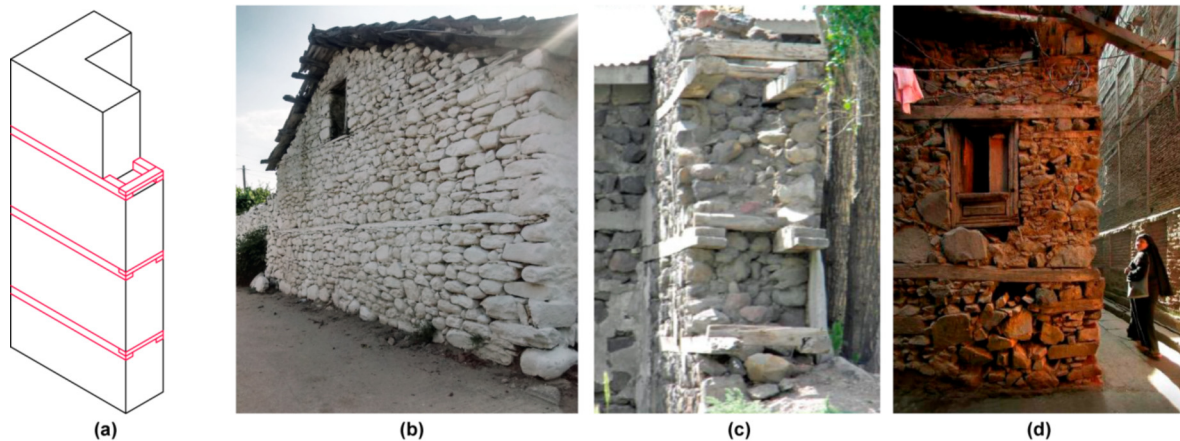
Fig. 13. (a) Traditional way of inserting horizontal timber elements within the masonry walls; (b) timber-laced wall in Greece; (c) timber-laced wall or “hatil” in Turkey [78]; and (d) timber-laced wall or “taq” in India [11].

Besides the widespread use of timber ring beams at the top of the loadbearing walls aiming at improving the global behavior of masonry buildings, the insertion of timber elements within the masonry can also be clearly seen as a strengthening method (Fig. 13a). Timber elements are applied due to their excellent tensile properties, becoming successful slip planes in the horizontal direction and helping to dissipate great amounts of energy. This horizontal reinforcement usually runs continuously around the entire building, holding the walls together. Furthermore, it improves the out-of-plane bending and in-plane shear resistance because, by confining portions of masonry walls, it enhances their compressive strength, shear strength and deformability properties [50]. Since timber bands are typically inserted within the entire thickness of the walls, they can also avoid the separation of the leaves in multiple-leaf stone masonry walls and prevent crack propagation.

This is a very common vernacular construction practice in many seismic prone areas such as in Greece, in Turkey, where the resulting timber-laced masonry is generally known as “hatil”, and in India, where it is known as “taq” (Fig. 13b–d). In the case of earthen buildings, bamboo or reed elements can be placed inside the walls as internal reinforcement instead of timber. Timber elements can sometimes be inserted as reinforcement of structural elements other than walls. As an example, logs are inserted on top of the column capital, working as imposts from which the arches are built, in some buildings in the Casbah of Algiers, in Algeria. The presence of the logs allows some slip movement or rolling, providing ductility and energy dissipation in the occurrence of an earthquake [51].

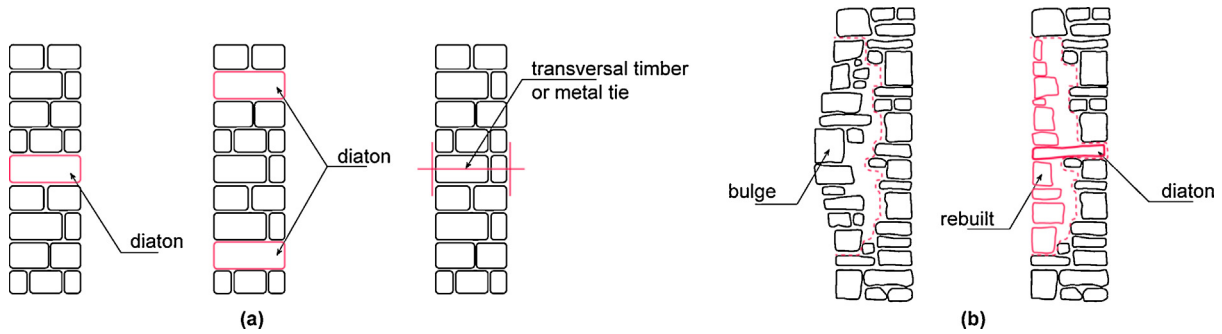
Fig. 15. (a) Use of through-stones or “diatons” and transversal elements; and (b) partial reconstruction of masonry wall using through-stones (adapted from [24]).

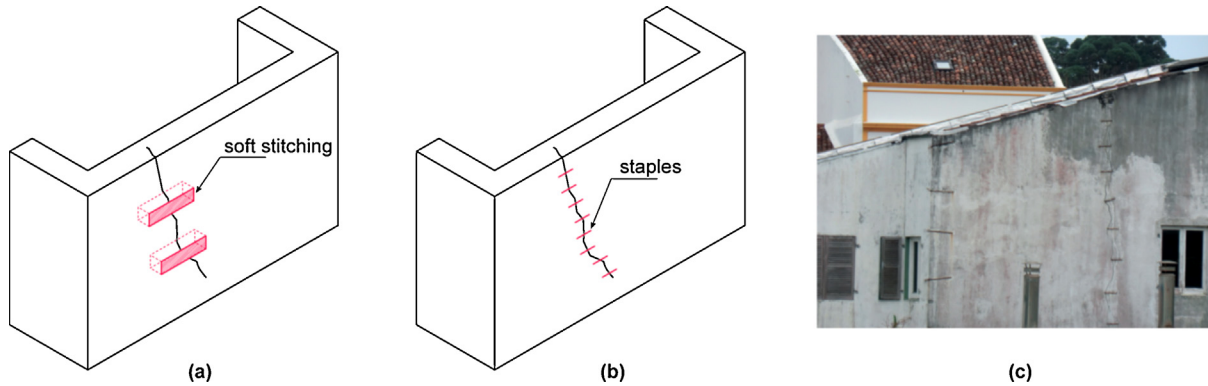
Fig. 16. Mended cracks: (a) soft stitching, characteristic of rammed earth constructions; (b) staples, characteristic of stone masonry construction; and (c) example of mended cracks in Azores, Portugal (photo by Mariana Correia, 2013).

Post-earthquake repairs such as mended cracks intend to restore the wall integrity and stabilize it. Many techniques can be traditionally applied to repair cracks. Partial reconstructions are used to recover heavily damaged parts of the masonry and fill cracks. However, they are labor-intensive and not very widespread as a traditional repairing technique. In the case of rammed earth structures, an ancient repair technique is soft stitching (Fig. 16a), which mainly consists of cutting chases both internally and externally around the cracks and re-filling them with rammed earth [54]. A common vernacular solution that can be found also in Portugal is the application of metallic staples at the cracks (Fig. 16b, c).

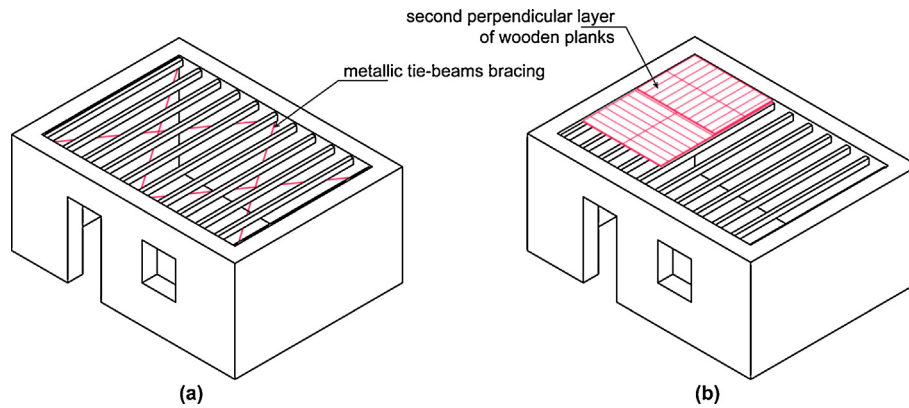
Fig. 18. (a) Traditional way of stiffening floors and roofs by diagonal bracing; and (b) floor stiffening by adding an extra floor layer consisting of wooden planks placed perpendicular to the existing ones.

through diagonal bracing, triangulation, or by providing a further layer of sheathing boards or wooden planks placed perpendicular to the existing one (Fig. 18). All these practices can be implemented as strengthening techniques. An illustrative example of a local seismic culture exists in Galaxidi, on the seismically hazardous Corinthian Bay in Greece. In this case, the typical structural system includes stiffening the ceiling by means of triangulation and proper coupling with the timber reinforcing components located on top of the masonry walls [57].

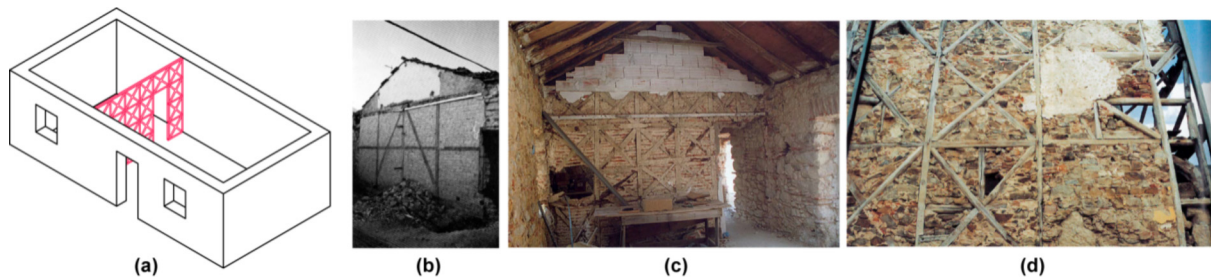
Fig. 19. (a) Traditional structural timber frame “frontal” wall; (b) “frontal” wall in Benavente, Portugal [80]; (c) “frontal” wall in Alcácer do Sal, Portugal [1]; and (d) “frontal” wall in Vila Real de Santo António, Portugal [66].

The structural system includes a highly perfected timber frame but the most significant resistant characteristic is the structural redundancy. The ground floor of the buildings is constructed with load bearing thick masonry walls but timber structural columns are also present as a secondary structure, independent from the first one. In this way, the masonry walls can collapse in the event of an earthquake and tend to be thrown towards the exterior due

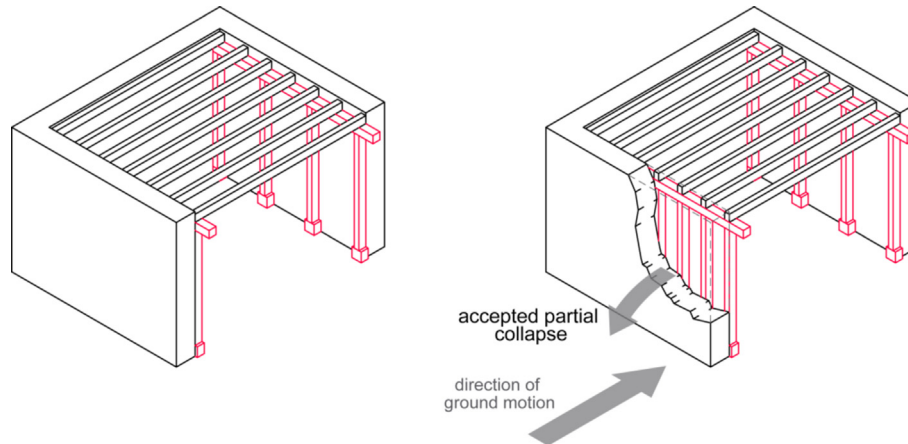
Fig. 20. Structural redundancy: the use of a dual load bearing structure allows the partial collapse of some elements while keeping the construction standing.

to the presence of the timber structure in the interior. The timber structure does not collapse because it is supported by the timber columns and keeps the building standing with the timber frame second floor and the roof intact. As a result, the people inside the building are more protected and the masonry walls can be easily and rapidly repaired. Today, this system is still common and widespread in the island and has proven to behave well against earthquakes. In the 2003 earthquake, none of these traditional buildings suffered total collapse, even though some three-story reinforced concrete buildings did, and just several of them suffered partial collapse of the timber frame masonry infill or the ground floor masonry walls [70].

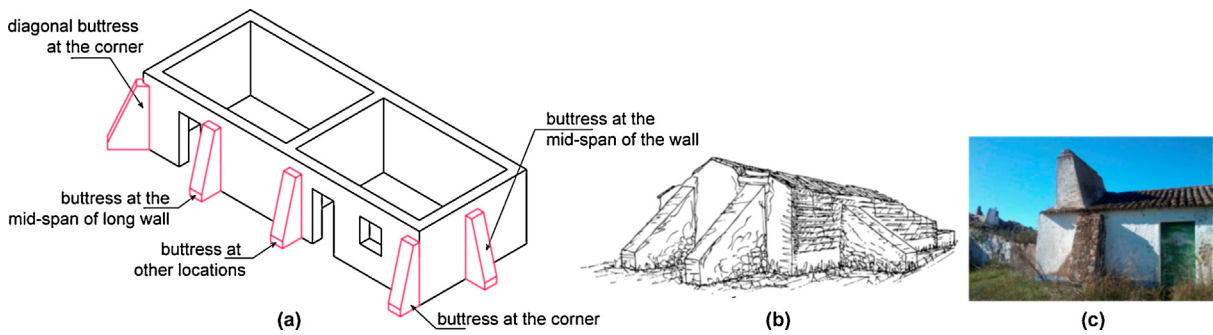
Fig. 21. (a) Different possible locations of butters; (b) butters in Redondo, Portugal [47]; and (c) butters in the region of Évora, Portugal (Photo by CI-ESG, 2013).

Techniques based on providing a counteracting effect against the buckling tendency of a wall are very common in most seismic prone regions [6]. The most common and widespread traditional strengthening technique used for resisting and counterbalancing seismic horizontal forces is the construction of *buttresses* or counterforts. They can also be known as pilasters if they are embedded within the walls in rammed earth buildings. They can be built at the same time as the building, as a deliberate feature, or they can be added as a reinforcement measure. They consist of pier-like, massive local additions typically of masonry, whose working principle is to counter the rotation of the façade thanks to their shear mass (Fig. 21).

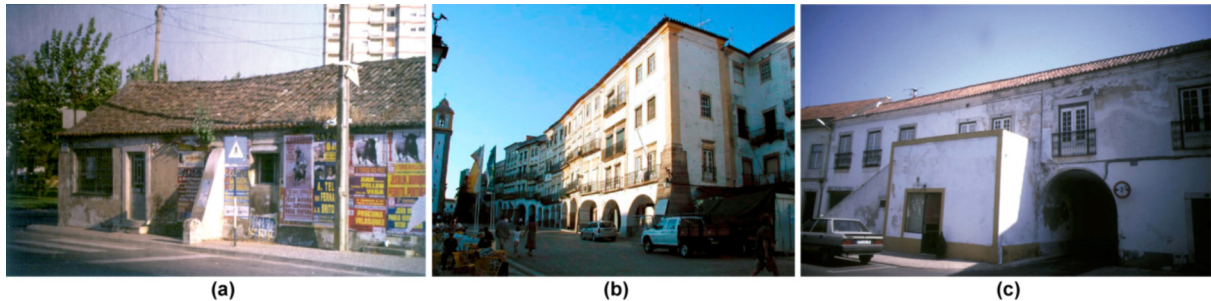
Fig. 22. (a) Butters invading the side walk in Samora Correia [1]; (b) two-floor butters in Évora [1]; and (c) external staircase in Benavente [1].

When adding a buttress as reinforcement, special attention should be put at its connection with the original walls. If they are not properly connected, they add little or no stability to the building, acting independently and only when the wall moves towards the buttress. They can even be prone to rock against the wall if the movement is the opposite, imposing an extra load. Therefore, it is recommended to tie the buttresses to the walls using, for example, cross ties [39]. Buttresses should be placed at critical locations, such as the mid-span of long walls, which are the most vulnerable elements to the effects of out-of-plane earthquake vibrations, and at the corners, in order to avoid the separation of the walls. They can be found in most seismic prone regions, such as Peru and Italy, but are also very common in Portugal (Fig. 22). Buttresses are also very common in an urban environment, and are distinctly a reinforcement measure because, when added to the buildings, they invade the public space, sacrificing the comfort of the inhabitants in pursuit of the seismic safety (Fig. 22a). Sometimes, other urban structures, such as external stairs, can also achieve a similar role of counteracting the rotation of the walls (Fig. 22c).

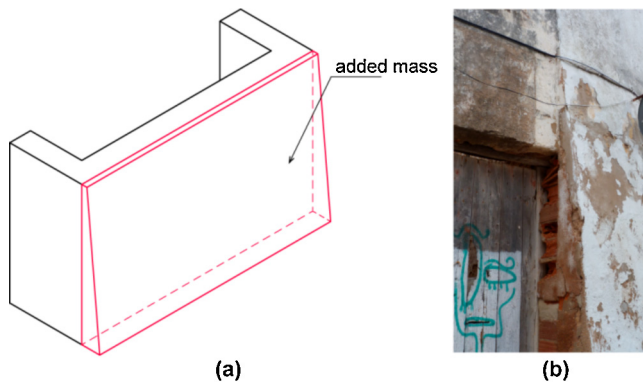
Fig. 23. (a) Traditional thickening of the wall by adding mass and increasing the resisting cross section; (b) example of thickened wall in Lagos, Portugal.

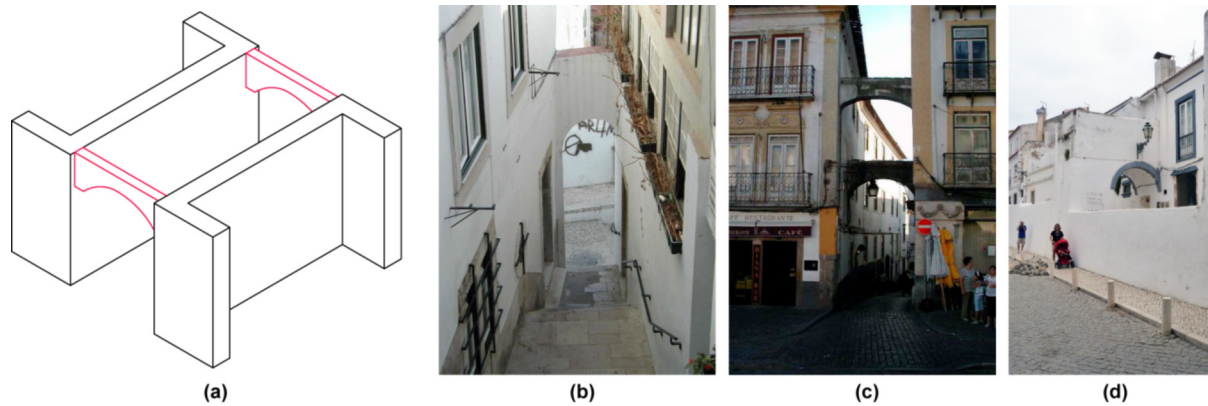
Fig. 24. (a) Traditional urban masonry reinforcing arches; (b) reinforcement arch in Alfama, Lisbon [1]; (c) reinforcement arches in Évora [1]; and (d) vaulted passage in Lagos, Portugal.

movements to be redistributed among their structural elements. In order to perform an effective reinforcing function, reinforcing arches should be properly connected with the old structures, and they should avoid differences in the level of the floors or ceilings, which may lead to dangerous eccentricities. Similarly to the butters, these arches work as propping structures and do not have an influence under static conditions. They are the typical historical solution to avoid the development of out-of-plane mechanisms at an urban level in villages built mainly of stone masonry, such as Italians, and have become part of their historical fabric. They can also be recognized in many Portuguese cities, such as Lisbon, Évora and Lagos (Fig. 24b–d).
