# Nondestructive Techniques for the Assessment and Preservation of Historic Structures

Edited by  
**Luisa M. S. Gonçalves**  
**Hugo Rodrigues**  
**Florindo Gaspar**

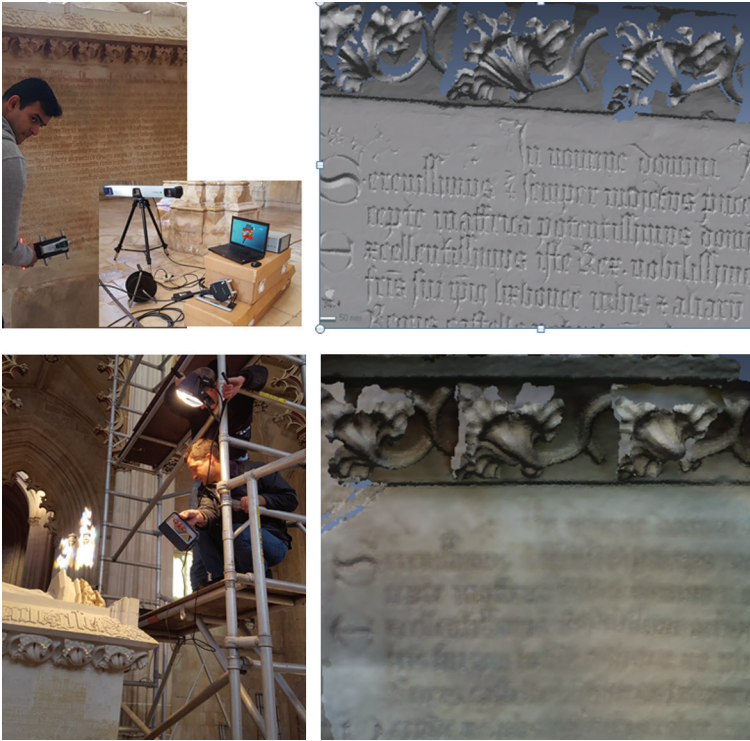
**FIGURE 1.1** Two scans performed in the Santa Maria da Vitoria Monastery of Batalha, Portugal, which were acquired with two different TLS systems.
