Seismic Vulnerability of Urban Vernacular Buildings in Nepal: Case of Newari Construction

Dipendra Gautam & Hugo Rodrigues

This paper analyzes the seismic vulnerability of vernacular Newari buildings in Nepal. Based on the damage statistics and failure modes recorded during 1934, 1988, 2011, and 2015 earthquakes, damage probability matrices and seismic fragility functions are derived in this paper. Notable seismic features of the Newari buildings are identified and reported using forensic approach. The result of this study highlights that the vernacular Newari buildings are highly vulnerable in the case of minor to major earthquakes; however, the seismic features have contributed to downscale the damage extent.

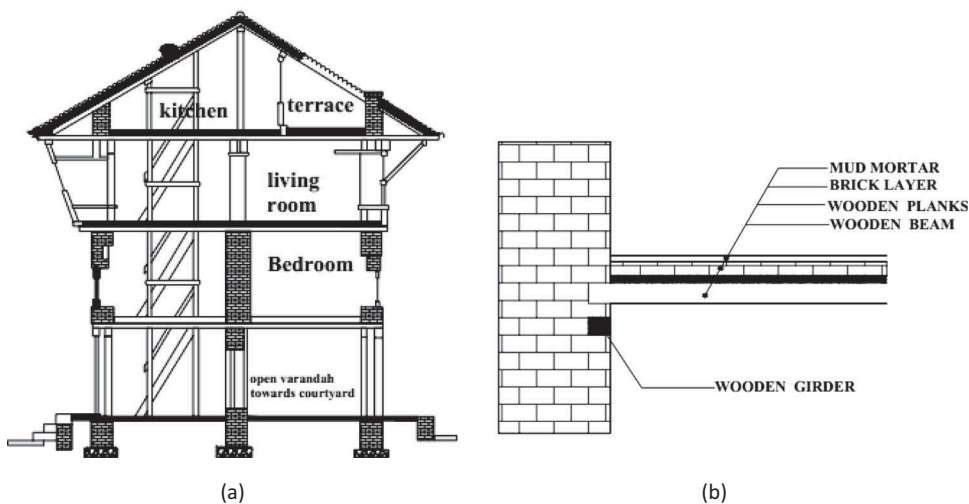
250 and 600 mm. The wall section comprises mud mortar, brick layer, wooden plank, and timber beam as shown in Fig. 2b. Two types of wall partitioning can be observed in vernacular buildings; the first is throughout wall construction with reduced dimension and the second is partitioning with veneers or wooden planks. Primarily, brick masonry-based shallow foundation is provided in vernacular Newari buildings.

Figure 2. (a) Vernacular Newari building (b) a section of a wall.

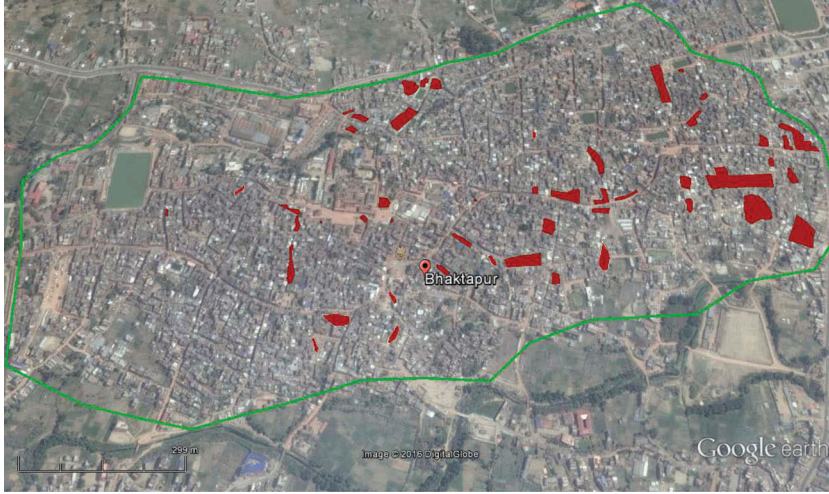
Although the intensity of earthquake in Kathmandu valley was generally VIII, some areas of Bhaktapur like; Golmadhi, Suryamadhi, Jela, Byasi were destroyed. Thus, it is better to assign IX intensity to Bhaktapur. Fig. 8 depicts the areas which were heavily damaged or destroyed locations within Bhaktapur city. Apart from this, slight, minor and heavy damages were observed in all neighborhoods of the city. The major damage locations were toward the eastern fringe of the city and the settlements located on the sloping ground. The summary of component-wise failure modes is presented in Table 1.

Figure 8. Major building collapse areas within the ancient settlement of Bhaktapur city (modified from: <https://www.google.com/earth/>).

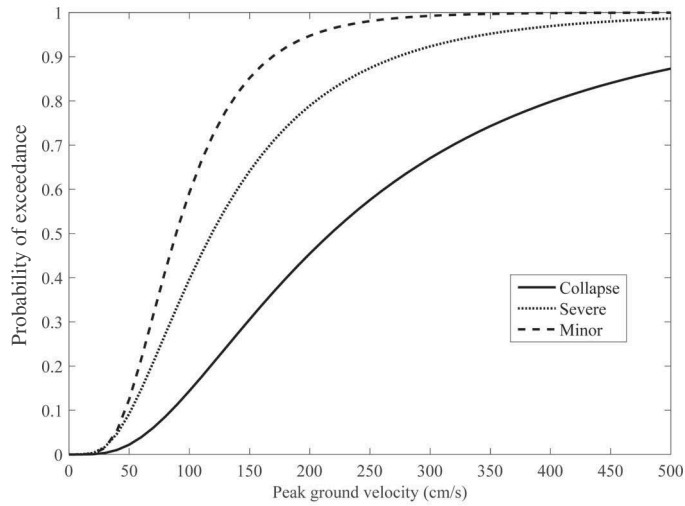
and PGA as IMs. The former is used to depict the fragility functions per the reported or estimated velocities, whereas, the latter is used to compare the newly derived fragility functions with the fragility functions derived for close building class. The lognormal distribution parameters can be easily estimated using available statistical packages or Microsoft Excel calculations. Further details on MS-Excel based calculation can be found in the paper by Porter *et al.* [2007]. Fragility functions for the vernacular Newari buildings considering PGV as IM are presented in Fig. 17. Meanwhile, Fig. 18 depicts the comparative plots of existing fragility functions for brick masonry buildings along with the newly derived fragility functions. As we did not find any fragility functions for close building class derived considering PGV as IM, we chose a different correlation to estimate PGA as shown in Eq. 4. As shown in Fig. 17, 50% probability of exceedance for minor damage state occurs at the PGV lower than 100 cm/s. This highlights that vernacular Newari buildings are likely to be damaged even in minor to moderate shaking. In the case of severe damage, 50% probability of exceedance is occurred at the PGV ~ 125 cm/s. The collapse state shows there is 50% probability of occurrence or exceedance of collapse state only at the PGV of >225 cm/s. As shown in the Fig. 17, the damage initiation could be seen at the PGV

Figure 17. Fragility functions for vernacular masonry buildings.

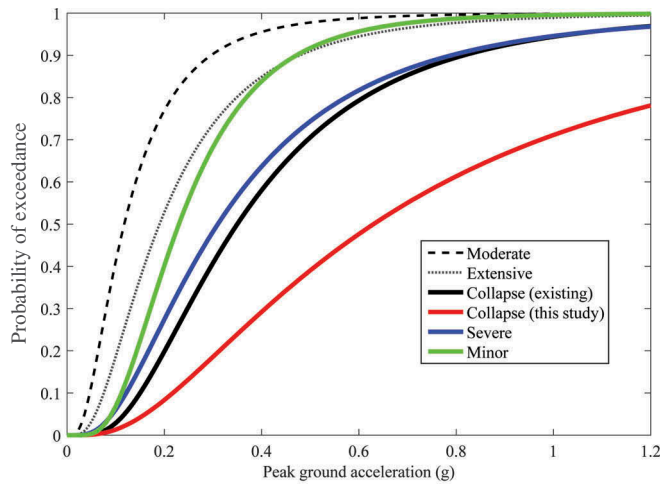
The comparative plot as shown in Fig. 18 highlights that the existing fragility curves generally overestimate the vulnerability. For instance, at 0.4 g PGA, existing curve depicts 60% probability of collapse whereas newly derived curve highlights 30% collapse probability only. It should be carefully noted that the comparison is made between broadly comparable building classes; however, brick masonry class used by Chaulgain *et al.* [2016] does not exhaustively represent vernacular Newari buildings. Hence, the discrepancies are obviously expected in fragility functions. It is interesting to note that the fragility curve for the minor damage state is even below the fragility curve for extensive damage state proposed by Chaulgain *et al.* [2016] until PGA 0.4g.

Figure 18. Comparison between the newly derived fragility functions for vernacular Newari buildings and the existing fragility functions for brick masonry buildings proposed by Chaulgain *et al.* [2016].
