# SEISMIC PRECAST

Seismic Performance Assessment of  
Existing Precast Industrial Buildings

## The project Seismic Precast

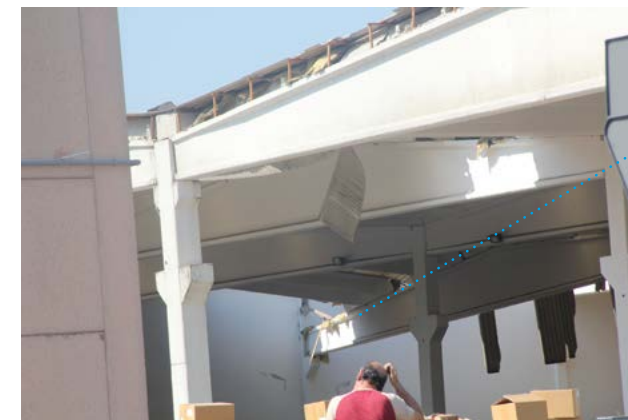
Figure 4 - Loss of support of the beam from the column

to the limited length of support and, in an earthquake event, the displacement between the beam and the column exceeding the available length leads to the beam's fall [6]. Figure 4 shows an example of the loss of support from the column due to the support forks failure.

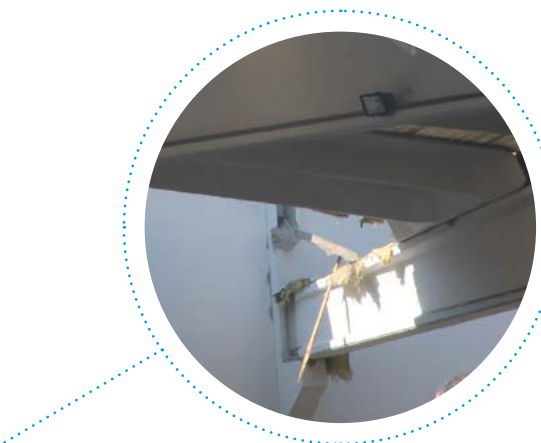
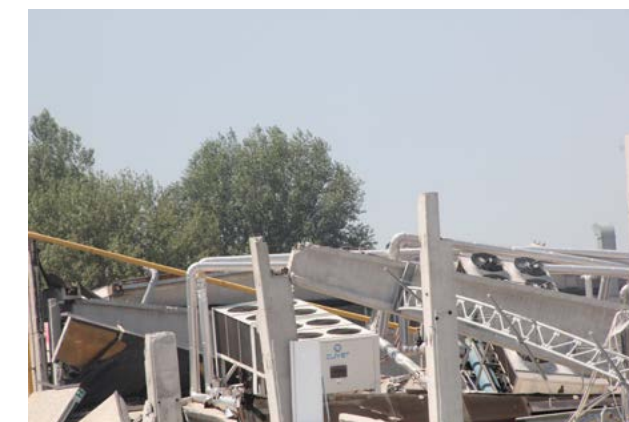
Figure 5 - Failure due to loss of support of the beam

Regarding the observed beam damages, compared to what has already been documented, beam failure is not very common. In fact, the main cause of beam failure is related to the loss of support (see Figure 5). The absence of a proper beam-to-column connection, which could also prevent the spalling between the column and the beam, is the main reason for the beam collapses [4], [15].

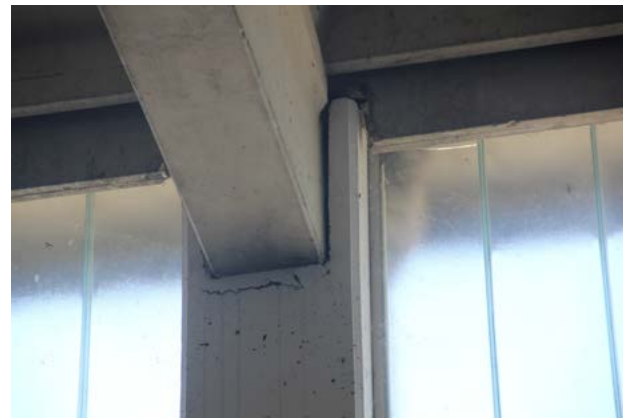
Figure 6 · Rotation of the beam

Another problem associated with beams is their rotation, as illustrated in Figure 6. This problem is associated with roof panels, more specifically with the lack of connection. In many cases, the roof's collapse is a consequence of the beam failure [5]. Bournas *et al.* [6] reported that 25% of PRC industrial buildings designed with no seismic provisions presented partial or total collapse of the roof and girders.

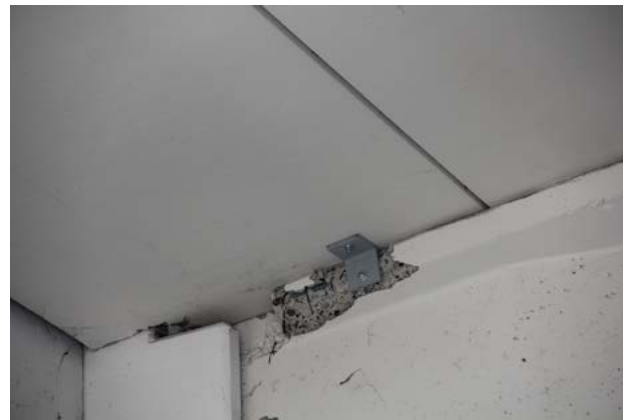
Figure 7 · Beam damage due to the roof-to-beam connection

Regarding the roofs, the flexible ones are the most used due to the absence of mechanical connections between the joints, so the seismic actions are directly transferred to the primary beams, which in some cases exceed their own out-of-plane capacity and collapse. Figure 7 illustrates beam damage due to the roof-to-beam connection.

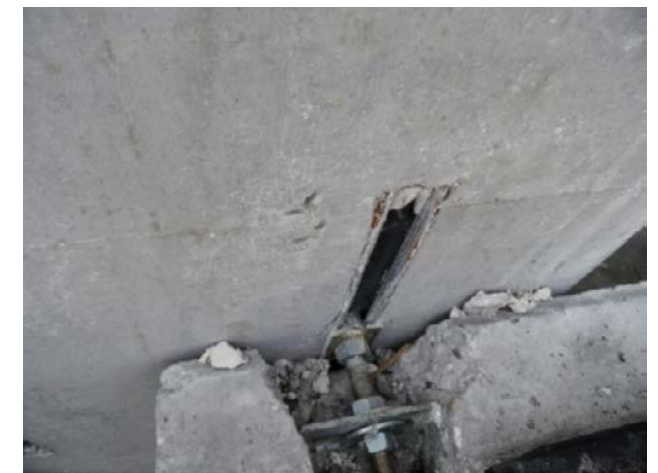
Figure 8 · Top view of the cladding-to-column connection failure [16]

Some of the critical problems reported in recent earthquakes in Italy are associated with the cladding-to-structure devices used in the past [24]. The observed damages in cladding panels are mainly related to the failure of the fastening elements and the consequent out-of-plane overturning [4]. Figure 8 represents details of the detachment of a horizontal cladding panel connection like typical connections found in Portugal. The most current arrangement of cladding panels observed in PRC buildings in the Portuguese industrial park is the horizontal ones [25], identified by several authors [2], [26], [27] as the most vulnerable one.

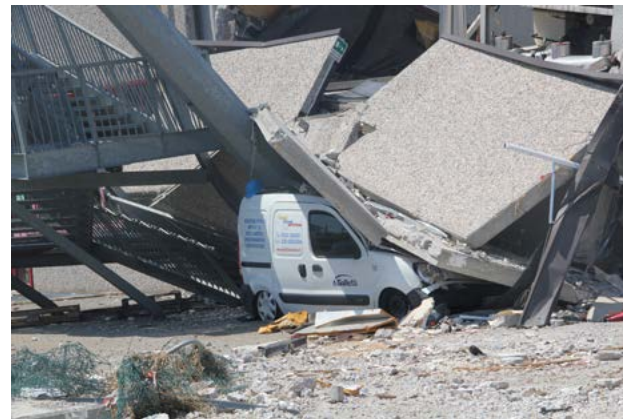
Figure 9 - Example of a collapsed cladding panel after the 2012 Emilia-Romagna Earthquake in Italy

The previous considerations highlight that ignoring these elements' contribution may lead to the serious collapse of these types of elements (Figure 9) and represent a potential hazard for humans and huge economic losses [16], [23]. Moreover, the different cladding-to-structure fastenings play a key role in the safety, performance, and economics of the cladding system as well as the main structure itself.

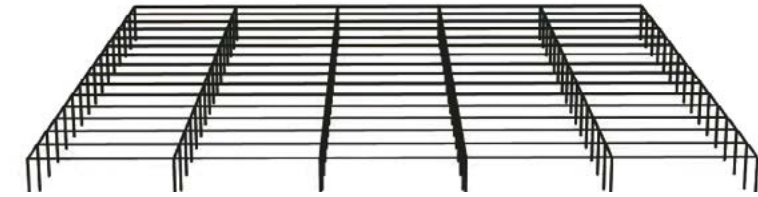
Figure 28 - 3D overview of the building under study

The PRC building under study represents an existing industrial framed structure (Figure 28) constituted by one floor with an area of  $180 \times 175 \text{ m}^2$  and a height of 12 m. The structure has 5 spans in the X direction (Figure 29) with 35 m of length each and 15 spans in the Y direction with 12 m of length each. The columns of the structure have a height of

12 m (the height of the building) and a rectangular section of  $0,70 \times 0,50 \text{ m}^2$  (Figure 30) with a 40 mm cover. The concrete used was C40/50 and the steel the S500 NR-SD. The beams are prestressed with an "I" variable section, with a length of 36 m and a 30 mm cover. The columns are assumed fixed to the foundation.
