Article

Seismic Vulnerability Assessment of Existing Reinforced Concrete Buildings in Urban Centers

Keywords: seismic vulnerability index; RC buildings; damage mechanisms; damage scenarios

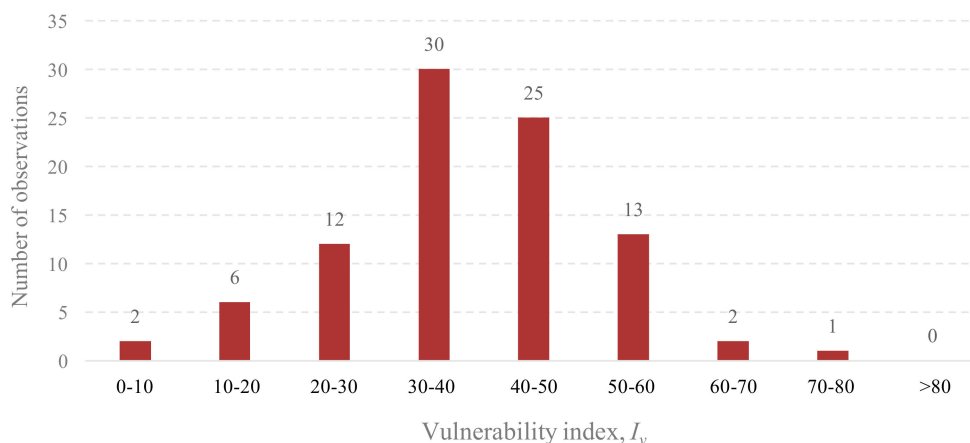
Figure 3. Distribution of the analyzed buildings over ranges of vulnerability index values.

The method was applied to the selected buildings and the overall results are presented and discussed next, in terms of vulnerability index and confidence factor. The results show a mean vulnerability index, I_v , of 38.73, with the standard deviation, σ_{I_v} , of 12.30. Figure 3 presents the histogram of the vulnerability index values obtained. The range between 30 and 40 presents the highest fraction of vulnerability index values, containing 30% of the buildings. Forty-five percent of the building stock has an I_v over 40, and about 18% has a value over 50. The maximum and minimum values calculated were 75 and 7.5, respectively.

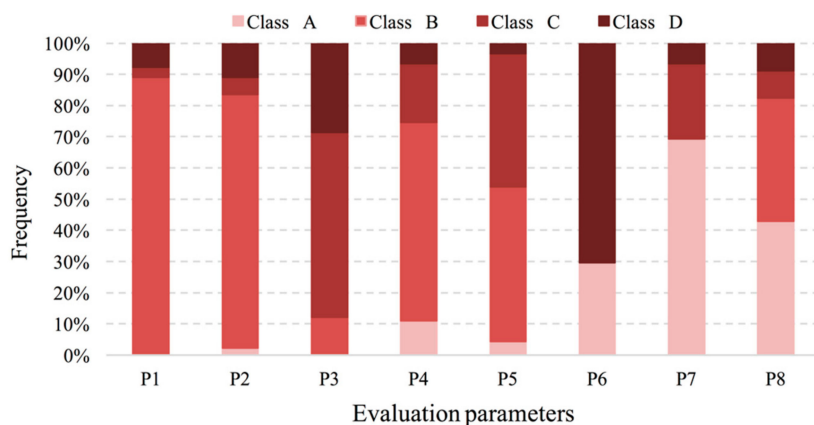
Figure 4. Influence of each one of the evaluation parameters on the final value of I_v .

Figure 4 presents the vulnerability classes distribution of the evaluation parameters over the percentage of buildings assessed. From the analysis of Figure 4, it is possible to observe that parameter P6, which assesses the soft-story mechanism, is the one that presents the higher number of buildings belonging to vulnerability class D (about 70% of the buildings assessed), followed by parameter P3, which accounts for the age of the building, with about 28%. Parameter P7, dedicated to the short columns, and parameter P8, which assesses the presence of non-structural elements, are the third and the fourth parameter with a higher percentage of buildings evaluated with vulnerability class A, with about 69% and 43%, respectively.

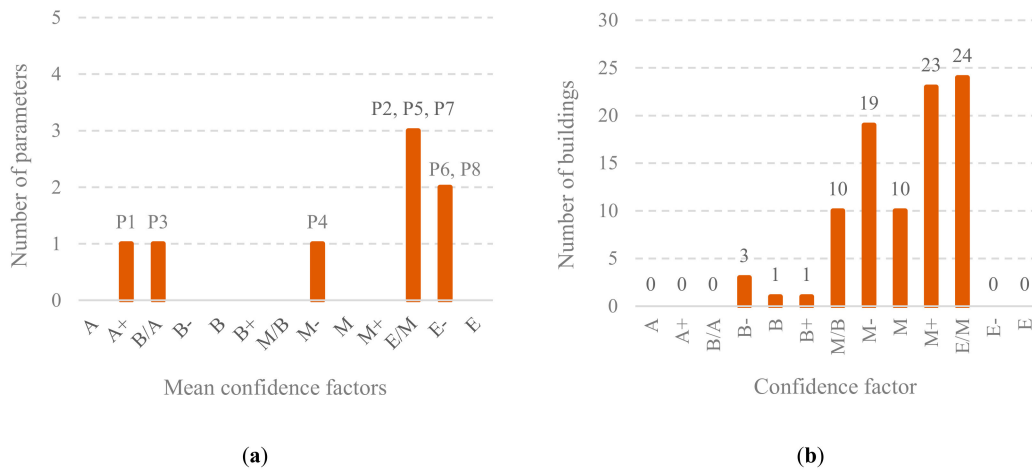
Figure 5. Distribution of the confidence factor associated with the evaluation parameters (a) and the global assessment (b).

Figure 5a,b present, respectively, the distribution of the mean confidence factors obtained from the evaluation of the parameters that compose the I_v and the global assessment of the 91 pilot-buildings.

As can be seen in Figure 5a, the mean CF E/M is the one that has been used more often, having been assigned to parameters P2, P5, and P7 (position into the aggregate, irregularities in height, and short columns). The second confident factor with higher expression is the E-, with parameters P6 and P8 (soft-story mechanisms and other structural elements). Finally, due to the lack of information on the type of soil, parameter P1, which evaluates the building location, is the one that presents the lowest mean confidence factor (A+). Figure 5b presents the mean confidence factor associated with the building's classification, i.e., corresponding to the average of the confidence factor attributed to each parameter assessed. The average confidence factor E/M is the one that has the most expression with 24 buildings (about 22% of the total sample), followed by the CF M+ with 23 buildings (about 21%). From this analysis, it is further possible to observe that there are five buildings with an average confidence factor lower than M/B. The average CF B- has three buildings (about 3%), whereas the average CFs B and B+ present one building each (about 1%).

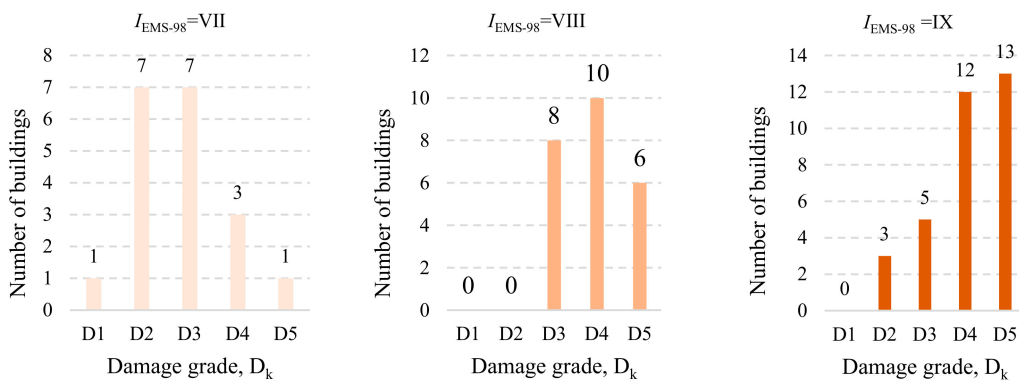
Figure 6. Distribution of the damage grades for different macroseismic scenarios.

Figure 6 presents the variations on the mean damage grade, μ_D , obtained for each building, organized by macroseismic intensity. It is worth noting that, due to the reduced number of buildings assessed for intensities $I_{EMS-98} = V$ and $I_{EMS-98} = VI$, such intensities were excluded from the sample subsequently used for constructing the vulnerability curves. In consequence to that, the estimation of cumulative losses due to frequent, low-intensity earthquakes in a given timeframe, is limited and therefore further efforts should be made to enlarge this database, mainly for intensities $I_{EMS-98} = V$ and $I_{EMS-98} = VI$.

From the analysis of Figure 6, it can be noted that, for a seismic scenario with an intensity equal or higher than VIII, most of the buildings considered in this analysis present mean damage grades of $D_k = 4$ and $D_k = 5$, which means severe damage or collapse.

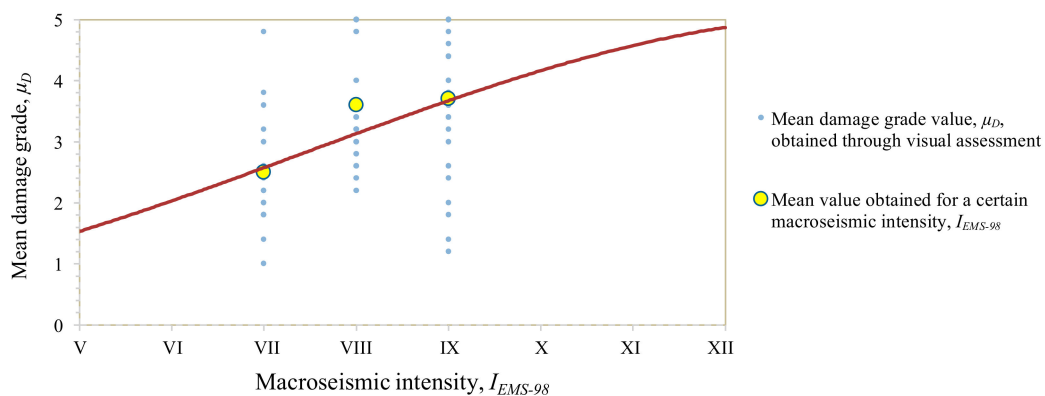
Figure 7. Best curve fit to the average values of the assessed buildings with damage.

Figure 7 shows the comparison between the results obtained and the analytical expressions given by Equation (5), considering the $I_{v,mean} = 38.73$ and the own damage grade observed for each one of these buildings. Additionally, three yellow dots, representing the mean values obtained from the I_v for each intensity, were also included.

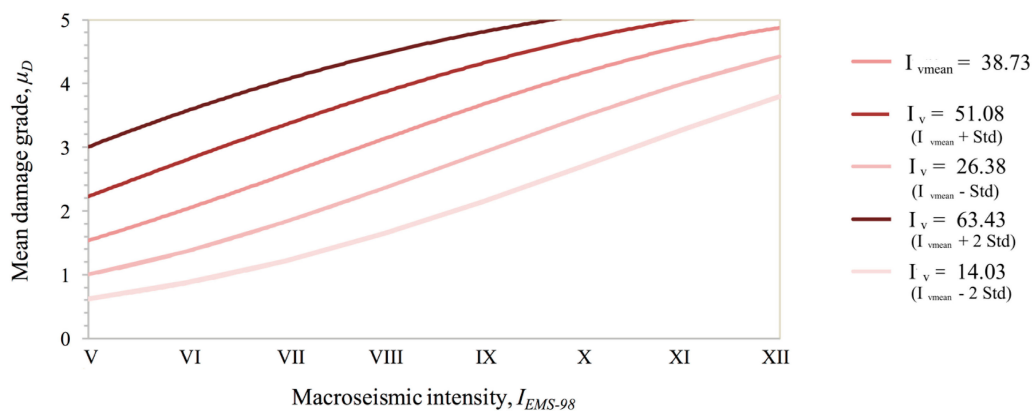
Figure 8. Vulnerability curves for Reinforced Concrete buildings.

Finally, Figure 8 presents the vulnerability curves obtained with the average value of the vulnerability index, with the addition and subtraction, single and double, of the standard deviation value obtained from the sample of 91 buildings. The analysis of the curves shows that the variation range of the degree of damage for each seismic intensity is relevant.

Based on the vulnerability curves presented in Figure 8, it is possible to observe that a building with a vulnerability index value higher than 51, a common value either for irregular buildings or with structural issues related with probable soft-stories or short columns, can present a mean damage grade between 2 and 3 for a seismic intensity of V, which means that it can present unneglectable structural damages. For seismic intensities between VIII and IX, the expectable mean damage grade can be 4 or higher, meaning that significant structural damages, or even collapse, may occur. For a regular

building without particular structural issues, the vulnerability index can be around 25, which represent a mean damage grade rounding 1 for a seismic intensity of V, and a mean damage grade lower than 3 (some structural damages without collapse) for a macroseismic intensity between VIII and IX.

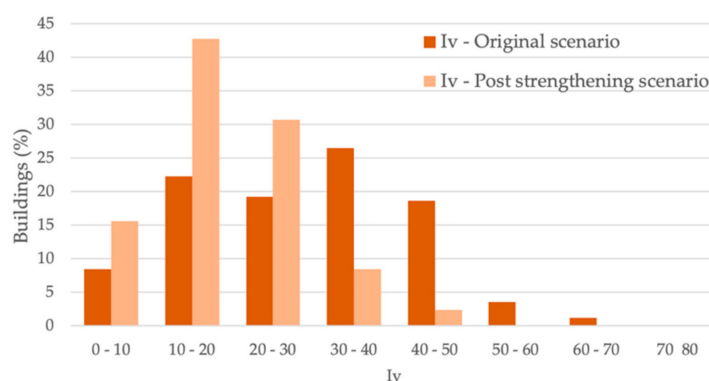
Figure 10. Comparison of the vulnerability index pre- and post-strengthening.

The change introduced in the vulnerability class of parameter P6 naturally leads to a reduction in the vulnerability index. Thus, an average I_v of 19.18 and a standard deviation, σ_{I_v} , of 8.94 was obtained, i.e., I_v and σ_{I_v} have a decrease of approximately 35% and 33%, respectively, from the initial value. Figure 10 shows the histogram of the distribution of values of vulnerability indices, pre- and post-strengthening. This comparison shows that the vulnerability index decreased significantly. In fact, with the strengthening, about 98% of buildings have a vulnerability class lower than 40, while only 2% have an I_v between 40 and 50. The maximum and minimum vulnerability index is 49.6 and 3.33, respectively.

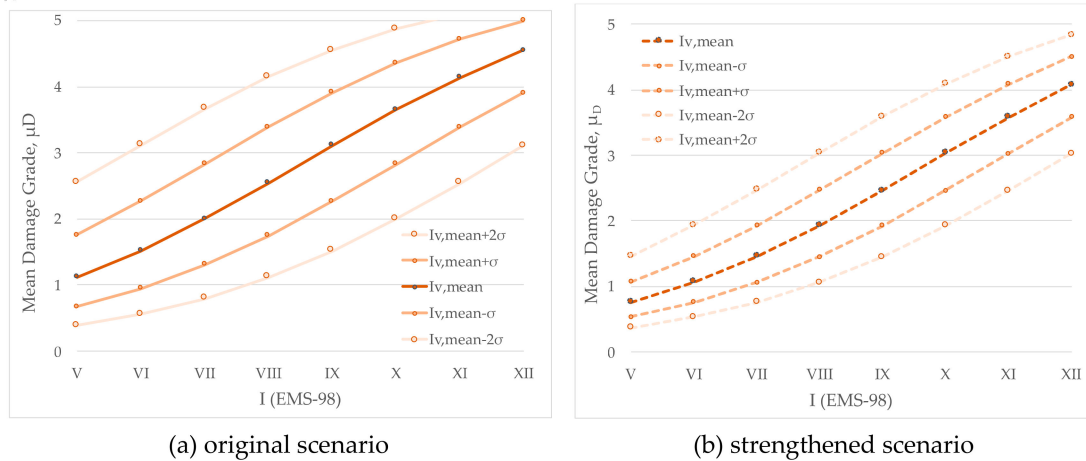
Figure 11. Vulnerability curves for the original (a) and the strengthened (b) scenarios.

After obtaining the new vulnerability indices for each building, the associated mean damage grades were re-estimated using the procedure presented earlier in Section 2.3. Figure 11 shows the vulnerability curves referring to the original and the strengthened scenarios, plotted for the characteristic values of the vulnerability index distributions: $I_{v,mean}$, $I_{v,mean} + \sigma_{Iv}$, $I_{v,mean} - \sigma_{Iv}$, $I_{v,mean} + 2\sigma_{Iv}$, and $I_{v,mean} - 2\sigma_{Iv}$.

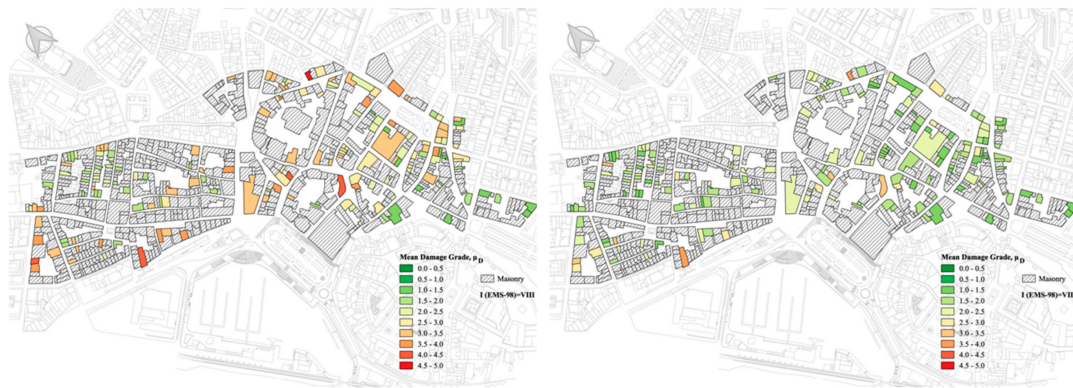
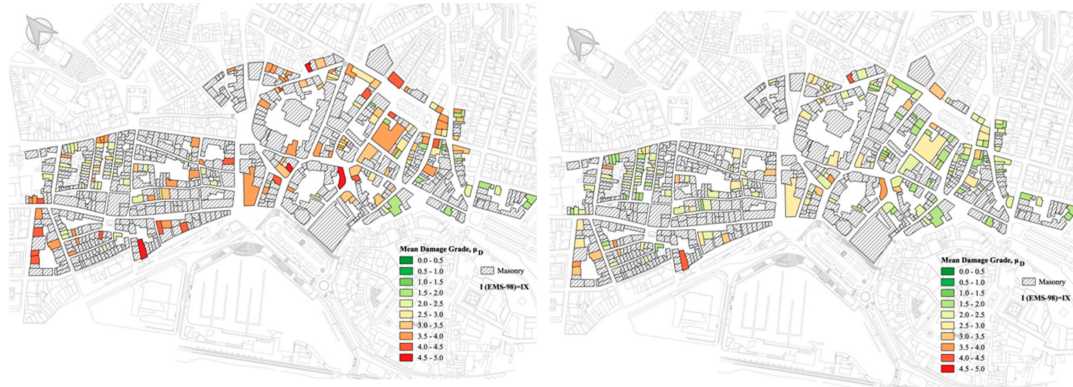
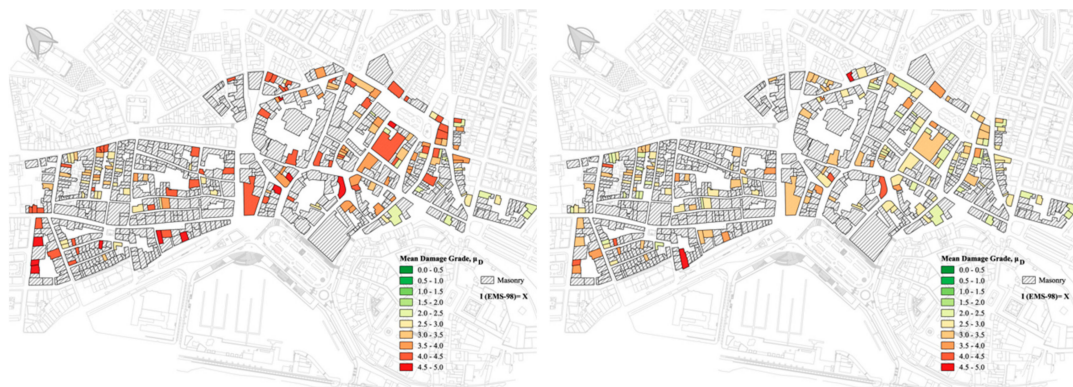
(a) $I_{EMS-98} = VII$

(b) $I_{EMS-98} = VIII$

(c) $I_{EMS-98} = IX$

(d) $I_{EMS-98} = X$

Figure 13. Original and post-strengthening damage scenarios.

Figure 13 shows the damage scenarios for seismic events characterized by macroseismic intensities, I_{EMS-98} , between VII and X. From the observation of the figures, it is possible to observe a significant difference in the color scale for the same macroseismic intensity after application of the seismic strengthening action.

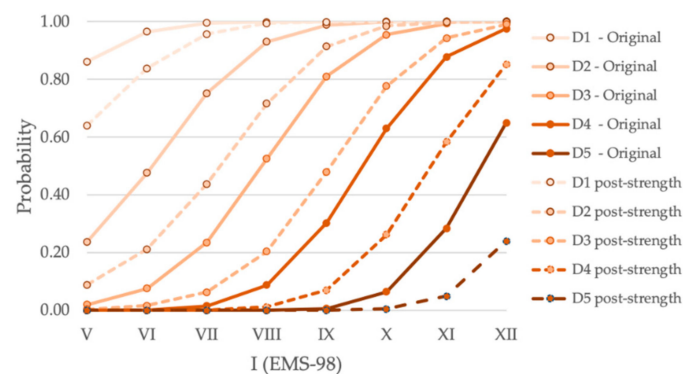
Figure 14. Comparison of fragility curves for the original and the strengthened scenario, i.e., for $I_v = 29.36$ and $I_v = 19.18$.

Figure 14 shows the fragility curves corresponding respectively to the original and the strengthened scenario. As can be seen from Figure 14 and as expected, after strengthening the critical buildings, the probability of exceeding the degree of damage decreases noticeably. By way of example, the probability of exceeding the degree of damage D3 for an earthquake of intensity VIII decreased by about 30%.

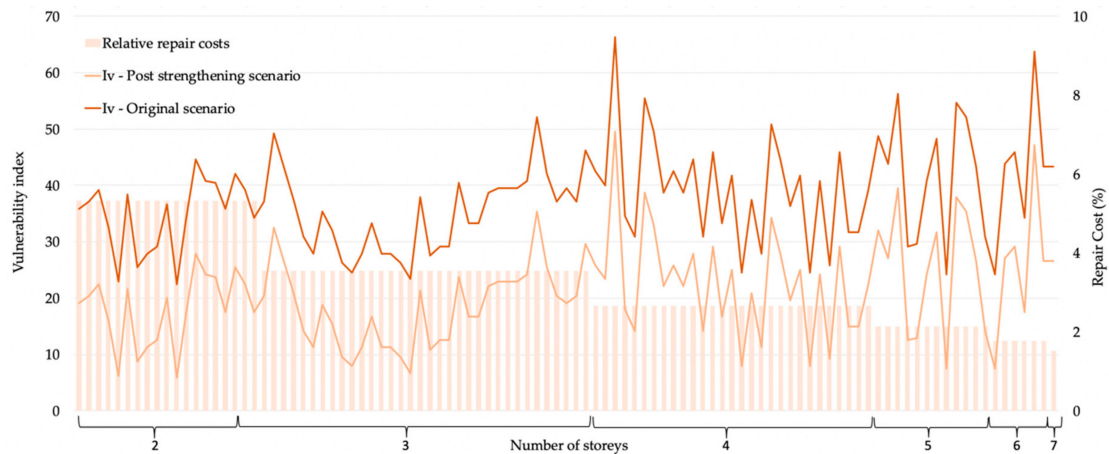
Figure 15. Relative costs of repair, pre-, and post-strengthening.

Given that the reinforcement of the structures is an intervention made only on the ground floor from energy dissipators [21], a total cost of strengthening was estimated as 80 €/m^2 , based on the values proposed by Furtado et al. [21]. For the construction cost, the average asset value of the buildings was taken into account. Thus, a value of 750 €/m^2 was assumed based on the average value attributed by the tax authorities to properties in the region. The area in plan refers to the area in plan of the building, and the construction area is the area in plan multiplied by the number of stories. Figure 15 shows the distribution of the relative cost of repair for the non-strengthened buildings and to the strengthened ones.

To observe its reduction after the intervention, the vulnerability index of the 101 buildings strengthened is also presented. In order to facilitate analysis, the buildings are organized by the number of floors. Figure 15 shows that the relative cost varies between 1.5% and 5.3%. Since the intervention was planned to be implemented only in the ground-stories, as expected, the taller buildings present lower relative cost when compared with the smaller ones. Thus, the relationship between the total cost of reinforcement and the total value of construction has higher values in buildings with fewer floors. In buildings with 6 or 7 floors, the relative cost is less than 2% of the construction value.

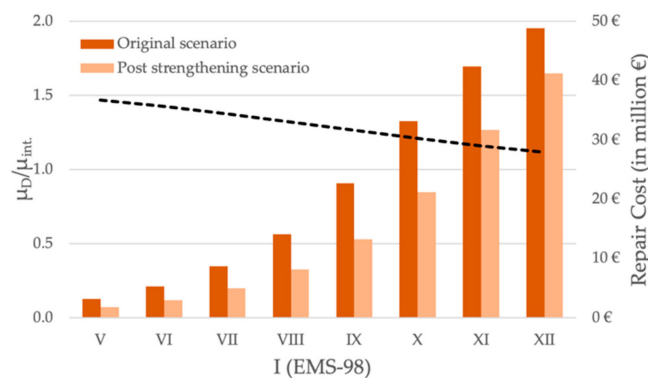
Figure 16. Estimated repair cost for different vulnerability indices.

The associated repair cost was estimated from the mean values of pre-reinforcement and post-reinforcement vulnerability indices, $I_{v,mean} = 29.36$, $I_{v,mean} = 19.18$, respectively. Figure 16 presents the estimated repair cost for the different vulnerability indices for the entire study area as a function of seismic intensity. Moreover, the relationship between the initially estimated degree of damage (μ_D) and the degree of damage after strengthening (μ_{Dint}) is also represented in the figure by the black slashed line.

As can be seen in Figure 16, the ratio of pre-strengthening and post-strengthening damage degrees decrease as the intensity increases. After strengthening the conditioning buildings, the estimated repair costs are significantly reduced. Intensity X deserves particular attention, since, besides it corresponds to the maximum historical intensity recorded in the city of Faro, it presents the most considerable difference in terms of repair cost between the original and the strengthened buildings.

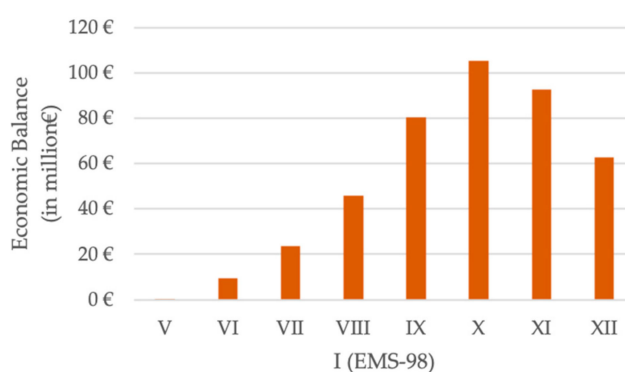
Figure 17. Economic balance for the whole study area.

Figure 17 presents the results of the economic balance of the entire study area as a function of macroseismic intensity.

As can be seen from Figure 17, in economic terms, the most favorable balance is obtained for the macroseismic intensity X. Moreover, it is also possible to observe that the strengthening solution analyzed in this work is efficient and economically viable for the whole intensity spectrum presented in Figure 16.
